# Rehabilitation of Wakamiya railway bridge (Japan)

#### 4. Rehabilitation of Wakamiya Railway Bridge (Japan)

**Owner:** Central Japan Railway Company  
**Engineer:** Central Japan Railway Company  
 Railway Technical Research Institute  
**Work's duration:** 3 months  
**Service date:** March of 1972 for up-bound line

The article describes the rehabilitation of a railway concrete slab girder bridge with double reinforcement by rigid concrete frame.

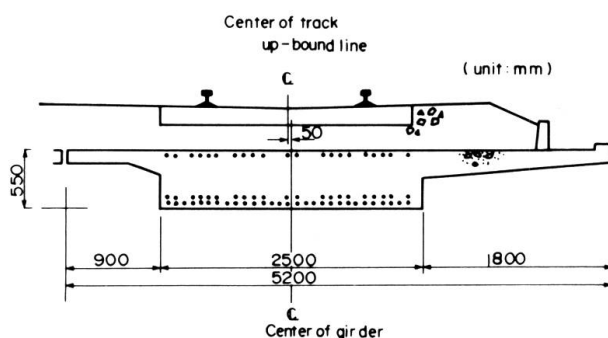
The Wakamiya bridge (Fig. 1), located at 439 km from Tokyo, was damaged as follows:

- 1) The bridge deflected vertically from 3.5 mm to 4.7 mm at the center of the span under a test train load. The ratios of deflection to span length are 1:2,860 and 1:2,130 respectively. These ratios are nearly equal to the specified value.

Fig. 1 Section of the girder of Wakamiya Bridge

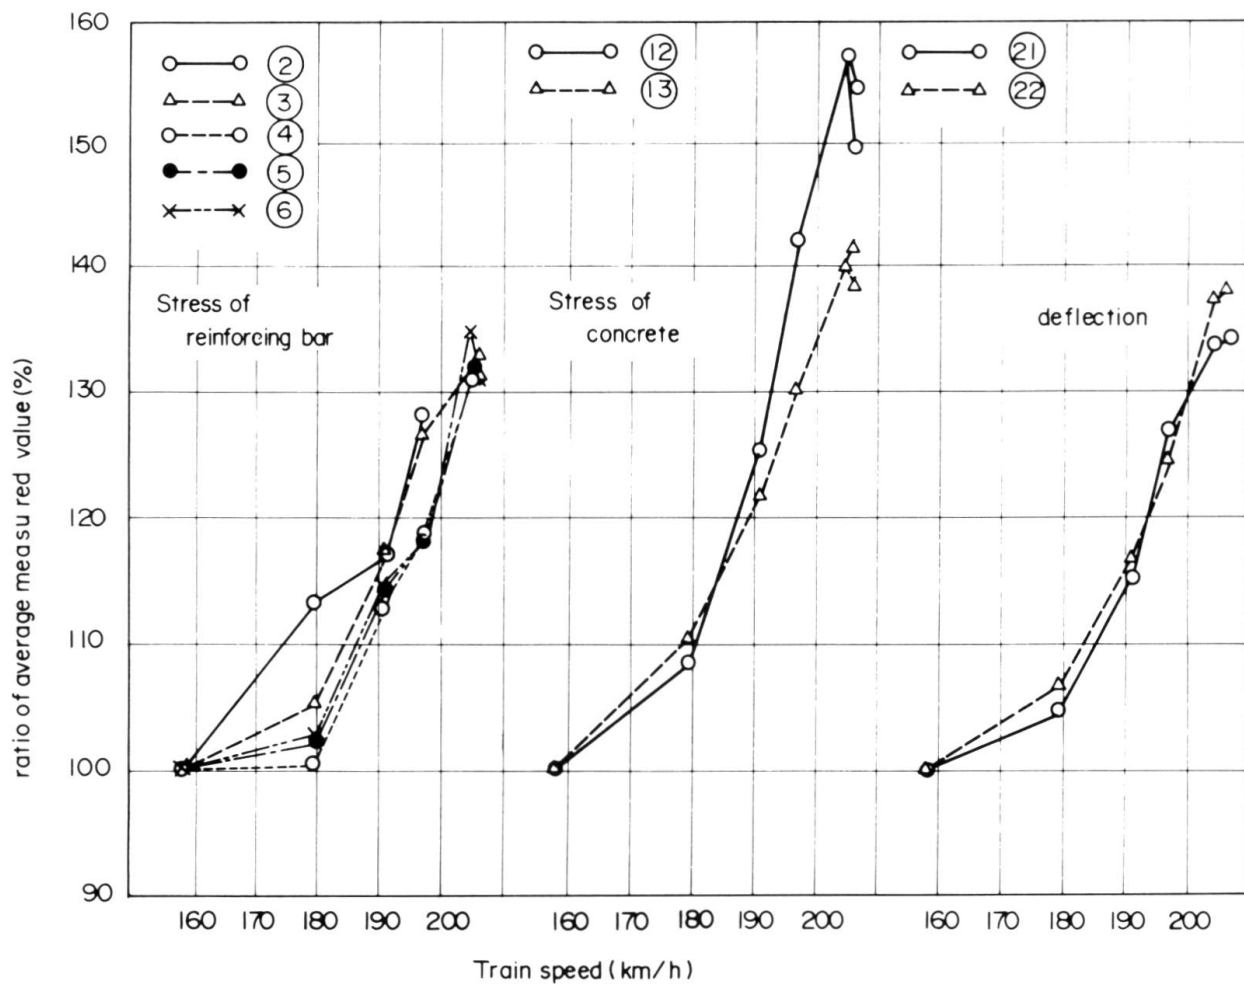
- 2) The maximum width of cracks on the surface of the concrete grew to 0.2 mm but most of them were 0.1 mm wide. Cracks opened on average by 0.04 mm under train load and returned by 0.01 mm.
- 3) The crack distributions on the concrete surface in June 1968 and in October 1970 are shown in Fig. 2. The number of cracks under repeated loading increased in about two years.
- 4) The ratios of the measured stress and deflection under test train loading are shown in Fig. 3, where the deflection ratio is the value of the deflection at the center of the span at each speed of test train to the value of the deflection at the speed of 158 km/h. The maximum increasing ratio amounts to 1.7, while the specified value is 1.43.

Fig. 3 Relationship between ratio of average measured value and train speed

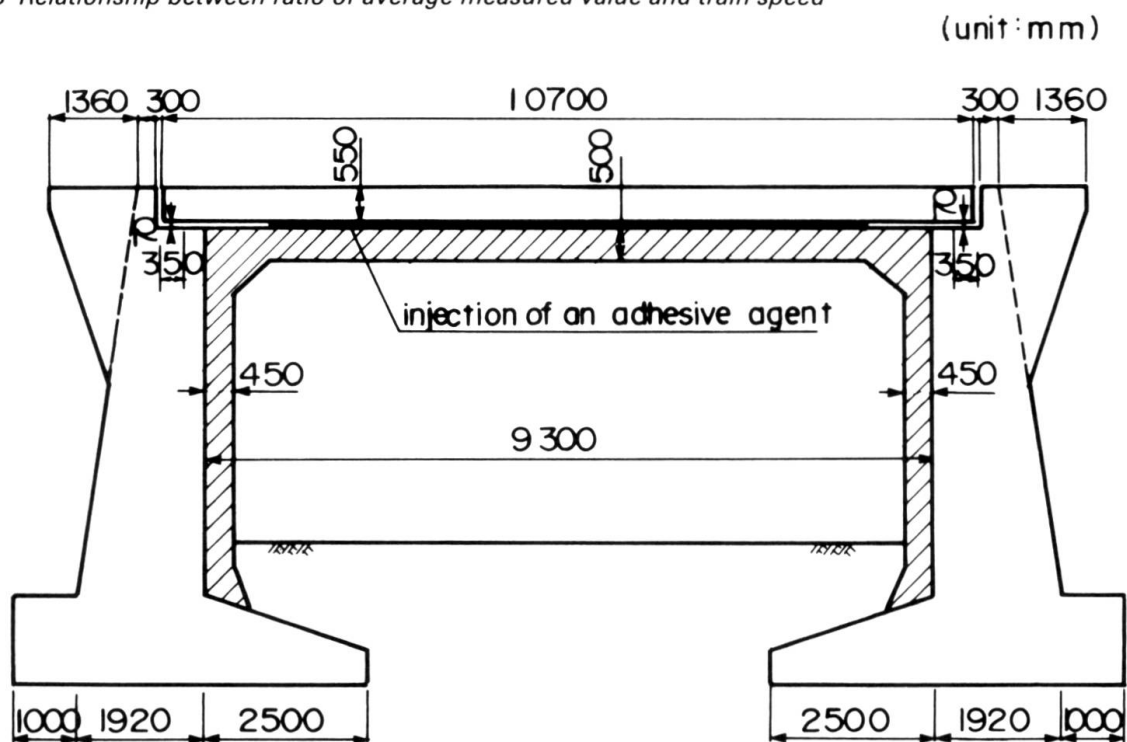
Fig. 4 General view of reinforced Wakamiya Bridge

The countermeasure to this damage is to avoid the resonance of the bridge. This is attained by setting the parameter  $v/2fl$  equal to less than  $1/3$ , where  $v$ : train speed,  $f$ : natural frequency of the bridge and  $l$ : span length. As the natural frequency increases according to the increase of the cross section of the bridge, it is possible to avoid the resonance. In the case of Wakamiya bridge, the slab girder was strengthened by a concrete rigid frame. The general view of reinforced Wakamiya bridge is shown in Fig. 4.

As the result of this reinforcement, the deflection was reduced to half of the original bridge. On Tokaido Shinkansen line, 8 girders of 4 bridges were improved by the same rehabilitation method.
