**Artikel:** Ohara Bridge fatigue crack repair (Japan)  
**Autor:** Miyazaki, Shoji  
**DOI:** <https://doi.org/10.5169/seals-20936>

## 6. Ohara Bridge Fatigue Crack Repair (Japan)

Owner: Toyama Prefecture  
 Engineer & Contractor: Kawada Industries  
 Work's duration: 6 months  
 Date of repair: 1984 – 1985

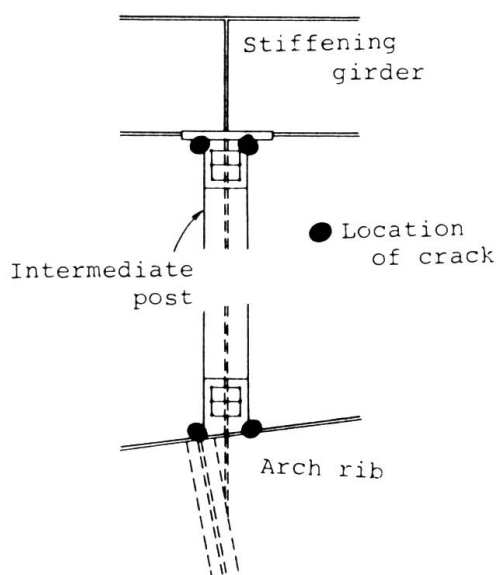
Fig. 2 Location of crack

The fatigue cracks occurred at the connecting gusset plates to each panel of intermediate post, which connects the stiffening girder to arch rib (Fig. 2, 3), and also at the web of stiffening girder above end post, which is the joint between center span and side span (Fig. 4, 5). These cracks were found by visual inspection during patrol in 1982.

According to the results of liquid penetrant tests conducted immediately after finding them, the maximum length of the cracks was 65 mm at the gusset plate of intermediate post, respectively 185 mm at the web of stiffening girder.

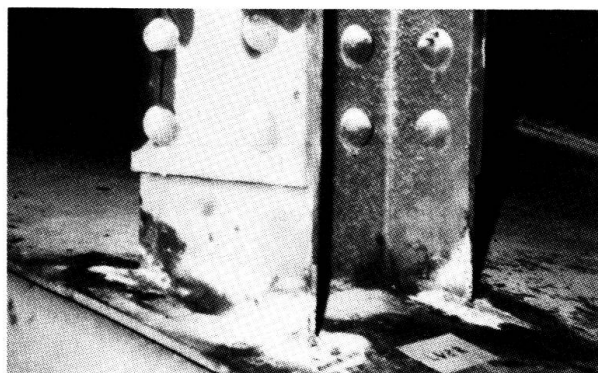
Fig. 3 Crack at gusset

The fatigue cracks in the gusset plates of intermediate posts were mainly caused by excessive stress concentration at the corner section. This stress concentration was caused by a relatively large longitudinal displacement between stiffening girder and arch rib, which was created by the movability of both end supports. This was confirmed from displacement obtained in a loading test on the actual bridge, results from stress measurements, and the results of 3-dimensional finite element method analysis (Fig. 6). Therefore, as repairing method, new damper bearings were installed on the top of both abutments for reducing the relative longitudinal displacement (Fig. 7). This damper bearing comprised a rubber bearing, return spring and special hydraulic damping system. The supporting condition provides movability at both support bearings for static movement such as temperature effect and resists only to vertical movement caused by live load, giving elastic restraint toward longitudinal movements. Moreover, improvement schemes by making rigid joints or by providing hinges at the gusset plates of intermediate posts were reviewed, but the former indicated an adverse influence upon arch rib and the latter was found to be uneasy to work with. In addition, the compression stress was found to be primary, and the relief of residual stress by the outbreak of cracks was found to be expectable, so both improvement schemes were not adopted this time.

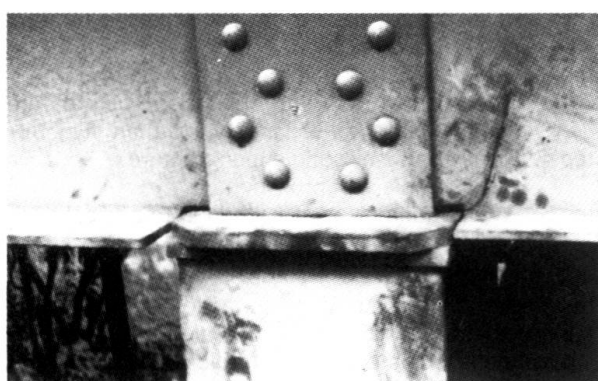
Fig. 5 Crack at stiffening girder web

With respect to the fatigue cracks in the web of stiffening girder above the end post, the stress concentration by secondary bending stress at the notches, which also resulted from out-of-plane displacement, was found to

Among these cracks, a temporary repair was made for the cracks in the web of stiffening girder immediately after finding them in order to prevent a rapid breakdown as explained below. That is, stop holes were drilled at the end of all cracks in the web. Moreover, steel brackets were installed on all end posts and were used as temporary supports for stiffening girders in side span and center span.

be the main cause of the fatigue cracks. This was also confirmed by the loading test on the actual bridge. In the repairing method adopted, it was first necessary to reduce the out-of-plane displacement of web and thus lateral bracings were added near the location of web. As repairing measures against the cracks in web, three schemes were reviewed: making rigid connections or hinged connections at the joints, or repairing cracked portion by double plates. In consequence, the scheme of repairing the cracked portion by double plates was adopted from the viewpoint of easier work and appearance (Fig. 8). It was decided to leave the steel brackets, installed during temporary repair, as they were.

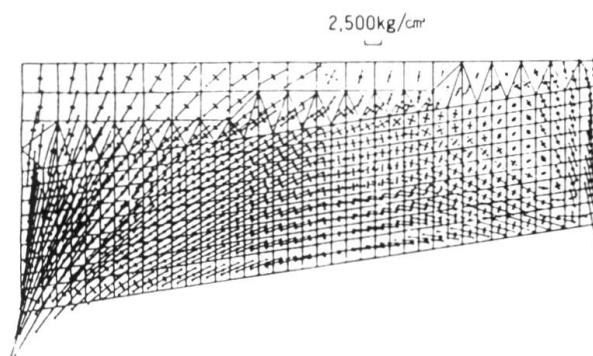
Fig. 6 F.E.M. analysis stress diagram
