Artikel: Ohara Bridge fatigue crack repair (Japan)
Autor: Miyazaki, Shoji
DOI: <https://doi.org/10.5169/seals-20936>

6. Ohara Bridge Fatigue Crack Repair (Japan)

Owner: Toyama Prefecture
 Engineer & Contractor: Kawada Industries
 Work's duration: 6 months
 Date of repair: 1984 – 1985

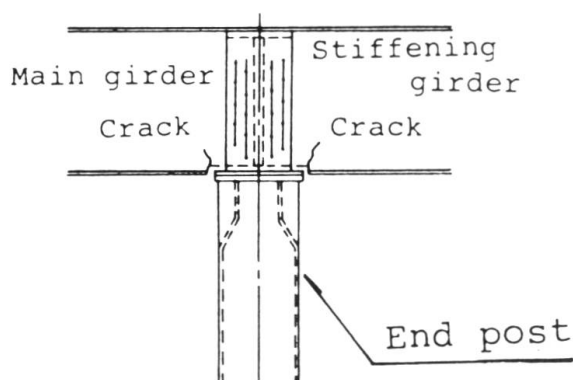
Fig. 4 Location of crack

The fatigue cracks occurred at the connecting gusset plates to each panel of intermediate post, which connects the stiffening girder to arch rib (Fig. 2, 3), and also at the web of stiffening girder above end post, which is the joint between center span and side span (Fig. 4, 5). These cracks were found by visual inspection during patrol in 1982.

According to the results of liquid penetrant tests conducted immediately after finding them, the maximum length of the cracks was 65 mm at the gusset plate of intermediate post, respectively 185 mm at the web of stiffening girder.

With respect to the fatigue cracks in the web of stiffening girder above the end post, the stress concentration by secondary bending stress at the notches, which also resulted from out-of-plane displacement, was found to

Among these cracks, a temporary repair was made for the cracks in the web of stiffening girder immediately after finding them in order to prevent a rapid breakdown as explained below. That is, stop holes were drilled at the end of all cracks in the web. Moreover, steel brackets were installed on all end posts and were used as temporary supports for stiffening girders in side span and center span.

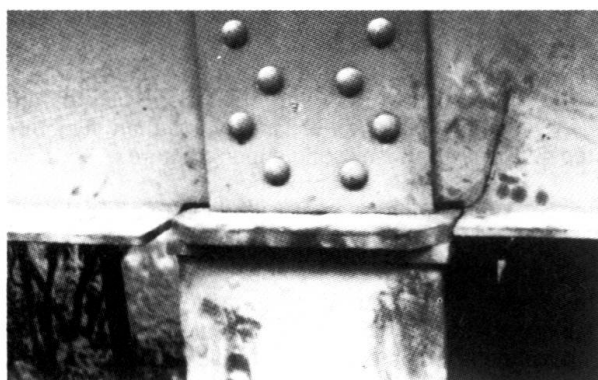
Fig. 5 Crack at stiffening girder web

be the main cause of the fatigue cracks. This was also confirmed by the loading test on the actual bridge. In the repairing method adopted, it was first necessary to reduce the out-of-plane displacement of web and thus lateral bracings were added near the location of web. As repairing measures against the cracks in web, three schemes were reviewed: making rigid connections or hinged connections at the joints, or repairing cracked portion by double plates. In consequence, the scheme of repairing the cracked portion by double plates was adopted from the viewpoint of easier work and appearance (Fig. 8). It was decided to leave the steel brackets, installed during temporary repair, as they were.
