**Zeitschrift:** IABSE structures = Constructions AIPC = IVBH Bauwerke  
**Band:** 12 (1988)  
**Heft:** C-47: Repair and rehabilitation of bridges: case studies II

**Artikel:** Ohara Bridge fatigue crack repair (Japan)  
**Autor:** Miyazaki, Shoji  
**DOI:** <https://doi.org/10.5169/seals-20936>

## 6. Ohara Bridge Fatigue Crack Repair (Japan)

**Owner:** Toyama Prefecture  
**Engineer & Contractor:** Kawada Industries  
**Work's duration:** 6 months  
**Date of repair:** 1984 – 1985

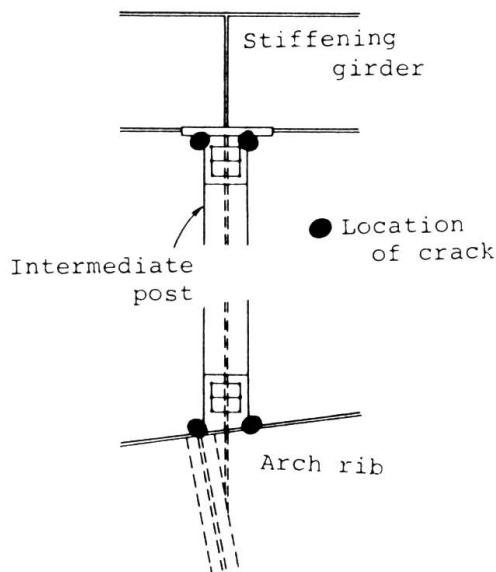
Fig. 2 Location of crack

The fatigue cracks occurred at the connecting gusset plates to each panel of intermediate post, which connects the stiffening girder to arch rib (Fig. 2, 3), and also at the web of stiffening girder above end post, which is the joint between center span and side span (Fig. 4, 5). These cracks were found by visual inspection during patrol in 1982.

According to the results of liquid penetrant tests conducted immediately after finding them, the maximum length of the cracks was 65 mm at the gusset plate of intermediate post, respectively 185 mm at the web of stiffening girder.

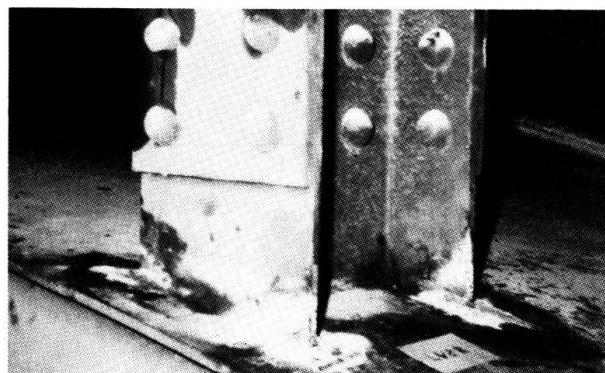
Fig. 3 Crack at gusset

The fatigue cracks in the gusset plates of intermediate posts were mainly caused by excessive stress concentration at the corner section. This stress concentration was caused by a relatively large longitudinal displacement between stiffening girder and arch rib, which was created by the movability of both end supports. This was confirmed from displacement obtained in a loading test on the actual bridge, results from stress measurements, and the results of 3-dimensional finite element method analysis (Fig. 6). Therefore, as repairing method, new damper bearings were installed on the top of both abutments for reducing the relative longitudinal displacement (Fig. 7). This damper bearing comprised a rubber bearing, return spring and special hydraulic damping system. The supporting condition provides movability at both support bearings for static movement such as temperature effect and resists only to vertical movement caused by live load, giving elastic restraint toward longitudinal movements. Moreover, improvement schemes by making rigid joints or by providing hinges at the gusset plates of intermediate posts were reviewed, but the former indicated an adverse influence upon arch rib and the latter was found to be uneasy to work with. In addition, the compression stress was found to be primary, and the relief of residual stress by the outbreak of cracks was found to be expectable, so both improvement schemes were not adopted this time.

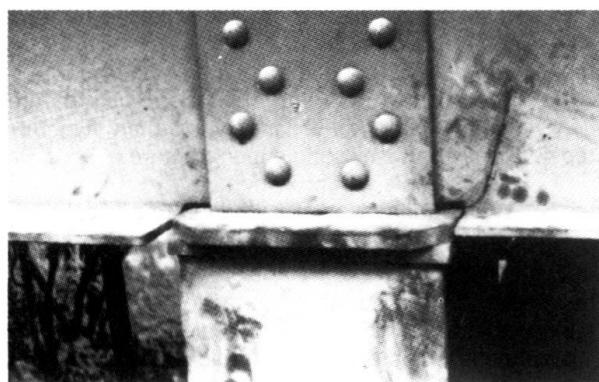
Fig. 5 Crack at stiffening girder web

With respect to the fatigue cracks in the web of stiffening girder above the end post, the stress concentration by secondary bending stress at the notches, which also resulted from out-of-plane displacement, was found to

Among these cracks, a temporary repair was made for the cracks in the web of stiffening girder immediately after finding them in order to prevent a rapid breakdown as explained below. That is, stop holes were drilled at the end of all cracks in the web. Moreover, steel brackets were installed on all end posts and were used as temporary supports for stiffening girders in side span and center span.

be the main cause of the fatigue cracks. This was also confirmed by the loading test on the actual bridge. In the repairing method adopted, it was first necessary to reduce the out-of-plane displacement of web and thus lateral bracings were added near the location of web. As repairing measures against the cracks in web, three schemes were reviewed: making rigid connections or hinged connections at the joints, or repairing cracked portion by double plates. In consequence, the scheme of repairing the cracked portion by double plates was adopted from the viewpoint of easier work and appearance (Fig. 8). It was decided to leave the steel brackets, installed during temporary repair, as they were.

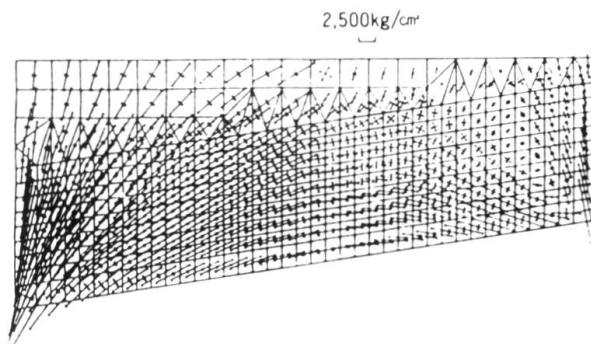
Fig. 6 F.E.M. analysis stress diagram

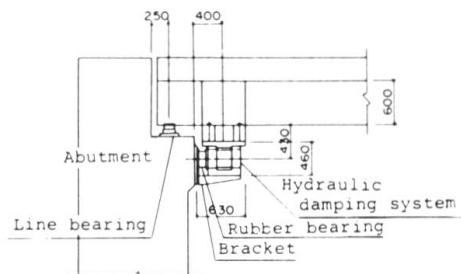
Fig. 7 Damper bearing

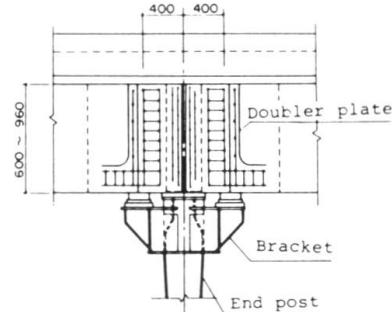
Fig. 8 Doubler plate added to web
