**Artikel:** Fujigawa Bridge rehabilitation project (Japan)  
**Autor:** Matsuo, Yoshio  
**DOI:** <https://doi.org/10.5169/seals-20937>

## 7. Fujigawa Bridge Rehabilitation Project (Japan)

<b>Owner:</b>	<i>Shizuoka Prefecture</i>
<b>Contractor:</b>	
<b>Substructure:</b>	<i>Sumitomo Construction</i>
<b>Deck replacement:</b>	<i>Japan Bridge</i>
<b>Superstructure:</b>	<i>Yokogawa Bridge Works</i>
<b>Work's duration:</b>	<i>6 months</i>
<b>Date of repair:</b>	<i>1987 – 1988</i>

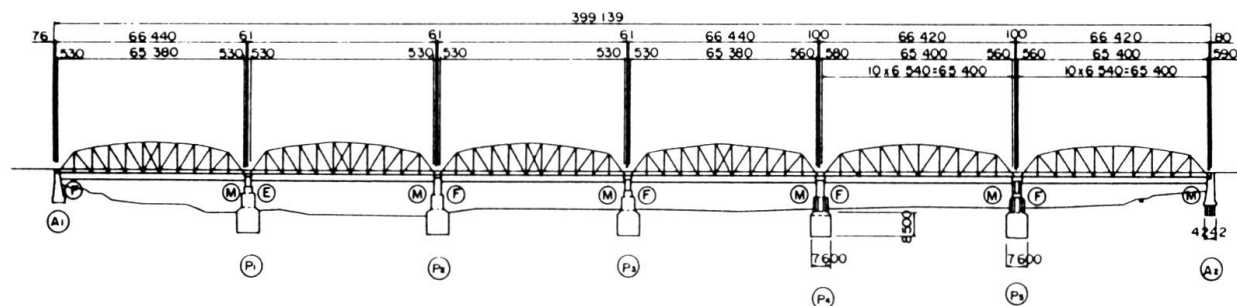
Fig. 1 Elevation

The Fujigawa Bridge, completed in 1924, over the Fuji River on Route 1 is a bridge with six-span curved chord pratt truss having a bridge length of 300.1 m, roadway width of 7.3 m and span of 65.4 m (Fig. 1). Route 1 is the most important road in Japan, and 60 years after completion of the bridge, the daily traffic flow was 21 000 vehicles, though bypass roads had been completed upstream and downstream of the bridge.

After many years of use, such problems as cracked concrete decks, corroded outer stringers, overstressed and deflected stringers, and scouring at the piers due to the lowered river bed of the Fuji River have occurred. Also, as a result of the increased traffic flow, traffic congestion caused by right turning cars holding the traffic had become a big problem.

To solve these problems, the substructure of the bridge was reinforced, and the stringers and deck on four spans to the left bank were replaced. Moreover, two spans to the right bank were replaced in order to install a right turning lane by the method that was chosen to complete the job with the least disturbance to traffic.
