Artikel: Strengthening of bridge slab at Kami-Imasu Bridge (Japan)
Autor: Inokuma, Yasuo
DOI: <https://doi.org/10.5169/seals-20938>

8. Strengthening of Bridge Slab at Kami-Imasu Bridge (Japan)

Owner: Japan Highway Public Corporation

Date of Repair: 1976

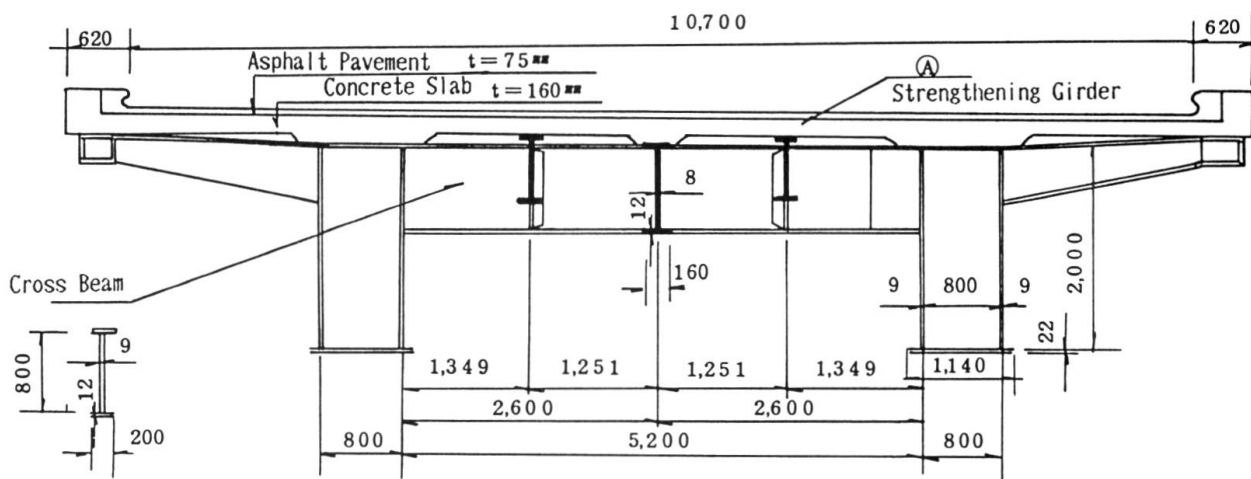
Fig. 1 Structure

After ten years of service, cracks in the slab increased to such an extent that it had to be repaired and strengthened. Finally it was decided to install stringers in between the original main box girders and the original central stringers as shown in Fig. 1. The reasons for the adoption of this method are as follows:

- 1) The traffic volume was so large that it was difficult to conduct the repair work on the upper side of the slab.
- 2) It was expected to be sufficiently effective on decrease of the bending moment of the slab.
