8. Strengthening of Bridge Slab at Kami-Imasu Bridge (Japan)

Owner: Japan Highway Public Corporation
Engineer: Japan Highway Public Corporation
Date of Construction: 1964
Date of Repair: 1976

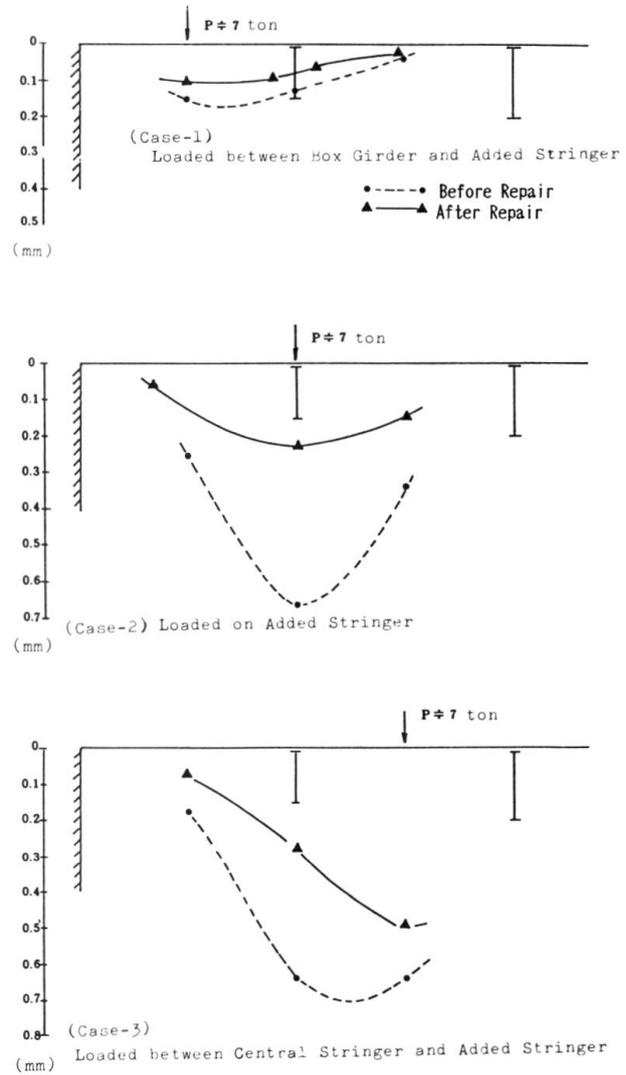
Fig. 2 Effect of Repair

A loading test was conducted, using a truck with a 7-ton rear wheel load in order to measure the difference of deflections before and after the strengthening. The result is shown in Fig. 2.

In cases where the wheel was located between the main box girder and the added stringer (Case-1), on the added stringer (Case-2) and between the original stringer and the added stringer (Case-3), the deflections at the loading points after repair were decreased to 60%, 66% and 78%, respectively. The repair work is, thus, estimated as successful.

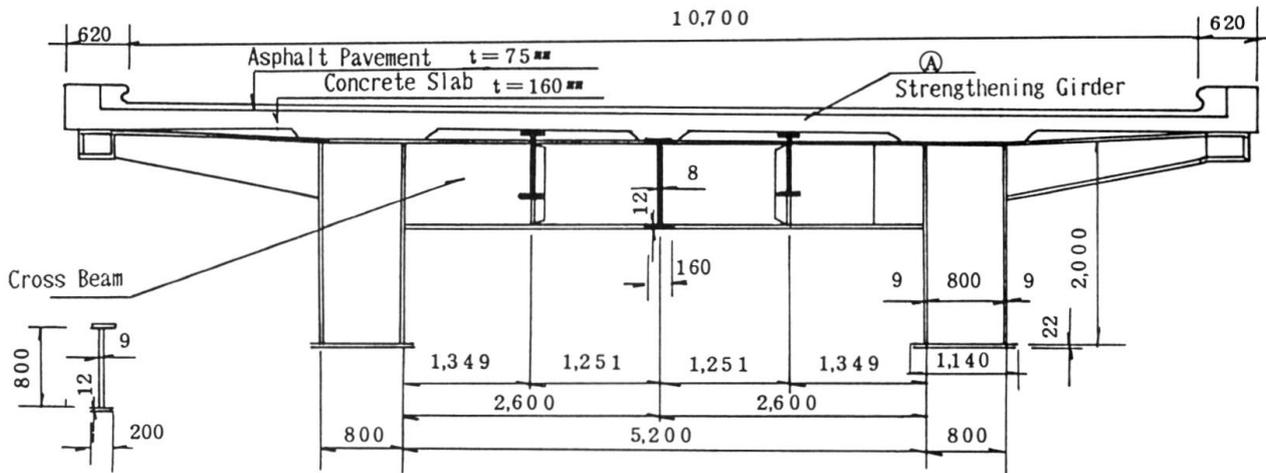
Fig. 1 Structure

After ten years of service, cracks in the slab increased to such an extent that it had to be repaired and strengthened. Finally it was decided to install stringers in between the original main box girders and the original central stringers as shown in Fig. 1. The reasons for the adoption of this method are as follows:

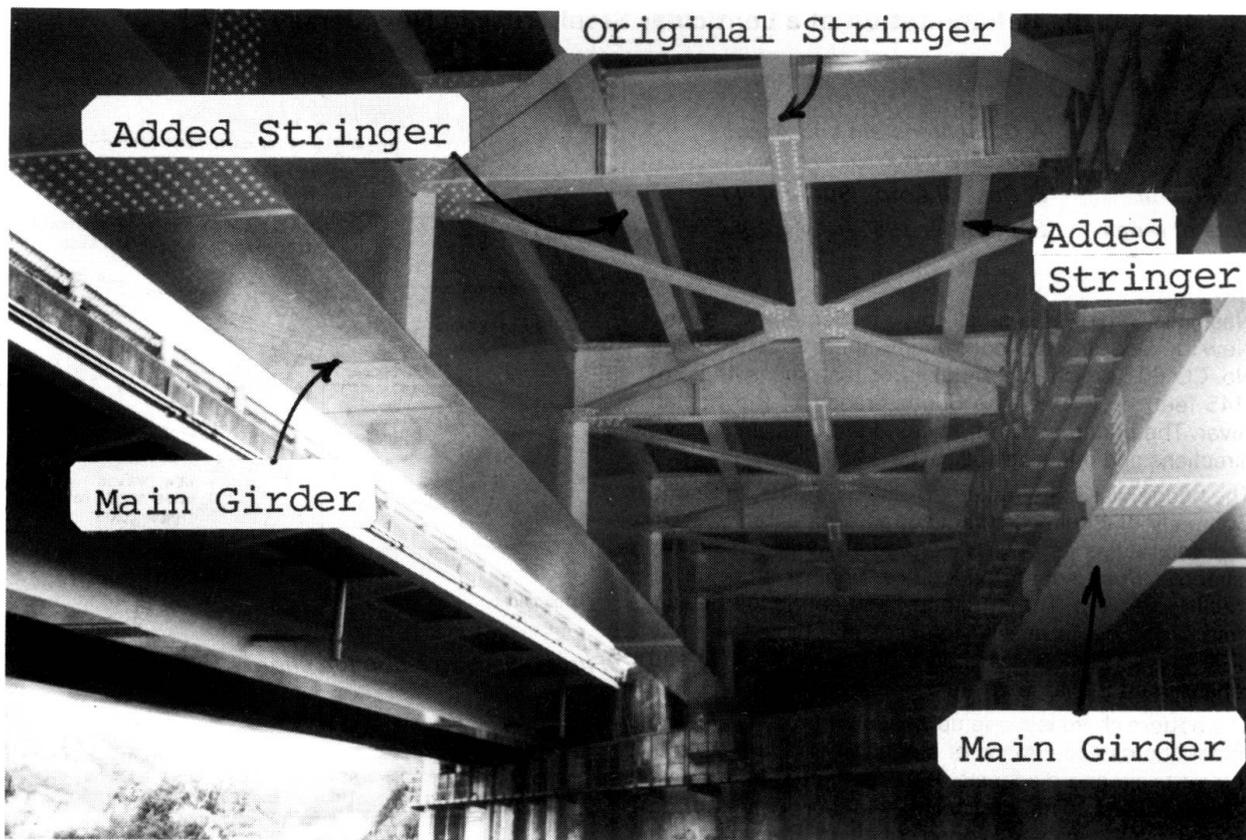
Photo 1 General View of Strengthening

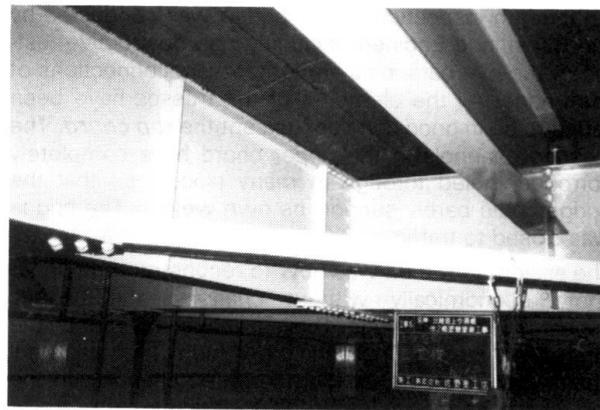
Photo 2 Detail of Added Stringer
