8. Strengthening of Bridge Slab at Kami-Imasu Bridge (Japan)

Owner: Japan Highway Public Corporation

Date of Repair: 1976

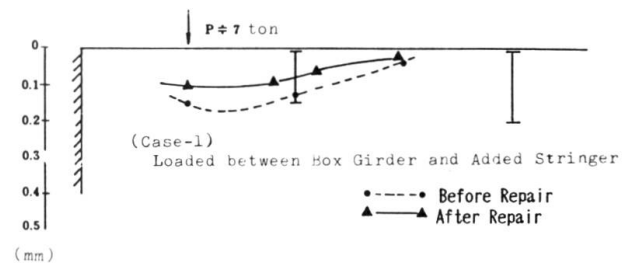
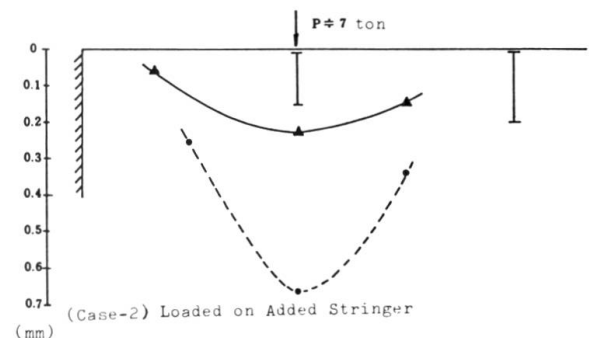
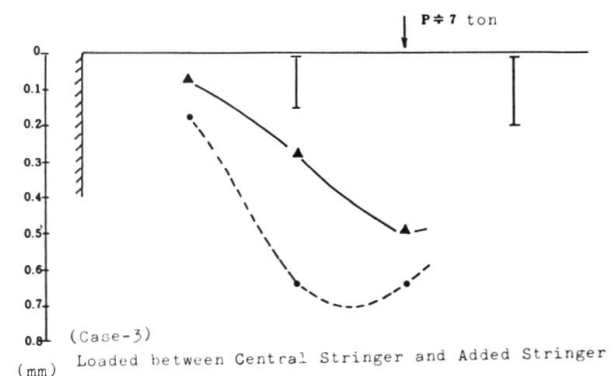
Fig. 2 Effect of Repair

A loading test was conducted, using a truck with a 7-ton rear wheel load in order to measure the difference of deflections before and after the strengthening. The result is shown in Fig. 2.

In cases where the wheel was located between the main box girder and the added stringer (Case-1), on the added stringer (Case-2) and between the original stringer and the added stringer (Case-3), the deflections at the loading points after repair were decreased to 60%, 66% and 78%, respectively. The repair work is, thus, estimated as successful.

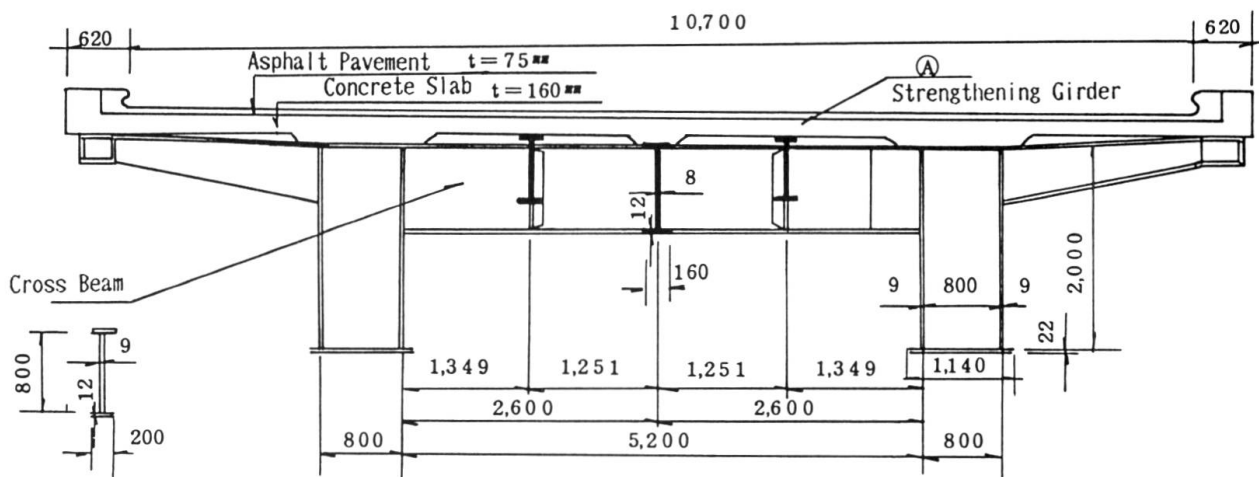
Fig. 1 Structure

After ten years of service, cracks in the slab increased to such an extent that it had to be repaired and strengthened. Finally it was decided to install stringers in between the original main box girders and the original central stringers as shown in Fig. 1. The reasons for the adoption of this method are as follows:

- 1) The traffic volume was so large that it was difficult to conduct the repair work on the upper side of the slab.
- 2) It was expected to be sufficiently effective on decrease of the bending moment of the slab.
