Artikel: Strengthening of bridge slab at Kami-Imasu Bridge (Japan)
Autor: Inokuma, Yasuo
DOI: <https://doi.org/10.5169/seals-20938>

8. Strengthening of Bridge Slab at Kami-Imasu Bridge (Japan)

Owner: Japan Highway Public Corporation

Date of Repair: 1976

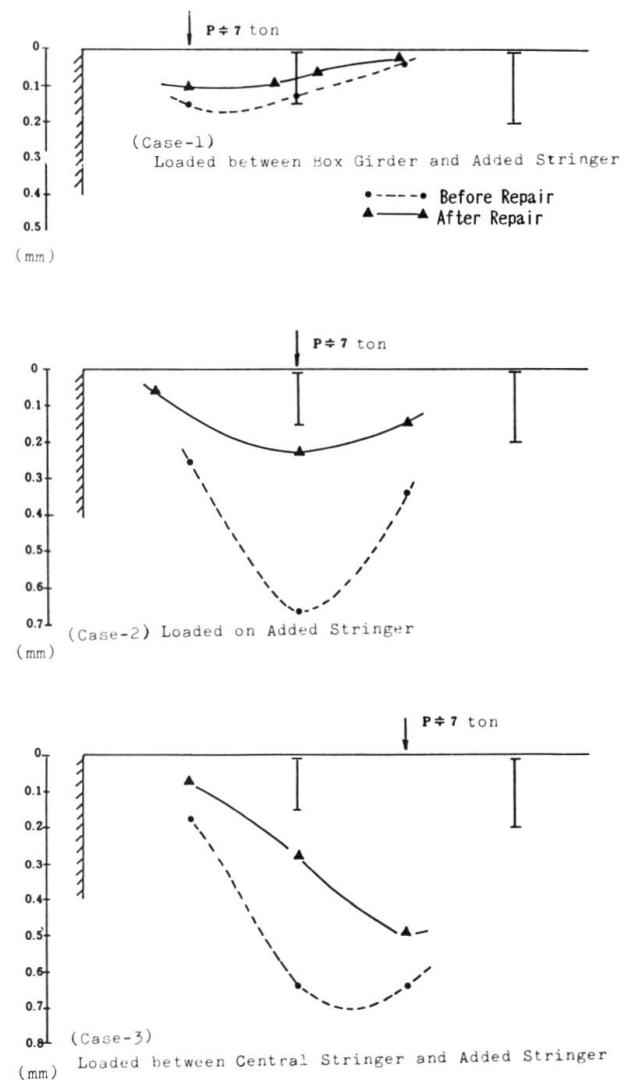
Fig. 2 Effect of Repair

A loading test was conducted, using a truck with a 7-ton rear wheel load in order to measure the difference of deflections before and after the strengthening. The result is shown in Fig. 2.

In cases where the wheel was located between the main box girder and the added stringer (Case-1), on the added stringer (Case-2) and between the original stringer and the added stringer (Case-3), the deflections at the loading points after repair were decreased to 60%, 66% and 78%, respectively. The repair work is, thus, estimated as successful.

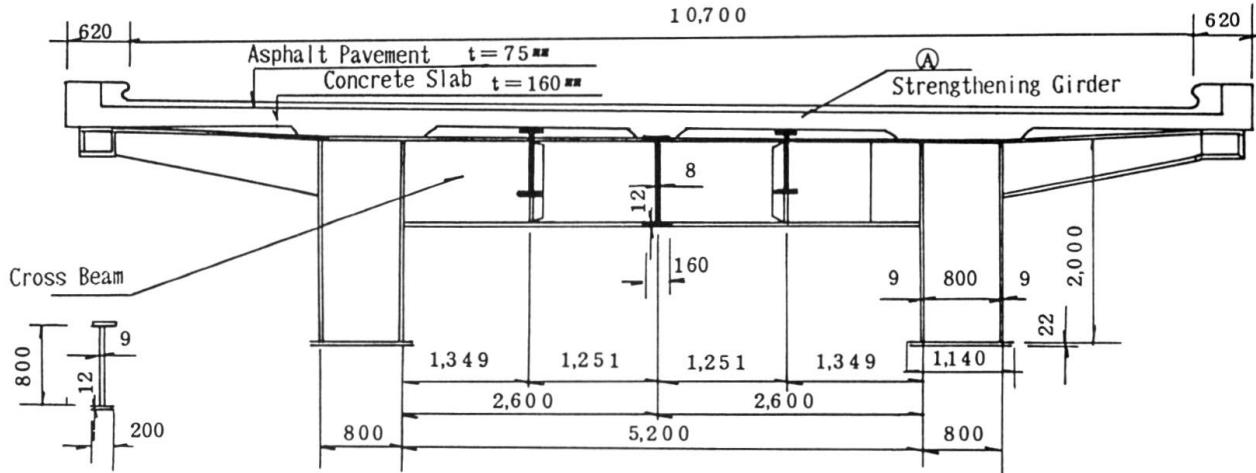
Fig. 1 Structure

After ten years of service, cracks in the slab increased to such an extent that it had to be repaired and strengthened. Finally it was decided to install stringers in between the original main box girders and the original central stringers as shown in Fig. 1. The reasons for the adoption of this method are as follows:

- 1) The traffic volume was so large that it was difficult to conduct the repair work on the upper side of the slab.
- 2) It was expected to be sufficiently effective on decrease of the bending moment of the slab.
