8. Strengthening of Bridge Slab at Kami-Imasu Bridge (Japan)

Owner: Japan Highway Public Corporation

Date of Construction: 1964

Date of Repair: 1976

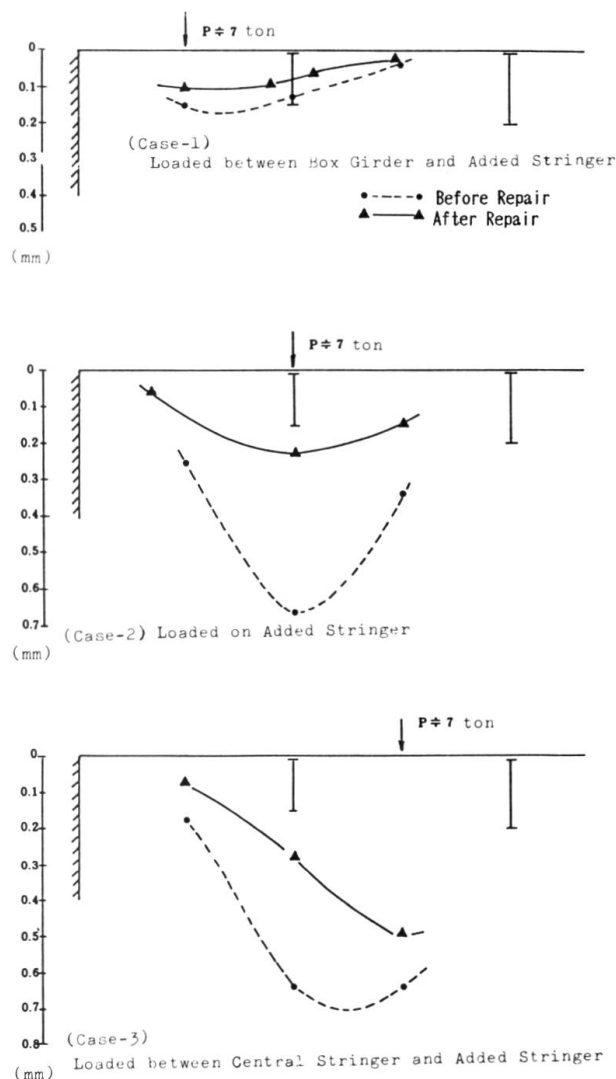
Fig. 2 Effect of Repair

A loading test was conducted, using a truck with a 7-ton rear wheel load in order to measure the difference of deflections before and after the strengthening. The result is shown in Fig. 2.

In cases where the wheel was located between the main box girder and the added stringer (Case-1), on the added stringer (Case-2) and between the original stringer and the added stringer (Case-3), the deflections at the loading points after repair were decreased to 60%, 66% and 78%, respectively. The repair work is, thus, estimated as successful.

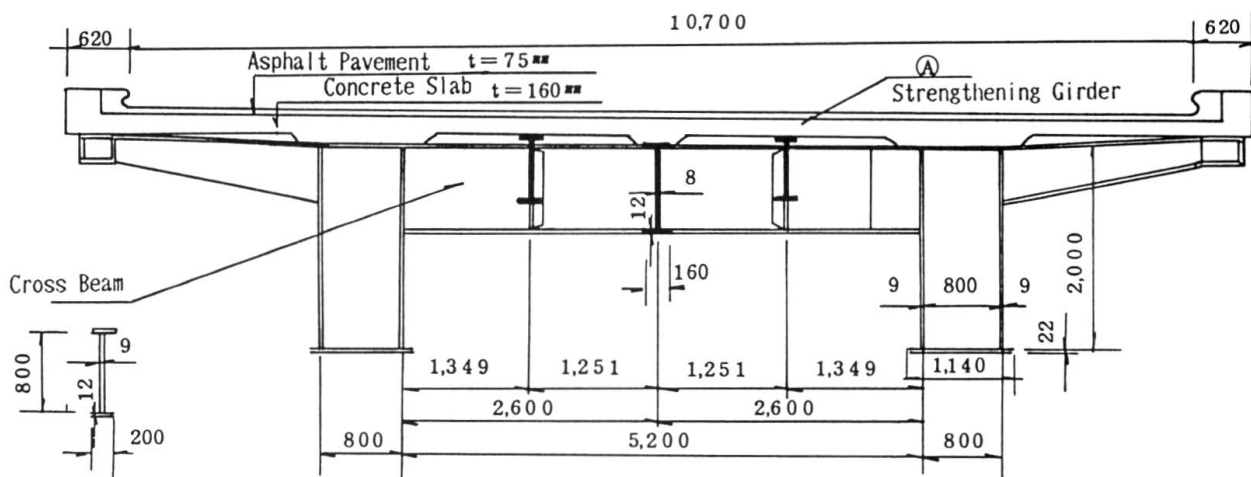
Fig. 1 Structure

After ten years of service, cracks in the slab increased to such an extent that it had to be repaired and strengthened. Finally it was decided to install stringers in between the original main box girders and the original central stringers as shown in Fig. 1. The reasons for the adoption of this method are as follows:

- 1) The traffic volume was so large that it was difficult to conduct the repair work on the upper side of the slab.
- 2) It was expected to be sufficiently effective on decrease of the bending moment of the slab.

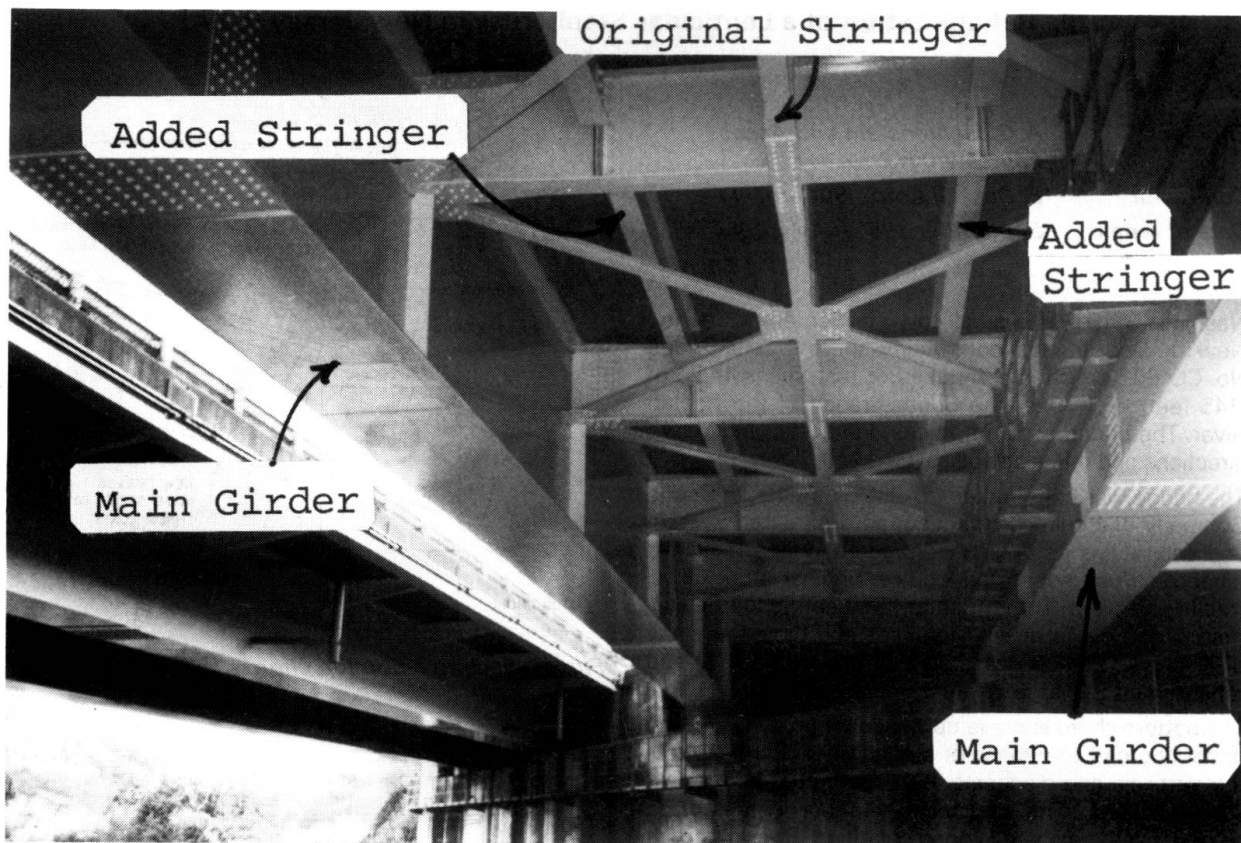
Photo 1 General View of Strengthening

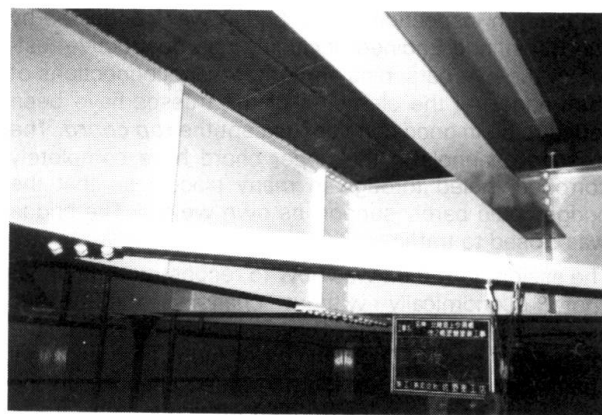
Photo 2 Detail of Added Stringer
