10. Repair and Rehabilitation of Roma-Viterbo Railway Bridges (Italy)

Owner: A.CO.TRA.L. – Azienda Consortile Trasporti Laziali

Design: Prof. Ing. Giorgio Croci

Contractor: NICIS S.P.A. – Roma

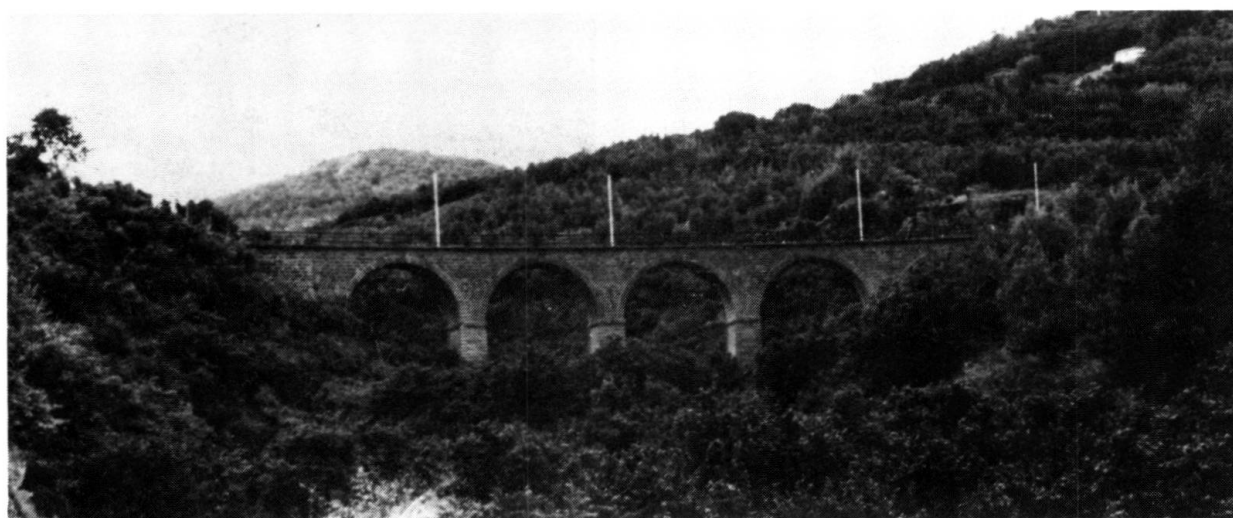
Fig. 1 Global view of the viaduct

The main cracking manifestations are located in correspondence of the connection zone between the external hanging and the arcades involving the almost longitudinal development of viaducts.

These crackings are located almost exclusively on the external side of the curves because of centrifugal actions (see fig. 1).
