Artikel: Repair and rehabilitation of Roma-Viterbo railway bridges (Italy)
Autor: Croci, G.
DOI: <https://doi.org/10.5169/seals-20940>

10. Repair and Rehabilitation of Roma-Viterbo Railway Bridges (Italy)

Owner: A.CO.TRA.L. – Azienda Consortile
Trasporti Laziali
Design: Prof. Ing. Giorgio Croci
Contractor: NICIS S.P.A. – Roma

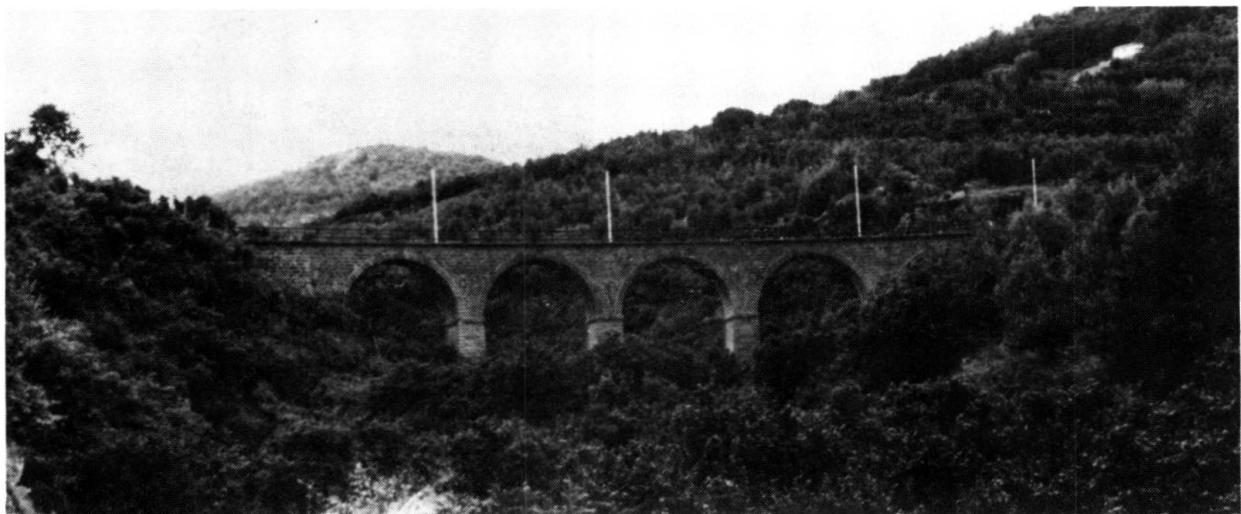
The main cracking manifestations are located in correspondence of the connection zone between the external hanging and the arcades involving the almost longitudinal development of viaducts.

These crackings are located almost exclusively on the external side of the curves because of centrifugal actions (see fig. 1).

Fig. 1 Global view of the viaduct

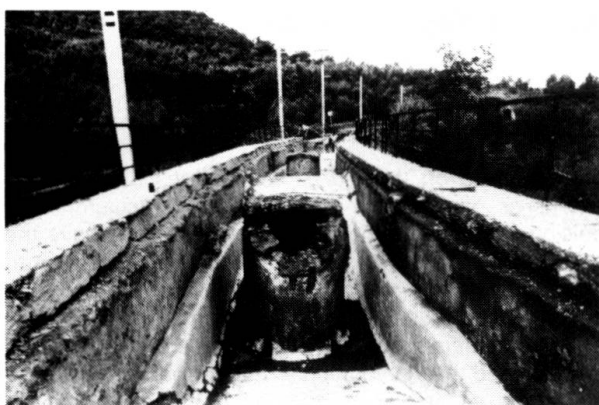
Fig. 2 A view of the inside of viaduct after removing of filling

The structural consolidation interventions consist in the realization of a reinforced concrete structure adherent on the existing masonry, after removing the internal filling (see fig. 2).

The slab on the extrados of the arcades has a thickness variable between 15 and 25 cm; the internal walls are 15 cm thick and follow the internal configuration of existing structures.
