Zeitschrift:	IABSE structures = Constructions AIPC = IVBH Bauwerke
Band:	12 (1988)
Heft:	C-47: Repair and rehabilitation of bridges: case studies II
Artikel:	Repair and rehabilitation of Roma-Viterbo railway bridges (Italy)
Autor:	Croci, G.

10. Repair and Rehabilitation of Roma-Viterbo Railway Bridges (Italy)

Owner:	A.CO.TRA.L. – Azienda Trasporti Laziali	Consortile
Design:	Prof. Ing. Giorgio Croci	
Contractor:	NICIS S. P. A. – Roma

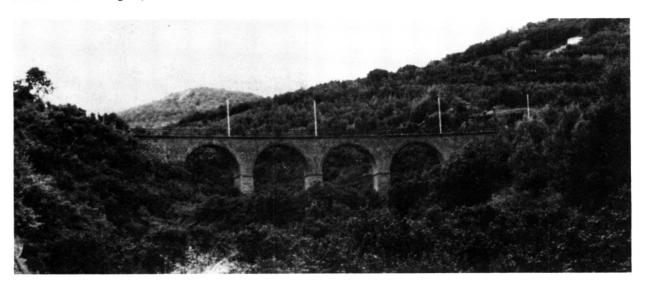
Fig. 1 Global view of the viaduct

The main cracking manifestations are located in correspondence of the connection zone between the external hanging and the arcades involving the almost longitudinal development of viaducts.

These crackings are located almost exclusively on the external side of the curves because of centrifugal actions (see fig. 1).
