Artikel: The collapse and reconstruction of a prestressed concrete box-section girder
Autor: Bachmann, Hugo / Horisberger, Werner
DOI: <https://doi.org/10.5169/seals-32462>

The Collapse and Reconstruction of a Prestressed Concrete Box-Section Girder

Hugo Bachmann

Werner Horisberger,

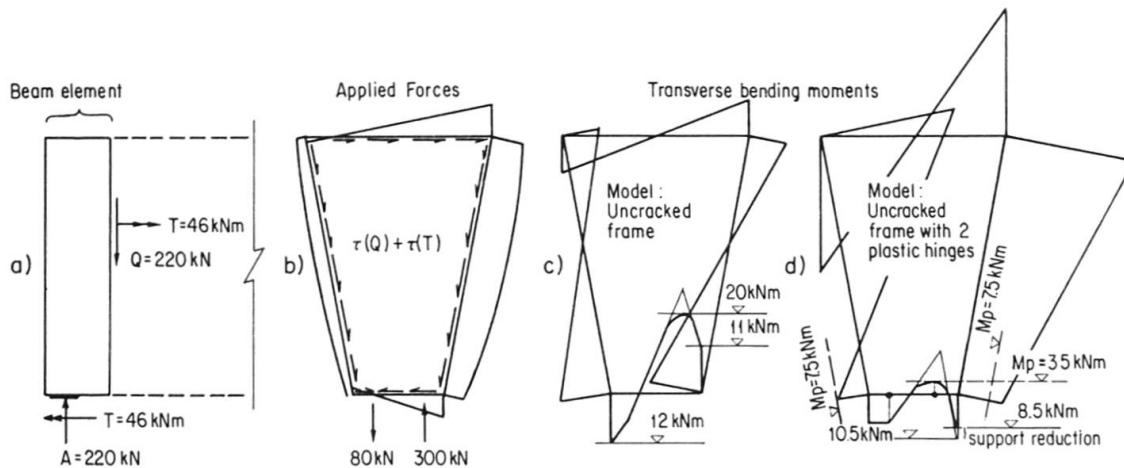
The concentric loading comes to $220/330 = 2/3$ of the previously analysed loading. Each support reaction comes to +110 kN. The torsional loading consists of a constant shear flow τt and equal but opposite reactions of ± 190 kN. Fig. 10b gives for the sum of both load cases the shear flow and support reactions of $110 \pm 190 = +300$ kN or -80 kN.

By a similar procedure to that in the previous section for firstly an uncracked frame, the moment diagram shown in Fig. 10c results. This however can not occur since the existent yielding moments(resisting) are exceeded. After the introduction of plastic hinges over the right support bearing point and at the transition of the bottom flange to the left web, the moment diagram in Fig. 10d results. This is however likewise not possible. As described in the previous section, there is a possible sideways displacement of the support reactions towards the webs. This is caused by plastic deformations and should be taken into consideration if an equilibrium condition is to be found.

Fig. 10 Transverse bending of support region after placement of the slab units on one side only (eccentric loading).

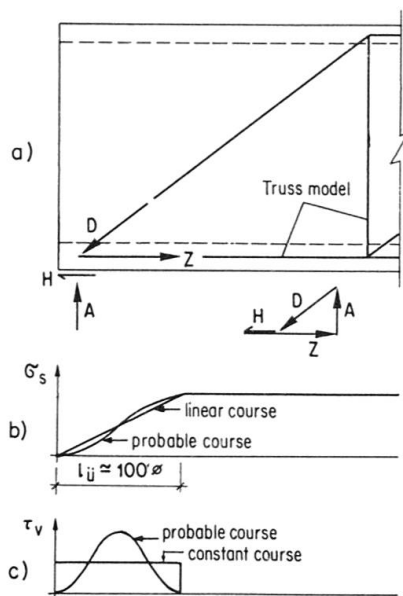
In Fig. 11a the force system in the web plane of the support region is schematically shown i.e. with a truss model that simplifies the actual situation. The inclined compressive force D stands in equilibrium with the tensile chord force Z and the support reaction A . If in addition there acts an external support force H , e.g. a secondary reaction, then Z must be increased with respect to H . If one takes an angle of inclination of 40° for D and ignores a possible H , then for a support reaction of 330 kN there results a Z of approximately 390 kN.

Fig. 11 End anchorage: internal forces following from the introduction of the support reaction (truss model); steel stresses and bond stresses from the prestress force.

These stipulations were in the discussed case either not at all or insufficiently fulfilled. The wires were cut through one after another with a power cutter. This led to a considerable disturbance of bond. Between various prestressed wires and parallel running end stirrups present the spacing was only a few millimeters. This did not everywhere keep to the well-known rule which states that the spacing of the placed steel should not be less than the the maximum aggregate diameter (here 15 mm).

From these points it can be assumed that the steel stress at the girder end was under proportional and only further into the girder interior increased to over proportional (Fig. 11b). Correspondingly the bond stress at the girder end was relatively small (Fig. 11c). With plausible assumptions the anchorage force comes within the region of 270 to 380 kN. Here the vertical end stirrups $\varnothing 8$ mm lying parallel to the prestress wires were not investigated. The bond of this steel with the concrete must, in consequence of the small spacing, have been relatively bad.

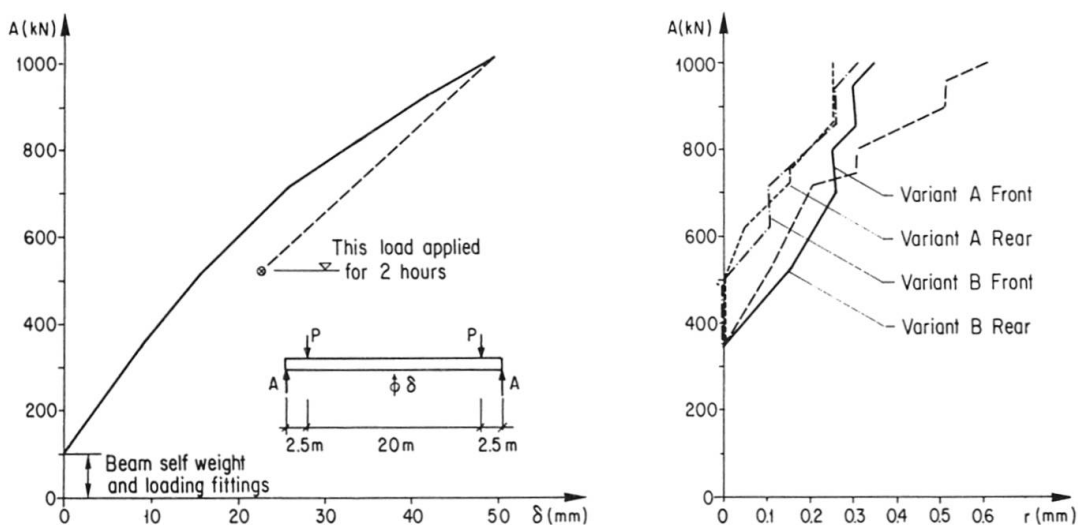
Both remedial solutions showed themselves to be workable. The self weight of the beam and the test fittings led to a support reaction of 115 kN. With a support reaction corresponding to that of a full working load i.e. with $Q(g+p) \approx 500$ kN there first appeared a few cracks in the web of maximum width 0.15 mm. The mid-span deflection (without self weight) was 16 mm. Following on from here a load giving a support reaction corresponding to twice the working load reaction, i.e. $2Q(g+p) \approx 1000$ kN, could be obtained without fracture. Under this maximum loading the largest crack width in the webs was 0.60 mm and the deflection midspan = 50 mm. Fig. 20 shows the midspan deflection and also the crack widths as functions of the support reaction. Fig. 21 shows the crack pattern at the girder end A.

Fig. 20 Midspan deflection of the girder and also the largest crack width r in the webs as a function of the support reaction
