Artikel: The collapse and reconstruction of a prestressed concrete box-section girder

The Collapse and Reconstruction of a Prestressed Concrete Box-Section Girder

Hugo Bachmann

Werner Horisberger,

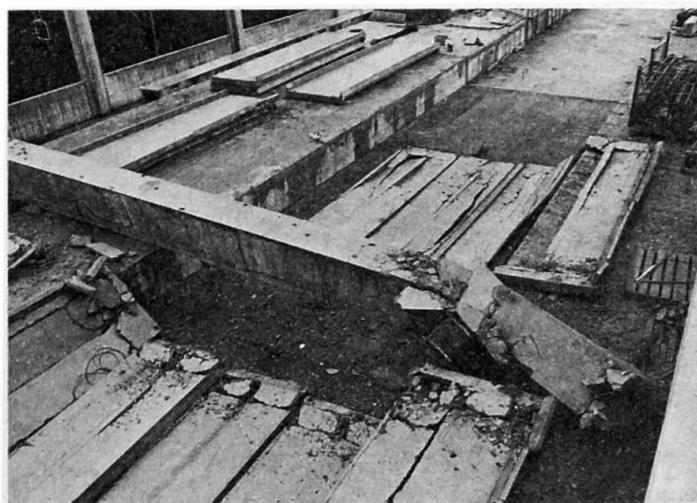
Fig. 2

The situation on the construction site immediately after the collapse is shown in Figs. 2, 3 and 4. The first examinations showed immediately that the girder 10/E-G had somehow broken through at the support at column E/10. From there it had fallen to the ground and in doing so also tore away from the support G/10.

View from E/9 towards the collapsed box-section girder. In front and behind are the collapsed roof slab units.

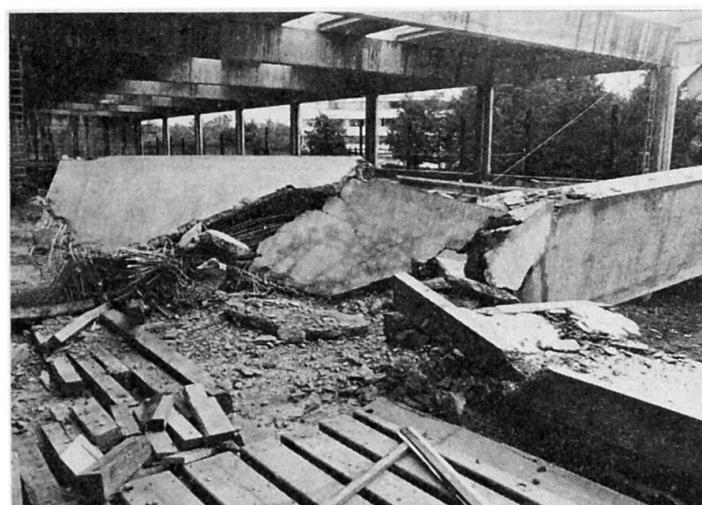
Fig. 3

View from E/11 towards the collapsed girder. The pre-stress wires of the bottom flange were fully exposed in the collapse.

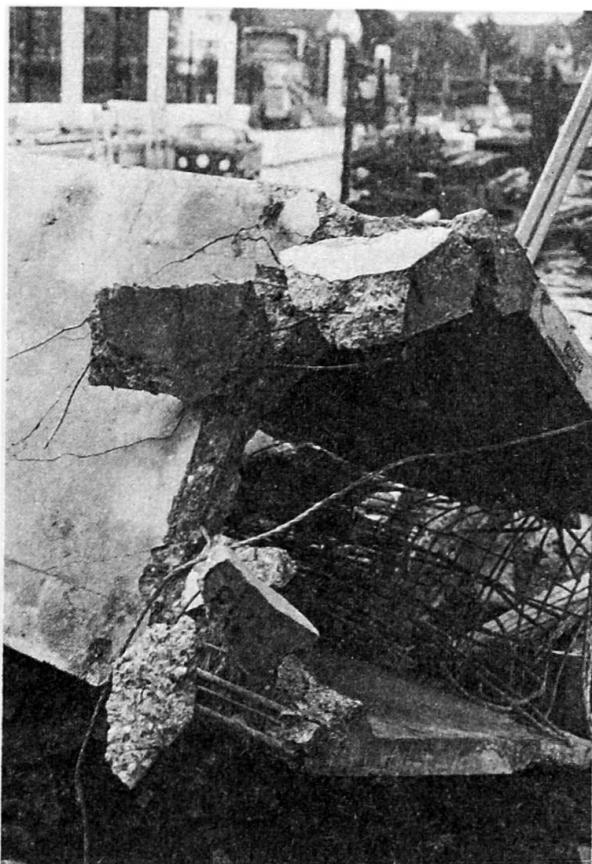
Fig. 4

View of girder end E/10. The girder has broken through the bottom and top flanges at the support.

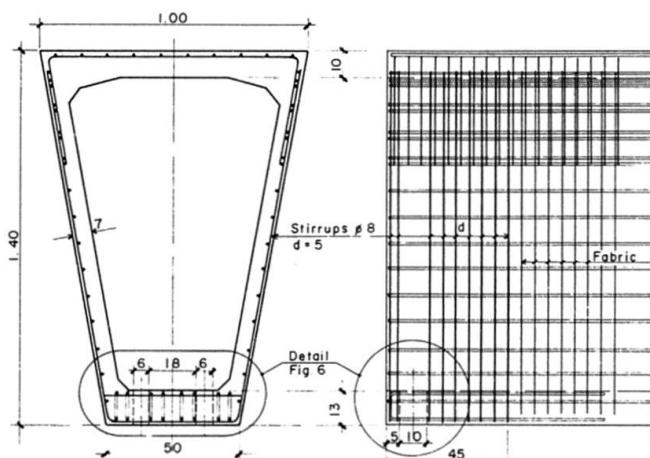
Fig. 5

The to scale dimensions and reinforcement of the support region are shown in Figs. 5 and 6. The girder had no transverse end beam. In the bottom flange were 10 cm long x 5 cm wide holes for 3 cm Ø bolts cast into the column. The support bearing points in the centre of these holes were to scale 10 cm from the girder

Dimensions and reinforcement of the girder support region.

end. However this value could be reduced to nearly 7 cm when measurement variations were taken into account. This was the case with the collapsed girder. The workers on site informed that the bolts had scarcely fitted through the holes in the girder. In the transverse direction the support points did not sit beneath the webs, but were about 10 cm within the cross-section.

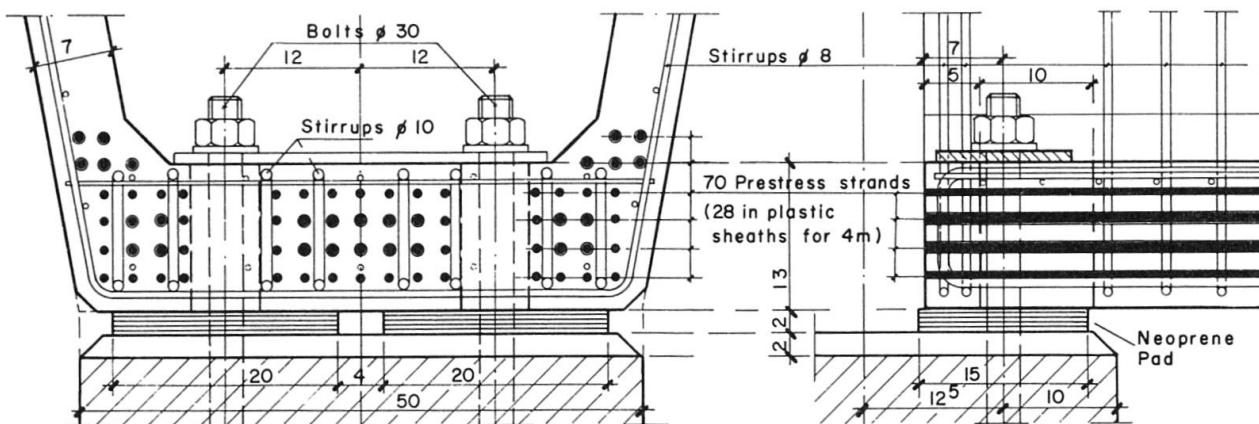
Fig. 6 Layout of the support region. Support in extreme situation.

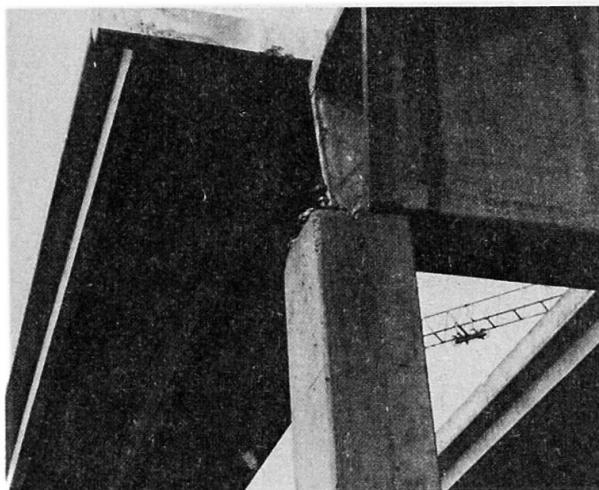
Fig. 7

View from beneath towards the column head E/10. Right is the girder 10/C-E. Left was the collapsed girder 10/E-G.

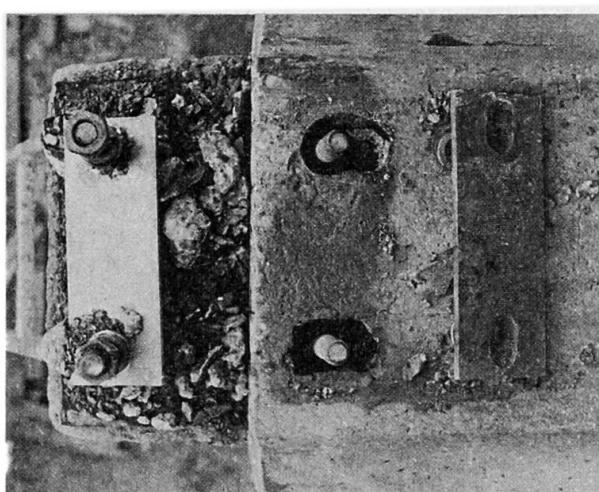
Fig. 8

View from above of the column head E/10. Righthand end of the beam 10/C-E with holes in the bottom flange and removed nuts and steel plate. Remainder of lefthand end of the collapsed girder 10/E-G with the still present nuts and top steel plate. Beneath the rubble are both the neoprene pads.

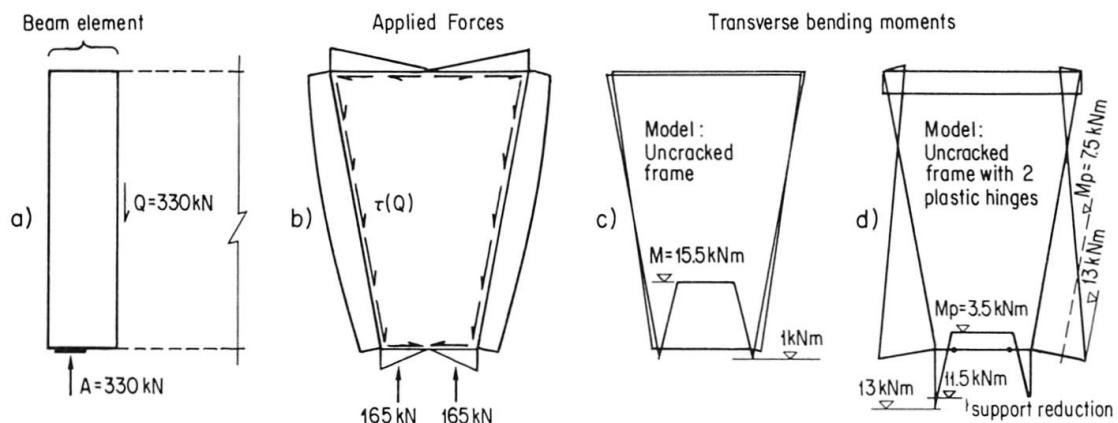
Firstly the transverse bending should be estimated for a concentric loading of the basic structural system's dead weight i.e. for a support reaction of 330 kN. A beam element at the end of the box-section girder, shown in Figs. 9a and 9b, is considered for this purpose. A closed frame is formed which is acted upon by the shear flow of the shear force and by the support reactions. Since both support bearing points are not located beneath the webs, considerable transverse bending moments arise. These, for the assumption of an uncracked section, are shown in Fig. 9c. The moment in the bottom flange comes to 15.5 kNm. With the reinforcement present over a locally supported width of 30 cm the corresponding yielding moment comes to only 3.5 kNm. This means that over both the support bearing points a plastic hinge must be assumed to occur. When one calculates for the remainder with the assumption of an uncracked frame, then the moment diagram of Fig. 9d results. Here the existent yielding moment in the web of 7.5 kNm is considerably exceeded. Thus a possible equilibrium condition can likewise not be found. That the beam did not collapse earlier with a smaller load therefore requires some explanation:

Due to the formation of the plastic hinges at the support bearing points considerable displacements arise. These cause a certain shifting through the neoprene pads of the produced reaction forces towards the webs. Thus the transverse bending is significantly reduced.

Fig. 9 Transverse bending of the support region after placement of the slab units on both sides (concentric loading).

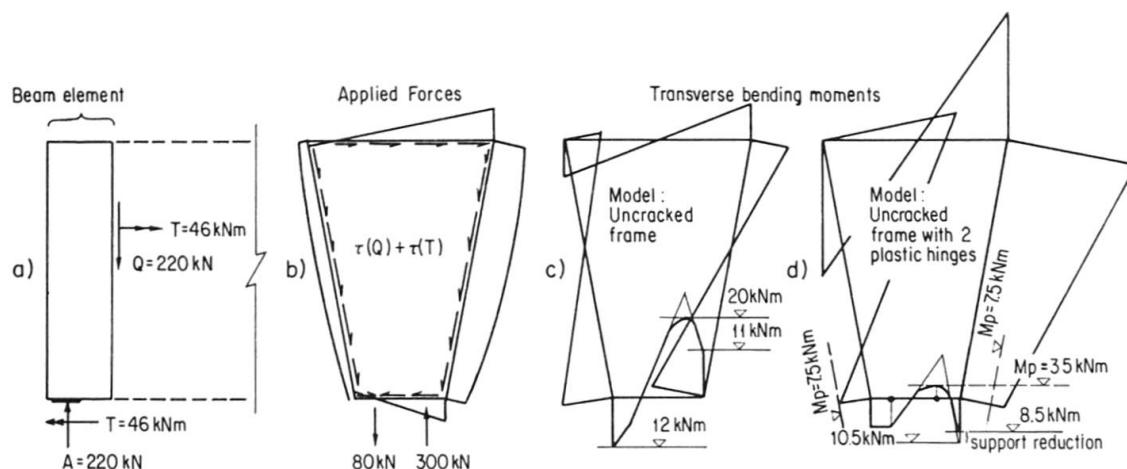
The concentric loading comes to $220/330 = 2/3$ of the previously analysed loading. Each support reaction comes to $+110$ kN. The torsional loading consists of a constant shear flow τ_t and equal but opposite reactions of ± 190 kN. Fig. 10b gives for the sum of both load cases the shear flow and support reactions of $110 \pm 190 = +300$ kN or -80 kN.

By a similar procedure to that in the previous section for firstly an uncracked frame, the moment diagram shown in Fig. 10c results. This however can not occur since the existent yielding moments (resisting) are exceeded. After the introduction of plastic hinges over the right support bearing point and at the transition of the bottom flange to the left web, the moment diagram in Fig. 10d results. This is however likewise not possible. As described in the previous section, there is a possible sideways displacement of the support reactions towards the webs. This is caused by plastic deformations and should be taken into consideration if an equilibrium condition is to be found.

Fig. 10 Transverse bending of support region after placement of the slab units on one side only (eccentric loading).

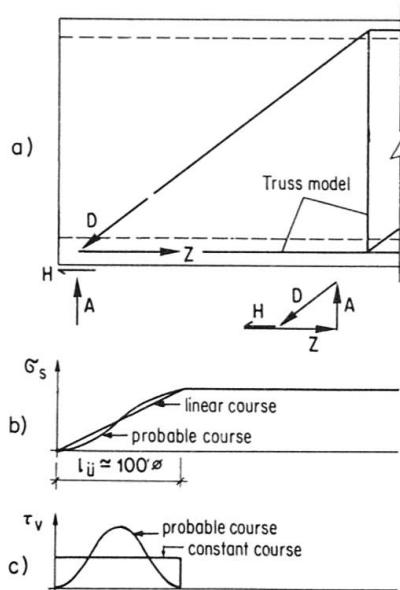
In Fig. 11a the force system in the web plane of the support region is schematically shown i.e. with a truss model that simplifies the actual situation. The inclined compressive force D stands in equilibrium with the tensile chord force Z and the support reaction A . If in addition there acts an external support force H , e.g. a secondary reaction, then Z must be increased with respect to H . If one takes an angle of inclination of 40° for D and ignores a possible H , then for a support reaction of 330 kN there results a Z of approximately 390 kN.

In order to determine these forces, the "truss nodal points" must be correspondingly developed. In particular the tensile force Z over the support must be dealt with through sufficient anchorage. For this purpose the prestressed wires can in certain circumstances be used. From Code SIA 162 [1], Art. 5.05, the transmission or anchorage length should not come to more than 100 wire diameters. In the discussed case this is 70 cm. If a linear stress distribution is assumed over this length, one obtains an anchorage bond stress of about 2.5 N/mm 2 .

Fig. 11 End anchorage:
internal forces following
from the introduction of the
support reaction (truss model);
steel stresses and bond stresses
from the prestress force.

From these points it can be assumed that the steel stress at the girder end was under proportional and only further into the girder interior increased to over proportional (Fig. 11b). Correspondingly the bond stress at the girder end was relatively small (Fig. 11c). With plausible assumptions the anchorage force comes within the region of 270 to 380 kN. Here the vertical end stirrups $\varnothing 8$ mm lying parallel to the prestress wires were not investigated. The bond of this steel with the concrete must, in consequence of the small spacing, have been relatively bad.

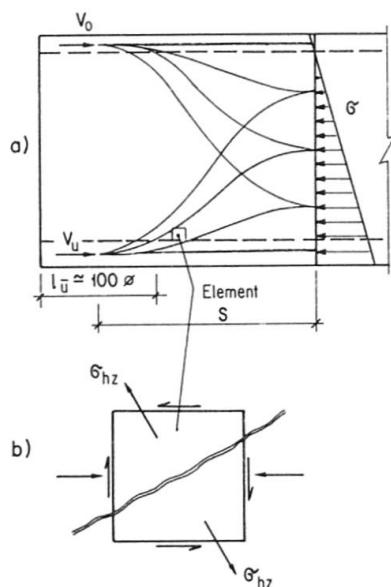
Fig. 12

In Fig. 12a the layout of the prestress wires in the upper and lower regions is schematically shown with respect to the introduction of the prestress forces. A part of these forces goes into the web (transition length S) while the other part remains in the flanges.

At the transition of the lower flange to the webs there is a calculated shear stress τ of $4.0 - 6.0 \text{ N/mm}^2$. This is based upon reasonable assumptions for an uncracked concrete cross-section. The corresponding considerably smaller main tensile stress σ_{hz} has the tendency to produce the cracks shown in Fig. 12b.

These stipulations were in the discussed case either not at all or insufficiently fulfilled. The wires were cut through one after another with a power cutter. This led to a considerable disturbance of bond. Between various prestressed wires and parallel running end stirrups present the spacing was only a few millimeters. This did not everywhere keep to the well-known rule which states that the spacing of the placed steel should not be less than the maximum aggregate diameter (here 15 mm).

Stresses and tendency to crack formation in consequence of introduction of pre-stress force.

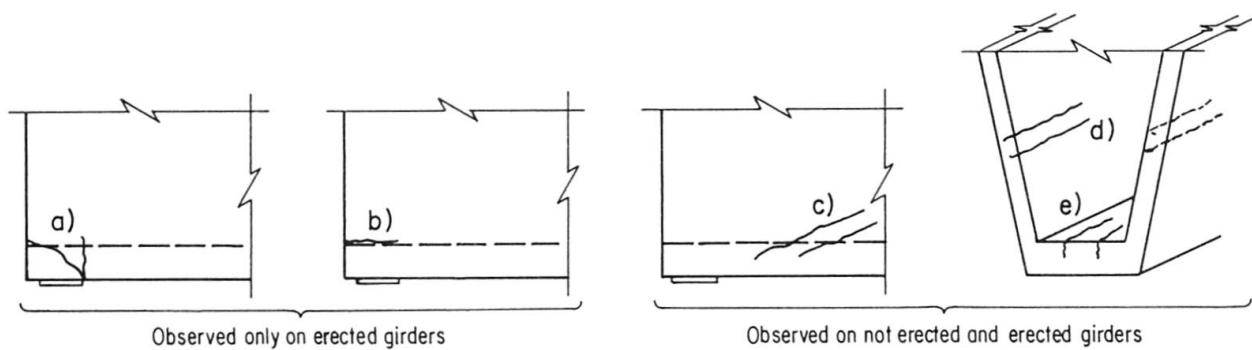
Fig. 13 Crack Types observed on the Girders.

These dangerous shearing-off cracks arise from insufficient end anchorage (cf. 3.4).

These cracks stem from the effects of transverse bending with concentric and eccentric loads (cf. 3.2 and 3.3).

These inclined cracks arise from the spreading of the prestress force from the bottom flange to the web.

Crack Type d): These longitudinal cracks arise probably through shrinkage. There was an adequately strong reinforcement only on the outside of the webs. In addition to this the girders during fabrication were warmed with steam from the inside in order to accelerate hardening.

These cracks can be explained in the same way as the Type d) cracks. They were however considerably wider and longer with the erected girders as with those not yet erected. This comes from the additional effect of the transverse bending (cf. 3.2 and 3.3).

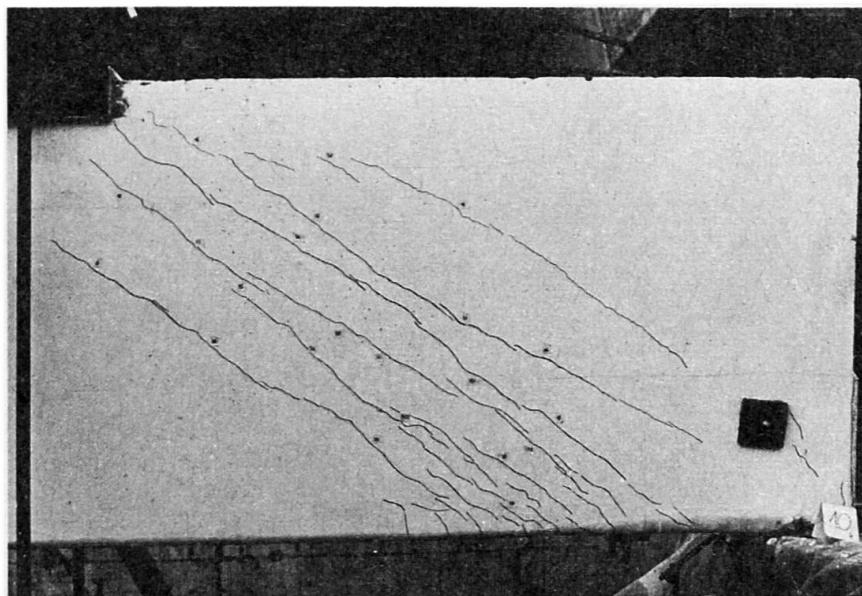
Both remedial solutions showed themselves to be workable. The self weight of the beam and the test fittings led to a support reaction of 115 kN. With a support reaction corresponding to that of a full working load i.e. with $Q(g+p) \approx 500$ kN there first appeared a few cracks in the web of maximum width 0.15 mm. The mid-span deflection (without self weight) was 16 mm. Following on from here a load giving a support reaction corresponding to twice the working load reaction, i.e. $2Q(g+p) \approx 1000$ kN, could be obtained without fracture. Under this maximum loading the largest crack width in the webs was 0.60 mm and the deflection midspan = 50 mm. Fig. 20 shows the midspan deflection and also the crack widths as functions of the support reaction. Fig. 21 shows the crack pattern at the girder end A.

Fig. 21 Crack pattern at girder end A
