The Collapse and Reconstruction of a Prestressed Concrete Box-Section Girder

Hugo Bachmann

Werner Horisberger,

On the 25th September 1974 a 20 x 25 m section of a prefabricated hall roof collapsed during erection. Within this collapse a box-section girder spanning 25 m and a series of immediately placed 10 m long slab units fell from a height of around 5 m onto the hall floor and were extensively damaged.

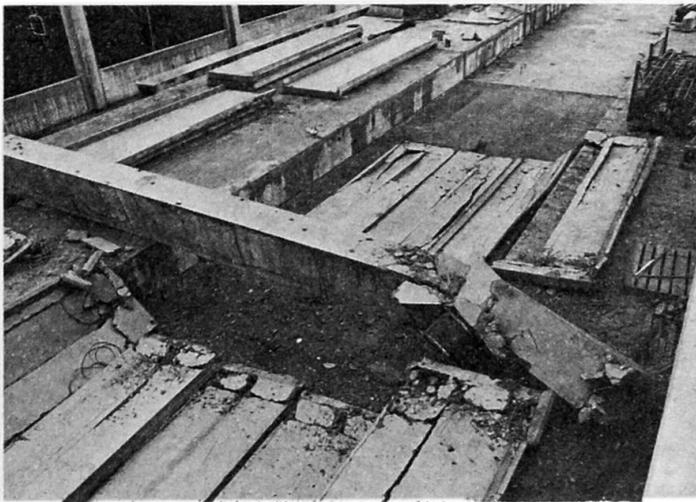
Fig. 2

The situation on the construction site immediately after the collapse is shown in Figs. 2, 3 and 4. The first examinations showed immediately that the girder 10/E-G had somehow broken through at the support at column E/10. From there it had fallen to the ground and in doing so also tore away from the support G/10.

View from E/9 towards the collapsed box-section girder. In front and behind are the collapsed roof slab units.

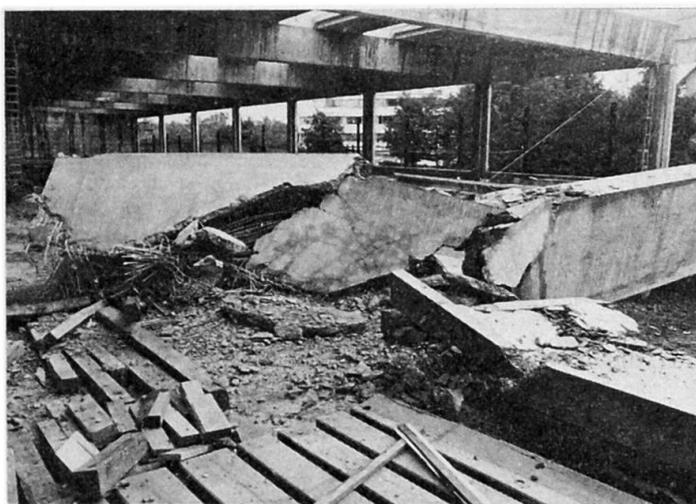
Fig. 3

View from E/11 towards the collapsed girder. The pre-stress wires of the bottom flange were fully exposed in the collapse.

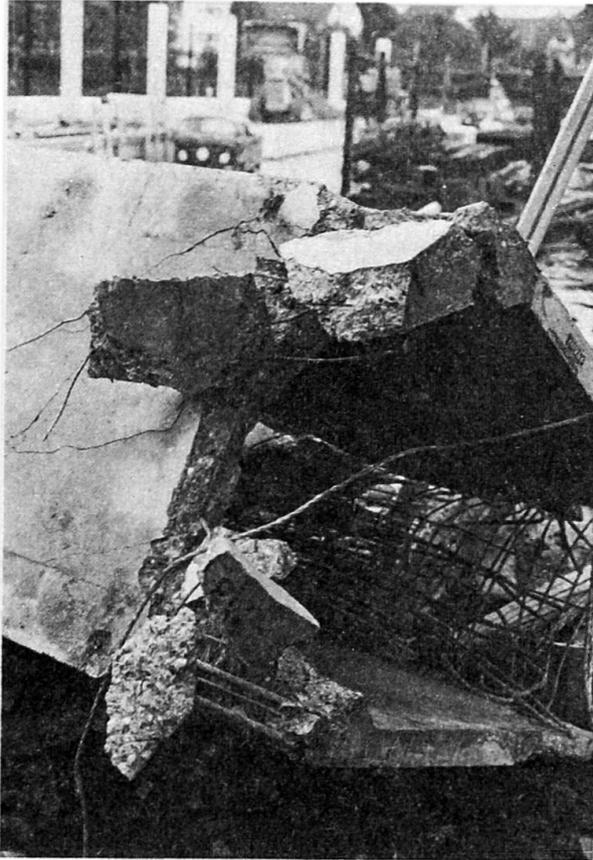
Fig. 4

View of girder end E/10. The girder has broken through the bottom and top flanges at the support.

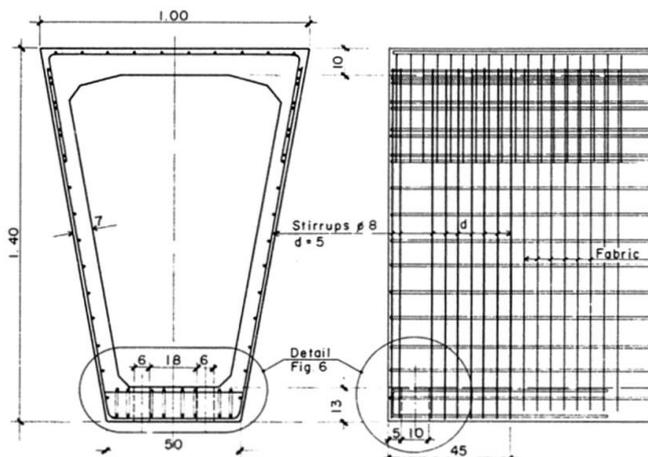
Fig. 5

The to scale dimensions and reinforcement of the support region are shown in Figs. 5 and 6. The girder had no transverse end beam. In the bottom flange were 10 cm long x 5 cm wide holes for 3 cm \varnothing bolts cast into the column. The support bearing points in the centre of these holes were to scale 10 cm from the girder

Dimensions and reinforcement of the girder support region.

end. However this value could be reduced to nearly 7 cm when measurement variations were taken into account. This was the case with the collapsed girder. The workers on site informed that the bolts had scarcely fitted through the holes in the girder. In the transverse direction the support points did not sit beneath the webs, but were about 10 cm within the cross-section.

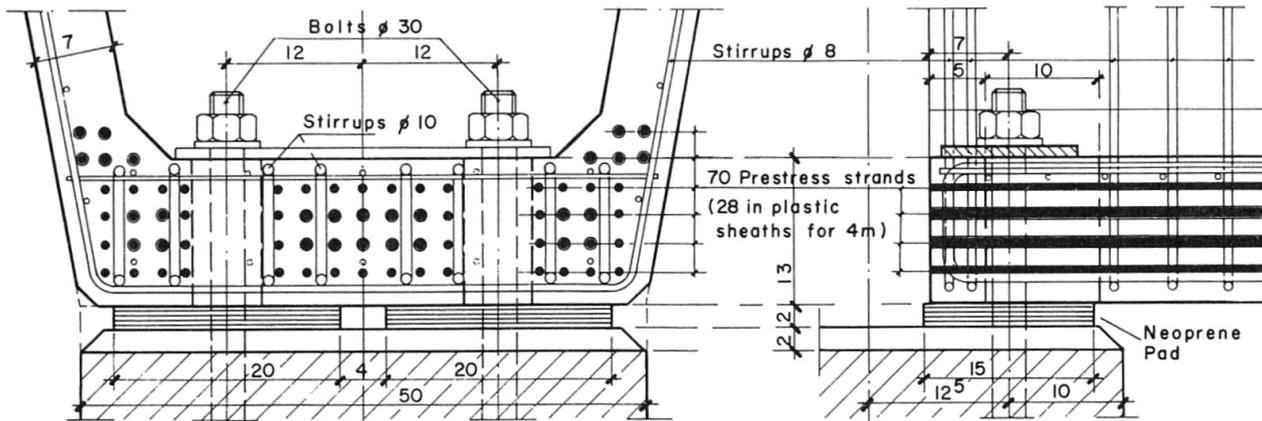
Fig. 6 Layout of the support region. Support in extreme situation.

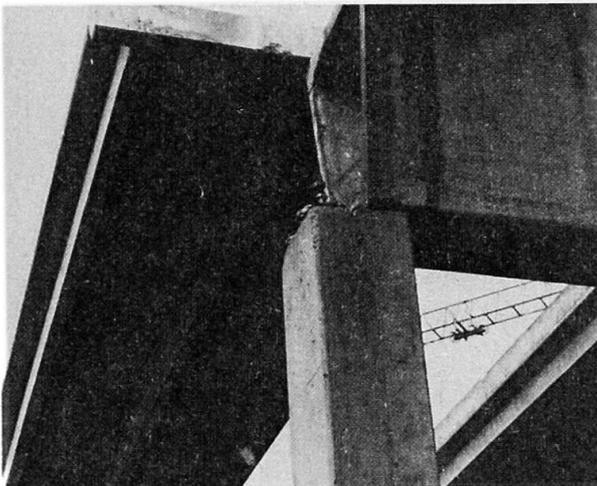
Fig. 7

View from beneath towards the column head E/10. Right is the girder 10/C-E. Left was the collapsed girder 10/E-G.

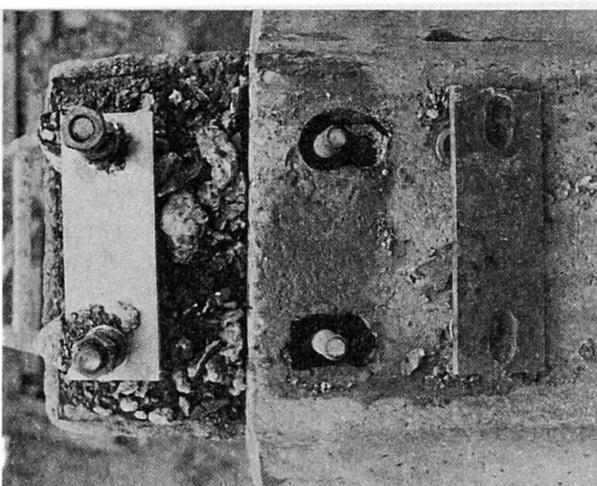
Fig. 8

View from above of the column head E/10. Righthand end of the beam 10/C-E with holes in the bottom flange and removed nuts and steel plate. Remainder of lefthand end of the collapsed girder 10/E-G with the still present nuts and top steel plate. Beneath the rubble are both the neoprene pads.

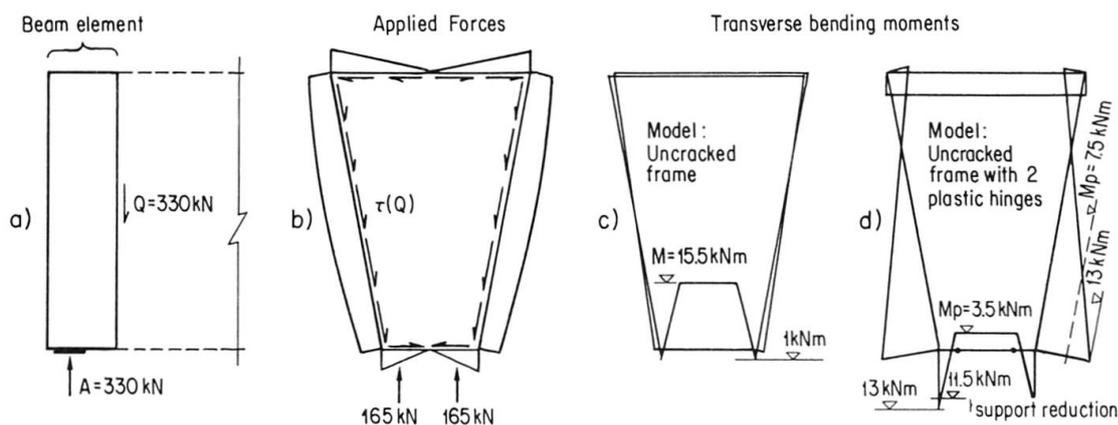
Firstly the transverse bending should be estimated for a concentric loading of the basic structural system's dead weight i.e. for a support reaction of 330 kN. A beam element at the end of the box-section girder, shown in Figs. 9a and 9b, is considered for this purpose. A closed frame is formed which is acted upon by the shear flow of the shear force and by the support reactions. Since both support bearing points are not located beneath the webs, considerable transverse bending moments arise. These, for the assumption of an uncracked section, are shown in Fig. 9c. The moment in the bottom flange comes to 15.5 kNm. With the reinforcement present over a locally supported width of 30 cm the corresponding yielding moment comes to only 3.5 kNm. This means that over both the support bearing points a plastic hinge must be assumed to occur. When one calculates for the remainder with the assumption of an uncracked frame, then the moment diagram of Fig. 9d results. Here the existent yielding moment in the web of 7.5 kNm is considerably exceeded. Thus a possible equilibrium condition can likewise not be found. That the beam did not collapse earlier with a smaller load therefore requires some explanation:

Due to the formation of the plastic hinges at the support bearing points considerable displacements arise. These cause a certain shifting through the neoprene pads of the produced reaction forces towards the webs. Thus the transverse bending is significantly reduced.

Fig. 9 Transverse bending of the support region after placement of the slab units on both sides (concentric loading).

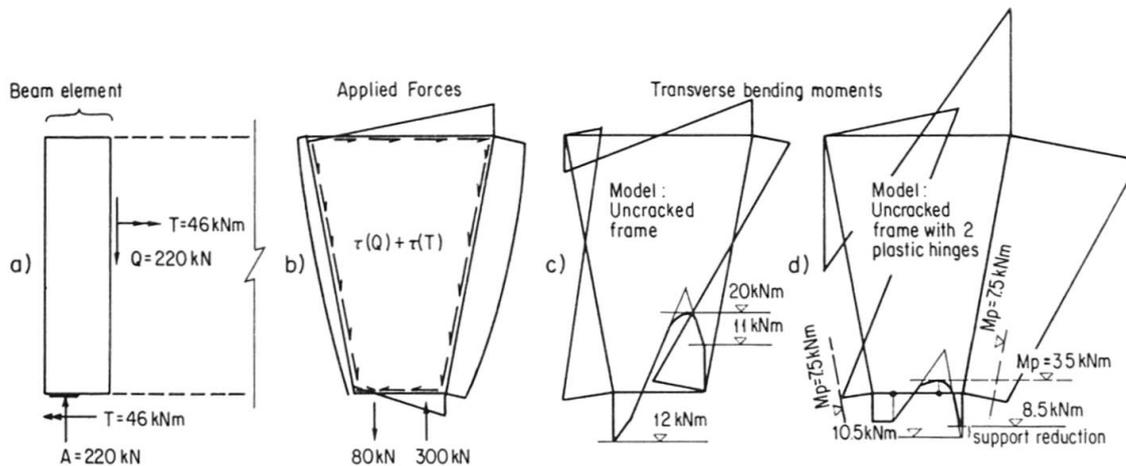
At the box-section girder supports there occurs during erection an eccentric loading condition and resulting torsion. This occurs when the roof slab units are placed first on one side only. Here a reaction force of 220 kN results with an additional torsional moment of 46 kNm. The stresses in the beam end element (see

The concentric loading comes to $220/330 = 2/3$ of the previously analysed loading. Each support reaction comes to $+110$ kN. The torsional loading consists of a constant shear flow τ and equal but opposite reactions of ± 190 kN. Fig. 10b gives for the sum of both load cases the shear flow and support reactions of $110 \pm 190 = +300$ kN or -80 kN.

By a similar procedure to that in the previous section for firstly an uncracked frame, the moment diagram shown in Fig. 10c results. This however can not occur since the existent yielding moments (resisting) are exceeded. After the introduction of plastic hinges over the right support bearing point and at the transition of the bottom flange to the left web, the moment diagram in Fig. 10d results. This is however likewise not possible. As described in the previous section, there is a possible sideways displacement of the support reactions towards the webs. This is caused by plastic deformations and should be taken into consideration if an equilibrium condition is to be found.

Fig. 10 Transverse bending of support region after placement of the slab units on one side only (eccentric loading).

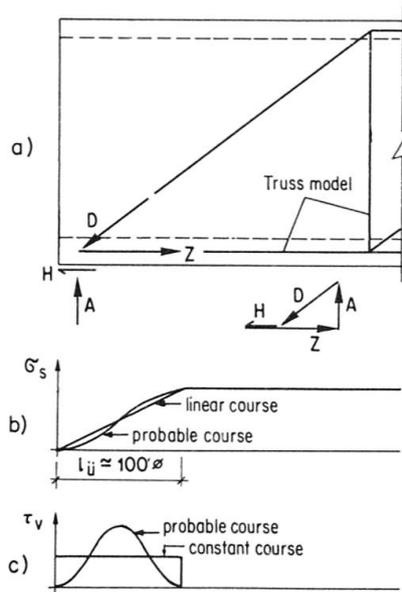
In Fig. 11a the force system in the web plane of the support region is schematically shown i.e. with a truss model that simplifies the actual situation. The inclined compressive force D stands in equilibrium with the tensile chord force Z and the support reaction A . If in addition there acts an external support force H , e.g. a secondary reaction, then Z must be increased with respect to H . If one takes an angle of inclination of 40° for D and ignores a possible H , then for a support reaction of 330 kN there results a Z of approximately 390 kN.

In order to determine these forces, the "truss nodal points" must be correspondingly developed. In particular the tensile force Z over the support must be dealt with through sufficient anchorage. For this purpose the prestressed wires can in certain circumstances be used. From Code SIA 162 [1], Art. 5.05, the transmission or anchorage length should not come to more than 100 wire diameters. In the discussed case this is 70 cm. If a linear stress distribution is assumed over this length, one obtains an anchorage bond stress of about 2.5 N/mm².

Fig. 11 End anchorage: internal forces following from the introduction of the support reaction (truss model); steel stresses and bond stresses from the prestress force.

These stipulations were in the discussed case either not at all or insufficiently fulfilled. The wires were cut through one after another with a power cutter. This led to a considerable disturbance of bond. Between various prestressed wires and parallel running end stirrups present the spacing was only a few millimeters. This did not everywhere keep to the well-known rule which states that the spacing of the placed steel should not be less than the maximum aggregate diameter (here 15 mm).

From these points it can be assumed that the steel stress at the girder end was under proportional and only further into the girder interior increased to over proportional (Fig. 11b). Correspondingly the bond stress at the girder end was relatively small (Fig. 11c). With plausible assumptions the anchorage force comes within the region of 270 to 380 kN. Here the vertical end stirrups ϕ 8 mm lying parallel to the prestress wires were not investigated. The bond of this steel with the concrete must, in consequence of the small spacing, have been relatively bad.

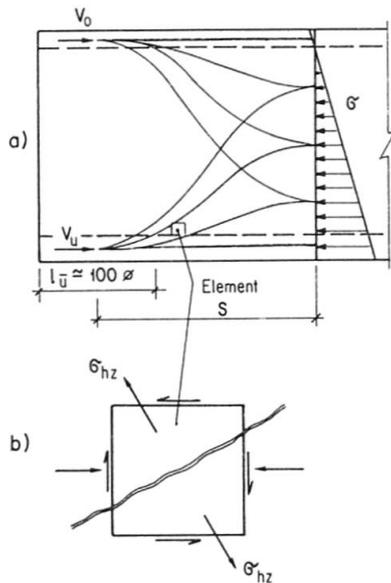
Fig. 12

In Fig. 12a the layout of the prestress wires in the upper and lower regions is schematically shown with respect to the introduction of the prestress forces. A part of these forces goes into the web (transition length S) while the other part remains in the flanges.

At the transition of the lower flange to the webs there is a calculated shear stress τ of 4.0 - 6.0 N/mm². This is based upon reasonable assumptions for an uncracked concrete cross-section. The corresponding considerably smaller main tensile stress σ_{hz} has the tendency to produce the cracks shown in Fig. 12b.

Stresses and tendency to crack formation in consequence of introduction of pre-stress force.

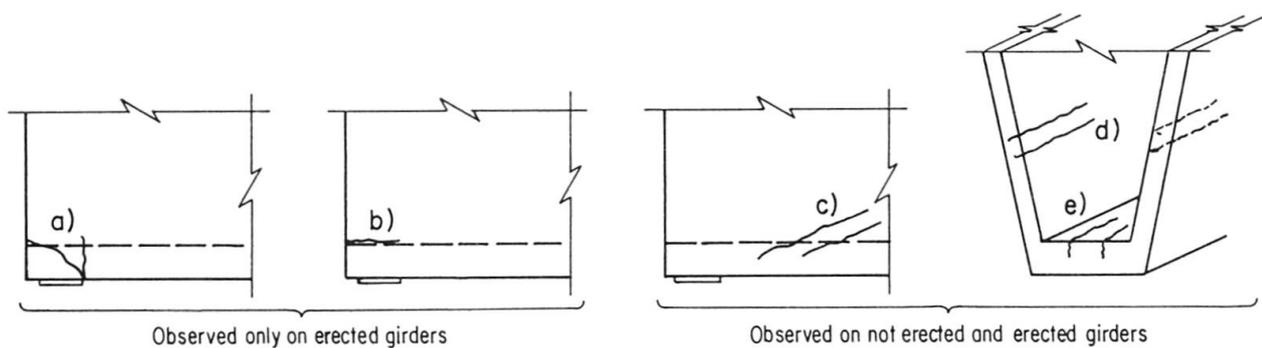
Fig. 13 Crack Types observed on the Girders.

These dangerous shearing-off cracks arise from insufficient end anchorage (cf. 3.4).

These cracks stem from the effects of transverse bending with concentric and eccentric loads (cf. 3.2 and 3.3).

These inclined cracks arise from the spreading of the prestress force from the bottom flange to the web.

Crack Type d): These longitudinal cracks arise probably through shrinkage. There was an adequately strong reinforcement only on the outside of the webs. In addition to this the girders during fabrication were warmed with steam from the inside in order to accelerate hardening.

These cracks can be explained in the same way as the Type d) cracks. They were however considerably wider and longer with the erected girders as with those not yet erected. This comes from the additional effect of the transverse bending (cf. 3.2 and 3.3).

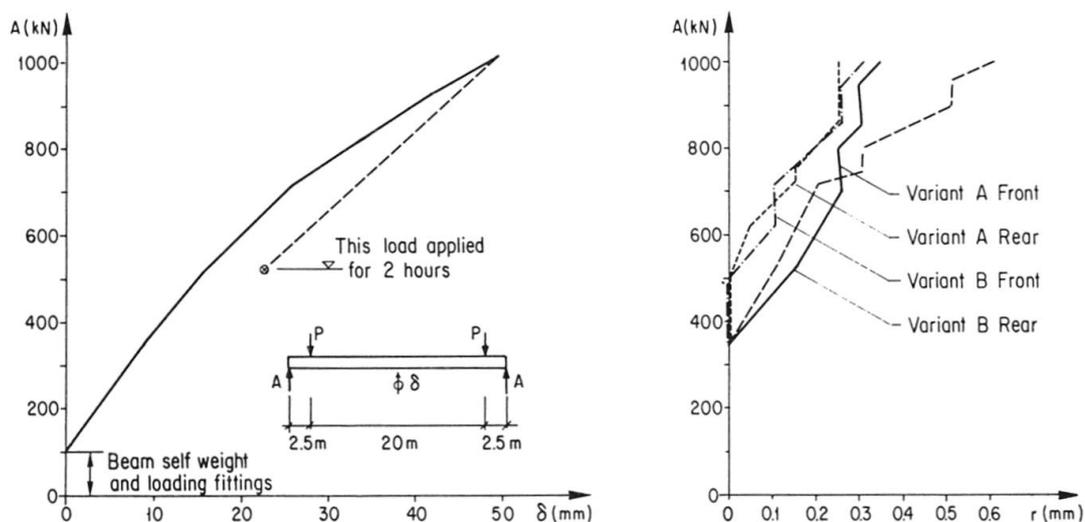
Both remedial solutions showed themselves to be workable. The self weight of the beam and the test fittings led to a support reaction of 115 kN. With a support reaction corresponding to that of a full working load i.e. with $Q(g+p) \approx 500$ kN there first appeared a few cracks in the web of maximum width 0.15 mm. The mid-span deflection (without self weight) was 16 mm. Following on from here a load giving a support reaction corresponding to twice the working load reaction, i.e. $2Q(g+p) \approx 1000$ kN, could be obtained without fracture. Under this maximum loading the largest crack width in the webs was 0.60 mm and the deflection midspan = 50 mm. Fig. 20 shows the midspan deflection and also the crack widths as functions of the support reaction. Fig. 21 shows the crack pattern at the girder end A.

Fig. 20 Midspan deflection of the girder and also the largest crack width r in the webs as a function of the support reaction

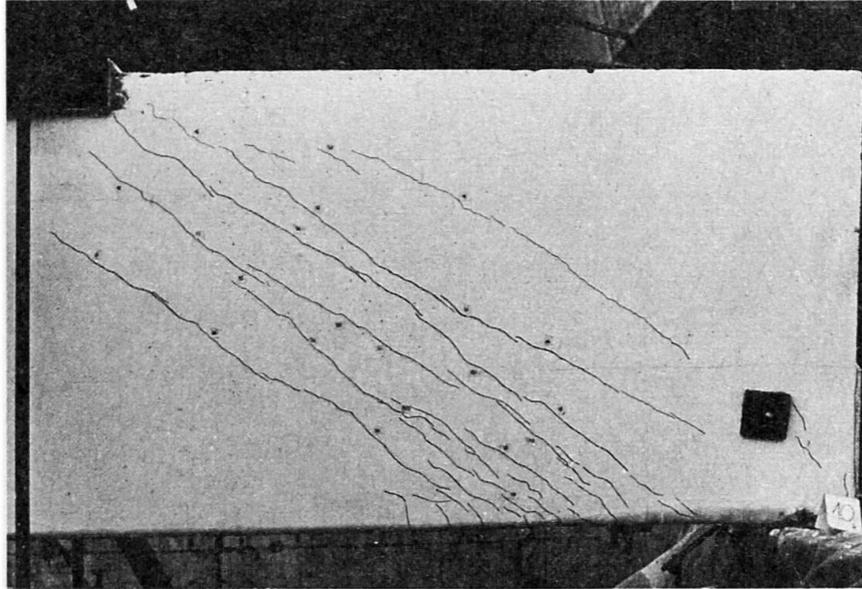
Fig. 21 Crack pattern at girder end A

In the inside of the beam cracks also occurred at the vertical contact surface between the concrete infill and the webs. They could be observed on the upper edge of the new concrete section. The cracking began at the girder end with about $1.5Q(g+p)$. With about $1.9Q(g+p)$ the contact surface was cracked through right along the girder. A maximum crack width of 0.4 mm and significant deformations between the new concrete section and the web could be observed. Between the variants A and B there was no significant difference. There was no sign of a failure beginning in the support regions. The girder came through the test excellently and it was possible to use it again in the building.
