## **The Collapse and Reconstruction of a Prestressed Concrete Box-Section Girder**

**Hugo Bachmann**

**Werner Horisberger,**

This surprising event occurred at the building site of the Swiss National Railway's new rapid goods station, Berne. The new rapid goods concept of the Swiss National Railway provides for the turn over of goods traffic on select trains to be concentrated in three centres (Berne, Zürich, Dänikon).

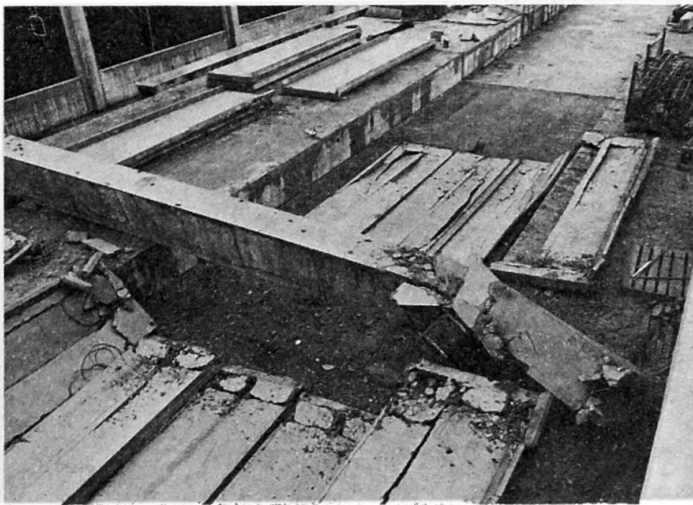
Fig. 2

View from E/9 towards the collapsed box-section girder. In front and behind are the collapsed roof slab units.

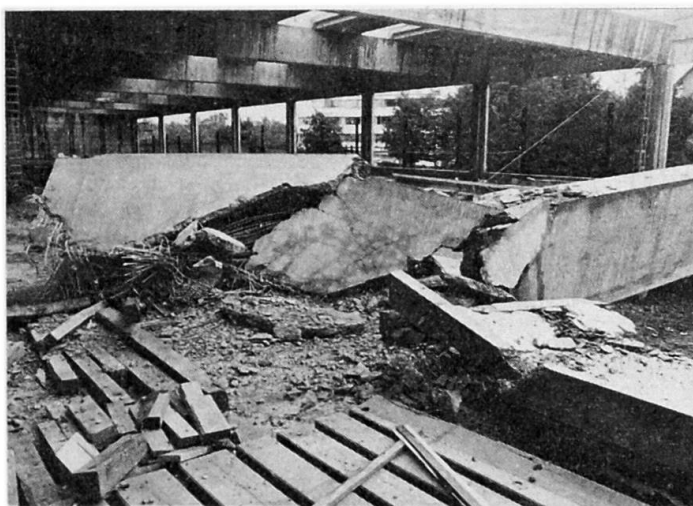
Fig. 3

View from E/11 towards the collapsed girder. The prestress wires of the bottom flange were fully exposed in the collapse.

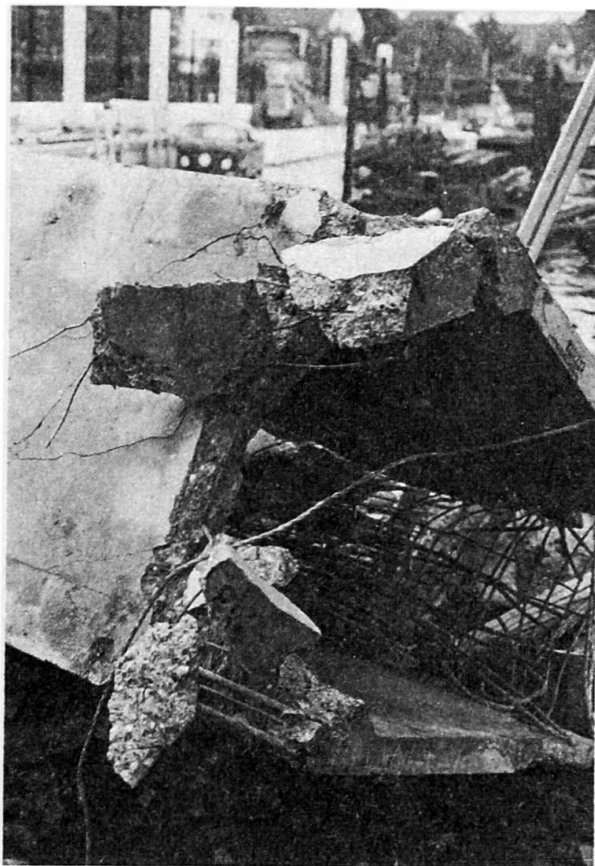
Fig. 4

The situation on the construction site immediately after the collapse is shown in Figs. 2, 3 and 4. The first examinations showed immediately that the girder 10/E-G had somehow broken through at the support at column E/10. From there it had fallen to the ground and in doing so also tore away from the support G/10.

View of girder end E/10. The girder has broken through the bottom and top flanges at the support.

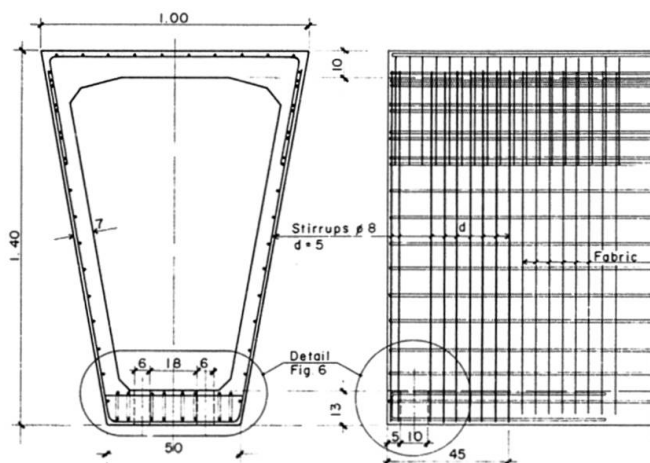
Fig. 5

The to scale dimensions and reinforcement of the support region are shown in Figs. 5 and 6. The girder had no transverse end beam. In the bottom flange were 10 cm long x 5 cm wide holes for 3 cm  $\varnothing$  bolts cast into the column. The support bearing points in the centre of these holes were to scale 10 cm from the girder

Dimensions and reinforcement of the girder support region.

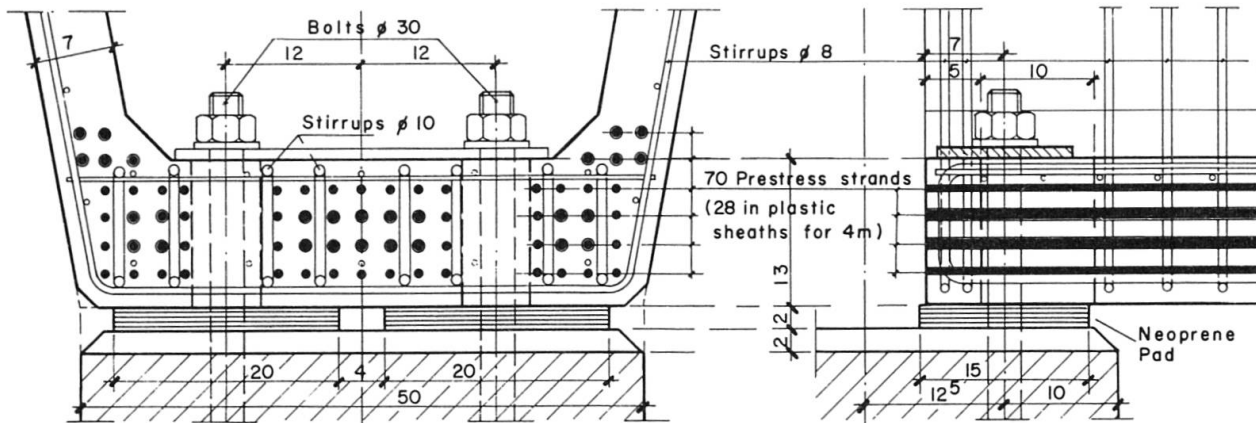
Fig. 6 Layout of the support region. Support in extreme situation.

end. However this value could be reduced to nearly 7 cm when measurement variations were taken into account. This was the case with the collapsed girder. The workers on site informed that the bolts had scarcely fitted through the holes in the girder. In the transverse direction the support points did not sit beneath the webs, but were about 10 cm within the cross-section.

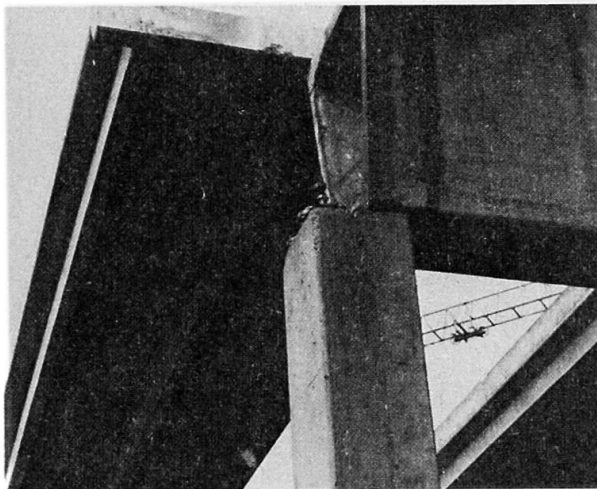
Fig. 7

View from beneath towards the column head E/10. Right is the girder 10/C-E. Left was the collapsed girder 10/E-G.

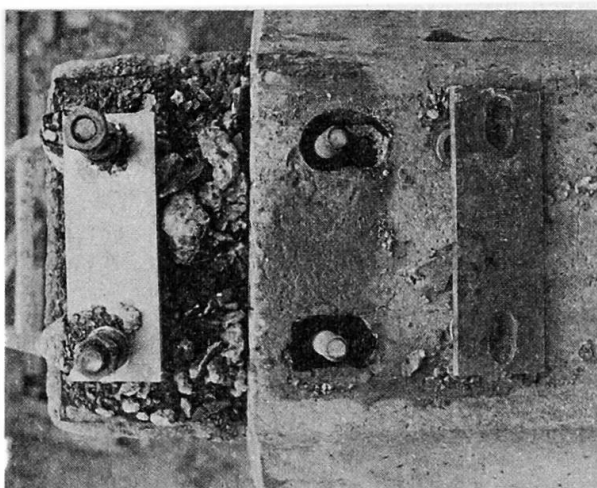
Fig. 8

View from above of the column head E/10. Righthand end of the beam 10/C-E with holes in the bottom flange and removed nuts and steel plate. Remainder of lefthand end of the collapsed girder 10/E-G with the still present nuts and top steel plate. Beneath the rubble are both the neoprene pads.

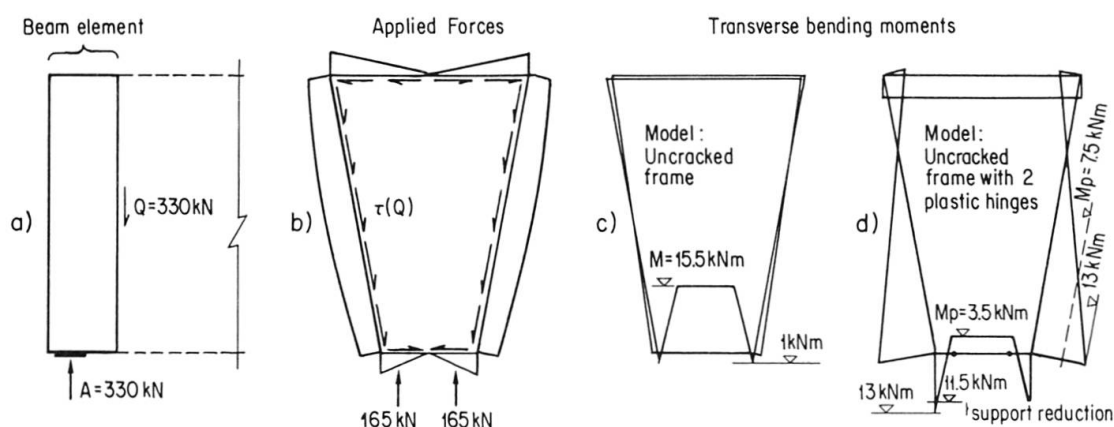
Firstly the transverse bending should be estimated for a concentric loading of the basic structural system's dead weight i.e. for a support reaction of 330 kN. A beam element at the end of the box-section girder, shown in Figs. 9a and 9b, is considered for this purpose. A closed frame is formed which is acted upon by the shear flow of the shear force and by the support reactions. Since both support bearing points are not located beneath the webs, considerable transverse bending moments arise. These, for the assumption of an uncracked section, are shown in Fig. 9c. The moment in the bottom flange comes to 15.5 kNm. With the reinforcement present over a locally supported width of 30 cm the corresponding yielding moment comes to only 3.5 kNm. This means that over both the support bearing points a plastic hinge must be assumed to occur. When one calculates for the remainder with the assumption of an uncracked frame, then the moment diagram of Fig. 9d results. Here the existent yielding moment in the web of 7.5 kNm is considerably exceeded. Thus a possible equilibrium condition can likewise not be found. That the beam did not collapse earlier with a smaller load therefore requires some explanation:

Due to the formation of the plastic hinges at the support bearing points considerable displacements arise. These cause a certain shifting through the neoprene pads of the produced reaction forces towards the webs. Thus the transverse bending is significantly reduced.

Fig. 9 Transverse bending of the support region after placement of the slab units on both sides (concentric loading).

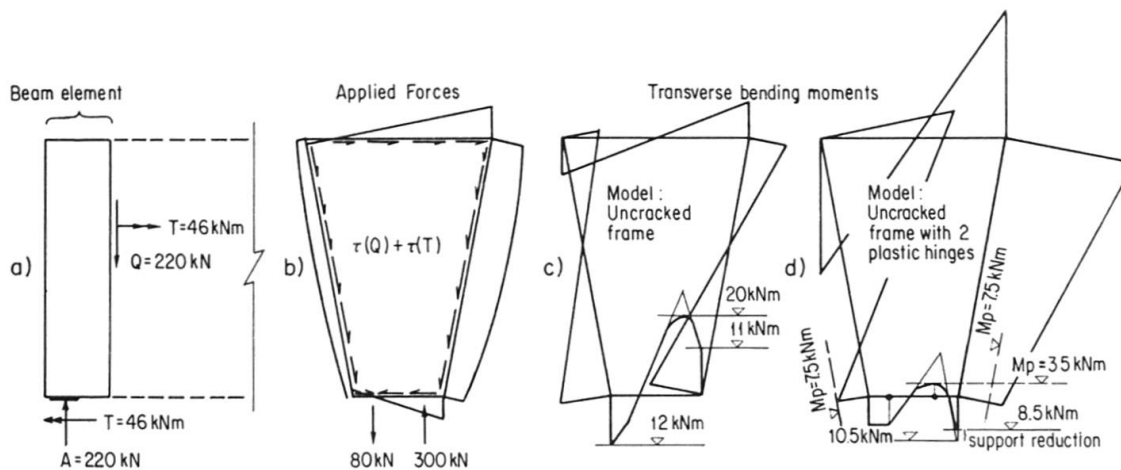
The concentric loading comes to  $220/330 = 2/3$  of the previously analysed loading. Each support reaction comes to +110 kN. The torsional loading consists of a constant shear flow  $\tau t$  and equal but opposite reactions of  $\pm 190$  kN. Fig. 10b gives for the sum of both load cases the shear flow and support reactions of  $110 \pm 190 = +300$  kN or -80 kN.

By a similar procedure to that in the previous section for firstly an uncracked frame, the moment diagram shown in Fig. 10c results. This however can not occur since the existent yielding moments(resisting) are exceeded. After the introduction of plastic hinges over the right support bearing point and at the transition of the bottom flange to the left web, the moment diagram in Fig. 10d results. This is however likewise not possible. As described in the previous section, there is a possible sideways displacement of the support reactions towards the webs. This is caused by plastic deformations and should be taken into consideration if an equilibrium condition is to be found.

Fig. 10 Transverse bending of support region after placement of the slab units on one side only (eccentric loading).

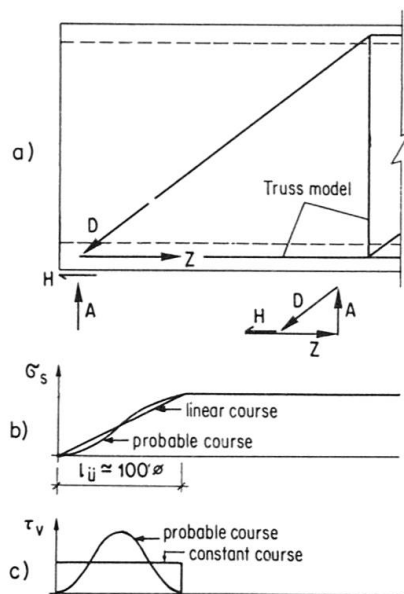
In Fig. 11a the force system in the web plane of the support region is schematically shown i.e. with a truss model that simplifies the actual situation. The inclined compressive force  $D$  stands in equilibrium with the tensile chord force  $Z$  and the support reaction  $A$ . If in addition there acts an external support force  $H$ , e.g. a secondary reaction, then  $Z$  must be increased with respect to  $H$ . If one takes an angle of inclination of  $40^\circ$  for  $D$  and ignores a possible  $H$ , then for a support reaction of 330 kN there results a  $Z$  of approximately 390 kN.

Fig. 11 End anchorage: internal forces following from the introduction of the support reaction (truss model); steel stresses and bond stresses from the prestress force.

These stipulations were in the discussed case either not at all or insufficiently fulfilled. The wires were cut through one after another with a power cutter. This led to a considerable disturbance of bond. Between various prestressed wires and parallel running end stirrups present the spacing was only a few millimeters. This did not everywhere keep to the well-known rule which states that the spacing of the placed steel should not be less than the the maximum aggregate diameter (here 15 mm).

From these points it can be assumed that the steel stress at the girder end was under proportional and only further into the girder interior increased to over proportional (Fig. 11b). Correspondingly the bond stress at the girder end was relatively small (Fig. 11c). With plausible assumptions the anchorage force comes within the region of 270 to 380 kN. Here the vertical end stirrups  $\varnothing 8$  mm lying parallel to the prestress wires were not investigated. The bond of this steel with the concrete must, in consequence of the small spacing, have been relatively bad.

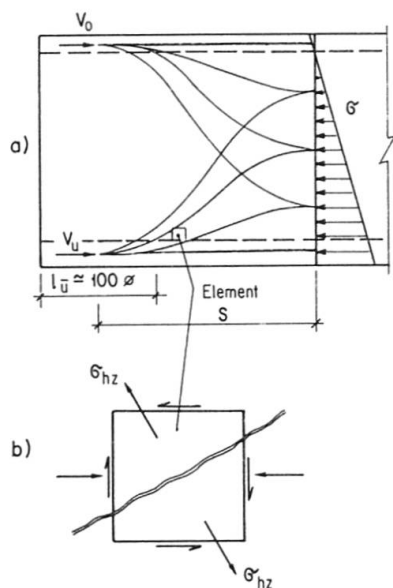
Fig. 12

At the transition of the lower flange to the webs there is a calculated shear stress  $\tau$  of  $4.0 - 6.0 \text{ N/mm}^2$ . This is based upon reasonable assumptions for an uncracked concrete cross-section. The corresponding considerably smaller main tensile stress  $\sigma_{hz}$  has the tendency to produce the cracks shown in Fig. 12b.

Stresses and tendency to crack formation in consequence of introduction of pre-stress force.

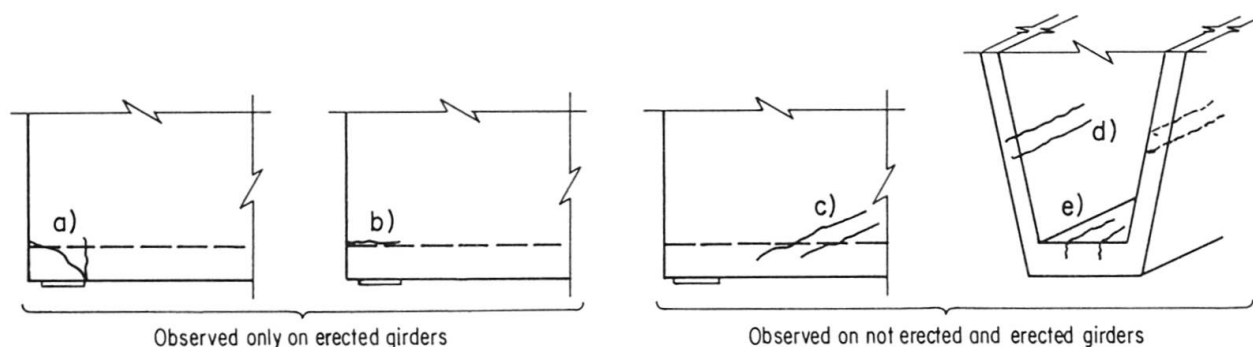
Fig. 13 Crack Types observed on the Girders.

These dangerous shearing-off cracks arise from insufficient end anchorage (cf. 3.4).

These cracks stem from the effects of transverse bending with concentric and eccentric loads (cf. 3.2 and 3.3).

These inclined cracks arise from the spreading of the prestress force from the bottom flange to the web.

Crack Type d): These longitudinal cracks arise probably through shrinkage. There was an adequately strong reinforcement only on the outside of the webs. In addition to this the girders during fabrication were warmed with steam from the inside in order to accelerate hardening.

These cracks can be explained in the same way as the Type d) cracks. They were however considerably wider and longer with the erected girders as with those not yet erected. This comes from the additional effect of the transverse bending (cf. 3.2 and 3.3).

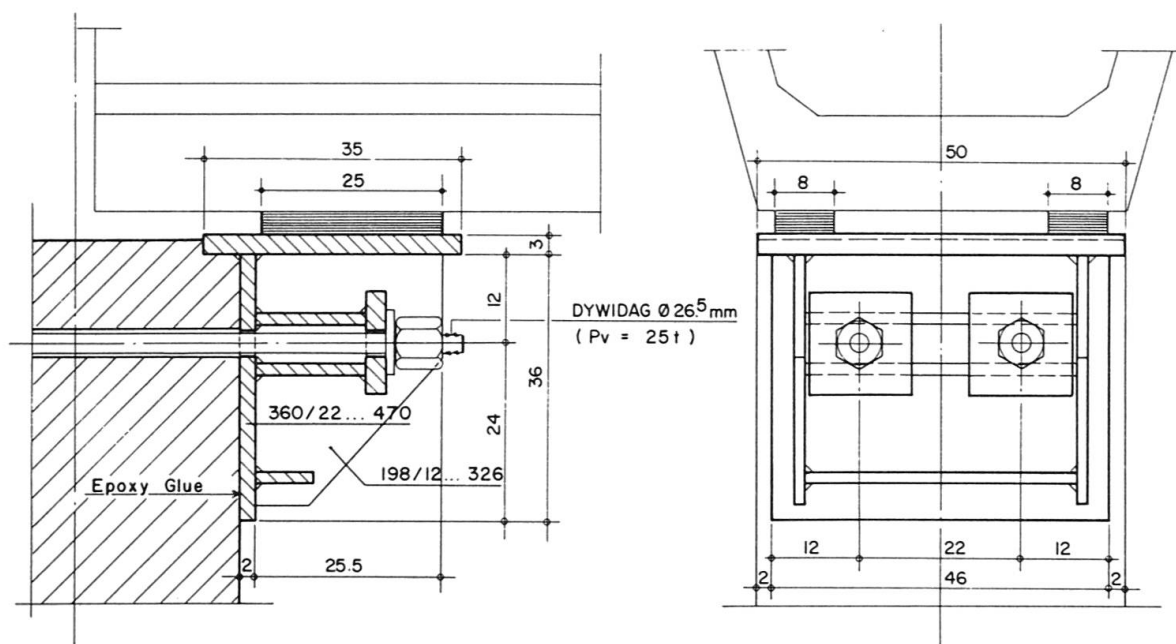
Two problems stand with this solution. Firstly, there is the introduction of eccentric nib loads to the edge columns. Then secondly there is the taking up of torsional effects on the girder stemming from one sided loading during erection. There are also the further disadvantages of high costs, difficult realisation with the already erected sections and dissatisfactory aesthetics. Therefore this variant was not taken any further.

A further possible remedial solution consists of sitting the girders upon steel nibs as shown in Fig. 15. If the deformation of the support surface is away from the end then sufficient end anchorage is guaranteed. The choice of special small neoprene pads allows the transference of the support forces directly beneath the webs. This largely eliminates the transverse bending. The steel nibs are connected to the in-situ concrete columns with post-tensioned rods.

Fig. 15 Remedial solution "Steel Nib"

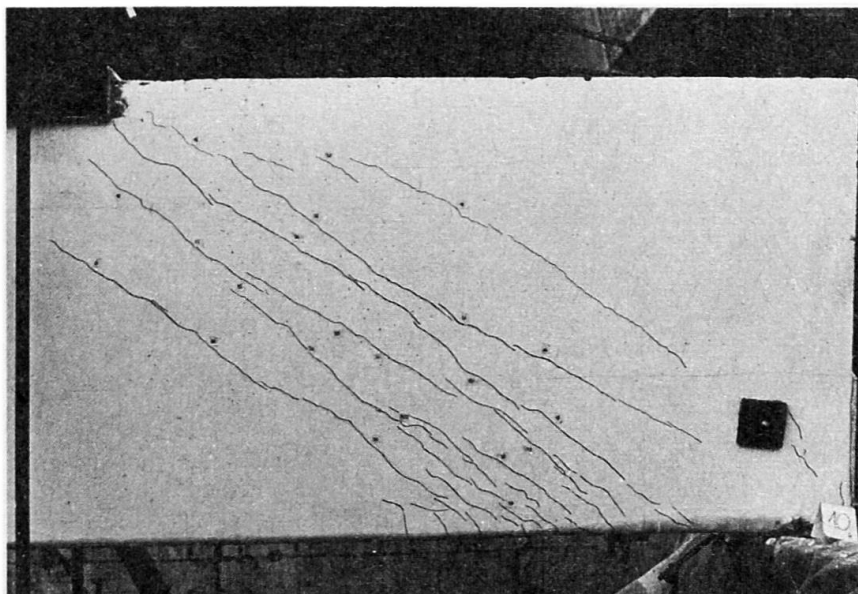
Fig. 21 Crack pattern at girder end A

In the inside of the beam cracks also occurred at the vertical contact surface between the concrete infill and the webs. They could be observed on the upper edge of the new concrete section. The cracking began at the girder end with about  $1.5Q(g+p)$ . With about  $1.9Q(g+p)$  the contact surface was cracked through right along the girder. A maximum crack width of 0.4 mm and significant deformations between the new concrete section and the web could be observed. Between the variants A and B there was no significant difference. There was no sign of a failure beginning in the support regions. The girder came through the test excellently and it was possible to use it again in the building.
