**Zeitschrift:** IABSE proceedings = Mémoires AIPC = IVBH Abhandlungen  
**Band:** 10 (1986)  
**Heft:** P-100: The Clifton Suspension Bridge: preservation for utilisation

## **The Clifton Suspension Bridge – Preservation for Utilisation**

### **M. Stuart CULLIMORE**

Deputy Chairman  
Clifton Suspension Bridge Trust  
Bristol, UK

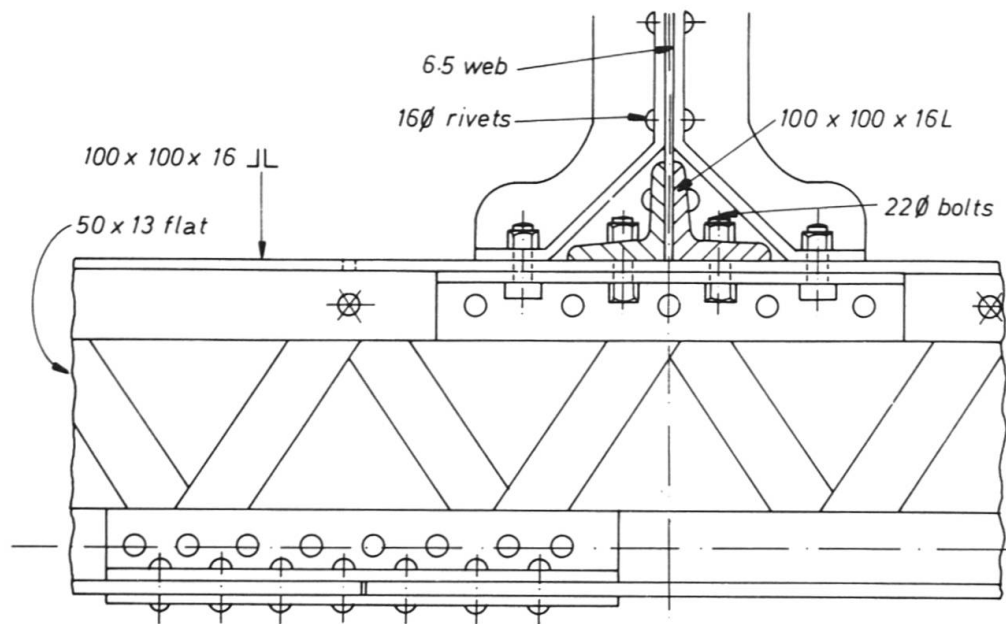
**Fig. 3** Longitudinal/cross girder connection

In this area of the structure (Fig. 3) the live load is transmitted from the deck, through the cross-girder to the longitudinal girder and thence to the suspender rod. This load concentration will result in stresses which are higher than in adjacent parts of the structure making it a possible fatigue cracking site.

A 2m long replica of the longitudinal girder and its attachments was fabricated from structural steel and loaded statically. The greatest live load stress measured around the area of the cross-girder connection was  $6 \text{ N/mm}^2$  per tonne. The stress range caused by the most severe vehicle loading would be  $22 \text{ N/mm}^2$ . This maximum loading occurs infrequently - probably not more than 1000 times per

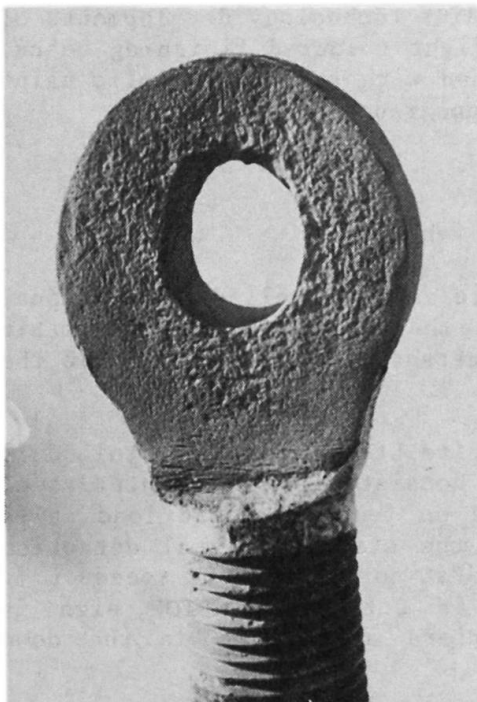
Fig. 5 Wear in suspension rod eye

The passage of a load across the span causes relative longitudinal movement between the chain and the stiffening girder. The resulting rotation of the ends of the suspender rods about the pins connecting them to the structure and the consequent wear is greatest at mid-span where the rods are shortest and decreases towards the ends of the span. Bolts in the shorter rods have been replaced at various times since 1887 but by 1970 wear of bolts, eye ends and shackles had become unacceptable in 66 rods around mid-span (Fig. 5).

Rods were removed for repair two or three at a time by transferring the load in each to a 12mm dia. length of pre-stressing strand which was attached to a yoke and tensioned with a pre-stressing jack. The rod eyes were filled with weld metal, bored, grit-blasted and bushed with a steel backed sintered bronze layer impregnated with a PTFE/lead mixture.

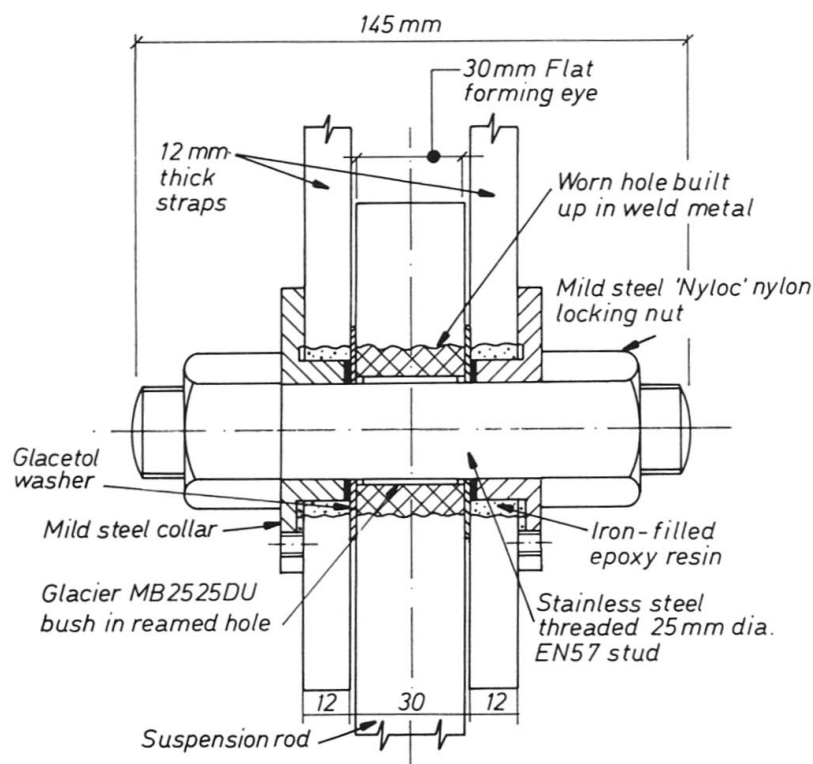
**Fig. 6** Suspension rod bolt replacement

The shackles and cleats were repaired in situ by fitting bushes bedded in iron loaded epoxy resin injected into the worn eyes (Fig. 6). Stainless steel studs, 25mm dia. replaced the 38mm dia. wrought iron bolts. The bottle screws in the rods had been freed by injecting penetrating oil under pressure so that when replaced the length of the rods could be adjusted to equalise their tensions.

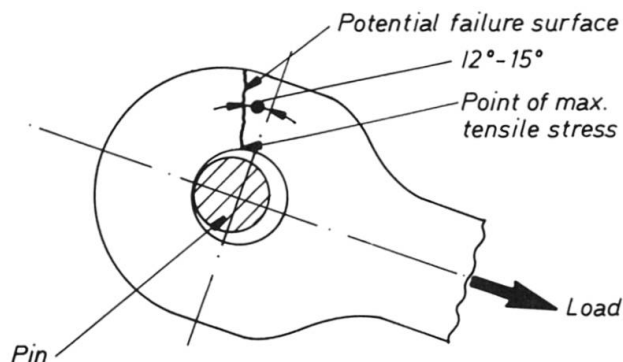
These rotations cause an effective eccentricity of the line of action of the load from the pin, resulting in variations of stress in the link and possible fatigue damage. A test was carried out in which rotations and strains in the end links were measured for various positions of a heavy load on the deck. The maximum stress at the inside of the eye (Fig. 7) was inferred from the measured strain on the outside of the eye using a finite element analysis, supported by tests on a full scale mild steel

**Fig. 7** Chain eye geometry

replica link. The three sets of results were in good agreement and indicated the maximum equivalent eccentricity of the load was  $+15 \text{ mm}$  and the maximum stress fluctuation  $+33.6 \text{ N/mm}^2$  about a mean stress of  $192 \text{ N/mm}^2$ . No results were available [4] for mean stresses as high as this but extrapolation indicated that the fatigue limit was near the measured stress fluctuation. It was then realised that not only had each link been subjected to a proof load but that the bridge itself had been proof loaded with 500 tonnes of stone. Either of these loadings would have caused yielding at the inside of the eyes which would give a residual compression stress there. The effect of this is estimated to reduce the mean stress to  $150 \text{ N/mm}^2$  at which the existing stress fluctuation would be acceptably below the fatigue limit.
