The Clifton Suspension Bridge – Preservation for Utilisation

M. Stuart CULLIMORE

Deputy Chairman
Clifton Suspension Bridge Trust
Bristol, UK

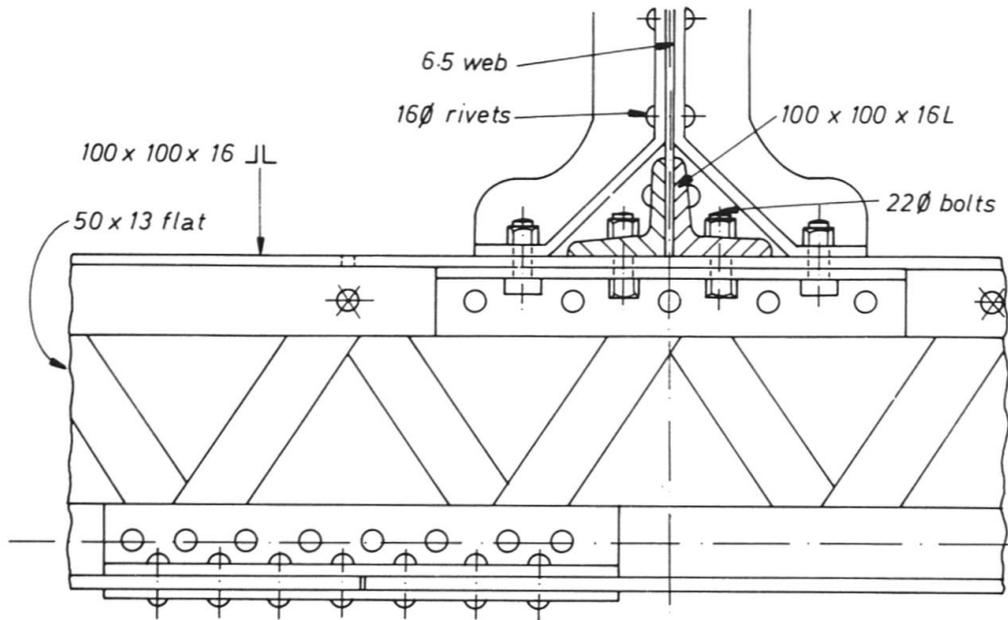
Fig. 3 Longitudinal/cross girder connection

In this area of the structure (Fig. 3) the live load is transmitted from the deck, through the cross-girder to the longitudinal girder and thence to the suspender rod. This load concentration will result in stresses which are higher than in adjacent parts of the structure making it a possible fatigue cracking site.

A 2m long replica of the longitudinal girder and its attachments was fabricated from structural steel and loaded statically. The greatest live load stress measured around the area of the cross-girder connection was 6 N/mm^2 per tonne. The stress range caused by the most severe vehicle loading would be 22 N/mm^2 . This maximum loading occurs infrequently - probably not more than 1000 times per

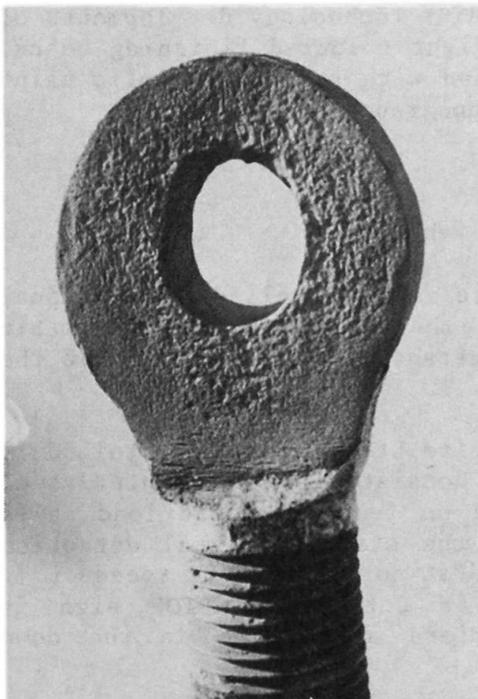
The passage of a load across the span causes relative longitudinal movement between the chain and the stiffening girder. The resulting rotation of the ends of the suspender rods about the pins connecting them to the structure and the consequent wear is greatest at mid-span where the rods are shortest and decreases towards the ends of the span. Bolts in the shorter rods have been replaced at various times since 1887 but by 1970 wear of bolts, eye ends and shackles had become unacceptable in 66 rods around mid-span (Fig. 5).

Fig. 5 Wear in suspension rod eye

Rods were removed for repair two or three at a time by transferring the load in each to a 12mm dia. length of pre-stressing strand which was attached to a yoke and tensioned with a pre-stressing jack. The rod eyes were filled with weld metal, bored, grit-blasted and bushed with a steel backed sintered bronze layer impregnated with a PTFE/lead mixture.

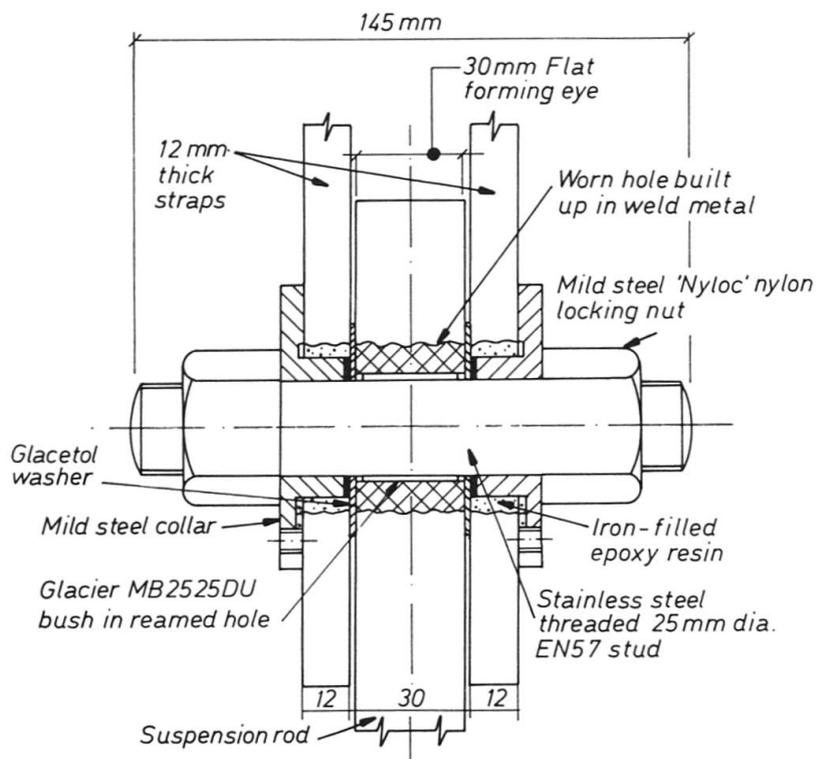
Fig. 6 Suspension rod bolt replacement

The shackles and cleats were repaired in situ by fitting bushes bedded in iron loaded epoxy resin injected into the worn eyes (Fig. 6). Stainless steel studs, 25mm dia. replaced the 38mm dia. wrought iron bolts. The bottle screws in the rods had been freed by injecting penetrating oil under pressure so that when replaced the length of the rods could be adjusted to equalise their tensions.

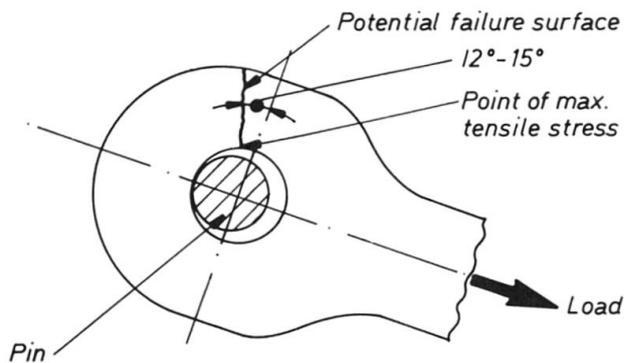
Fig. 7 Chain eye geometry

These rotations cause an effective eccentricity of the line of action of the load from the pin, resulting in variations of stress in the link and possible fatigue damage. A test was carried out in which rotations and strains in the end links were measured for various positions of a heavy load on the deck. The maximum stress at the inside of the eye (Fig. 7) was inferred from the measured strain on the outside of the eye using a finite element analysis, supported by tests on a full scale mild steel

replica link. The three sets of results were in good agreement and indicated the maximum equivalent eccentricity of the load was $+15 \text{ mm}$ and the maximum stress fluctuation $+33.6 \text{ N/mm}^2$ about a mean stress of 192 N/mm^2 . No results were available [4] for mean stresses as high as this but extrapolation indicated that the fatigue limit was near the measured stress fluctuation. It was then realised that not only had each link been subjected to a proof load but that the bridge itself had been proof loaded with 500 tonnes of stone. Either of these loadings would have caused yielding at the inside of the eyes which would give a residual compression stress there. The effect of this is estimated to reduce the mean stress to 150 N/mm^2 at which the existing stress fluctuation would be acceptably below the fatigue limit.
