The Clifton Suspension Bridge – Preservation for Utilisation

M. Stuart CULLIMORE

Deputy Chairman
Clifton Suspension Bridge Trust
Bristol, UK

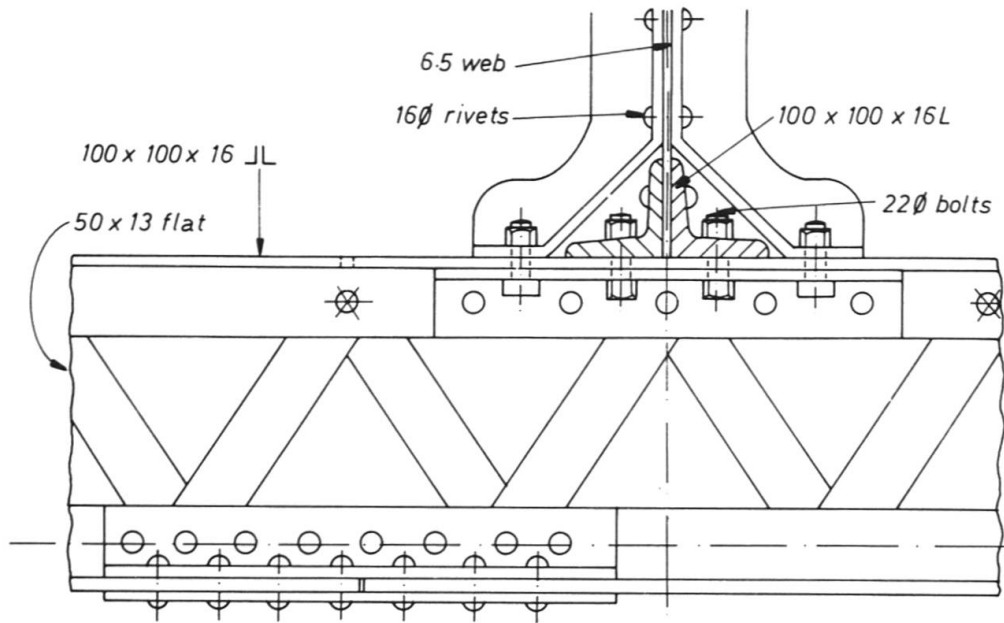
Fig. 3 Longitudinal/cross girder connection

In this area of the structure (Fig. 3) the live load is transmitted from the deck, through the cross-girder to the longitudinal girder and thence to the suspender rod. This load concentration will result in stresses which are higher than in adjacent parts of the structure making it a possible fatigue cracking site.

A 2m long replica of the longitudinal girder and its attachments was fabricated from structural steel and loaded statically. The greatest live load stress measured around the area of the cross-girder connection was 6 N/mm^2 per tonne. The stress range caused by the most severe vehicle loading would be 22 N/mm^2 . This maximum loading occurs infrequently - probably not more than 1000 times per

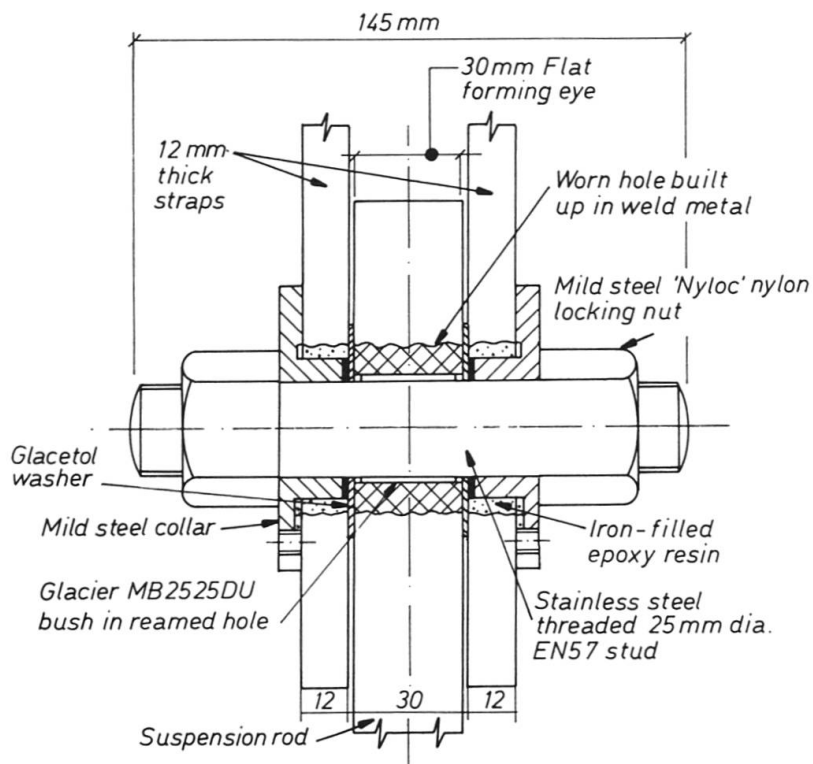
Fig. 6 Suspension rod bolt replacement

The shackles and cleats were repaired in situ by fitting bushes bedded in iron loaded epoxy resin injected into the worn eyes (Fig. 6). Stainless steel studs, 25mm dia. replaced the 38mm dia. wrought iron bolts. The bottle screws in the rods had been freed by injecting penetrating oil under pressure so that when replaced the length of the rods could be adjusted to equalise their tensions.

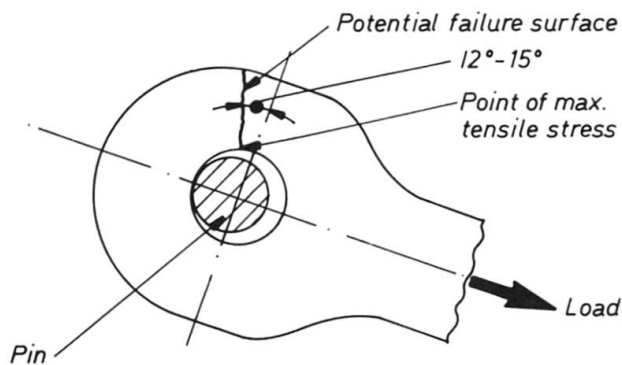
These rotations cause an effective eccentricity of the line of action of the load from the pin, resulting in variations of stress in the link and possible fatigue damage. A test was carried out in which rotations and strains in the end links were measured for various positions of a heavy load on the deck. The maximum stress at the inside of the eye (Fig. 7) was inferred from the measured strain on the outside of the eye using a finite element analysis, supported by tests on a full scale mild steel

Fig. 7 Chain eye geometry

replica link. The three sets of results were in good agreement and indicated the maximum equivalent eccentricity of the load was $+15 \text{ mm}$ and the maximum stress fluctuation $+33.6 \text{ N/mm}^2$ about a mean stress of 192 N/mm^2 . No results were available [4] for mean stresses as high as this but extrapolation indicated that the fatigue limit was near the measured stress fluctuation. It was then realised that not only had each link been subjected to a proof load but that the bridge itself had been proof loaded with 500 tonnes of stone. Either of these loadings would have caused yielding at the inside of the eyes which would give a residual compression stress there. The effect of this is estimated to reduce the mean stress to 150 N/mm^2 at which the existing stress fluctuation would be acceptably below the fatigue limit.
