Zeitschrift: IABSE reports of the working commissions = Rapports des commissions de travail AIPC = IVBH Berichte der Arbeitskommissionen

Artikel: American experiences with thick pavements on orthotropic steel deck bridges

Autor: Fondriest, F.F.

AMERICAN EXPERIENCES WITH THICK PAVEMENTS ON ORTHOTROPIC STEEL DECK BRIDGES

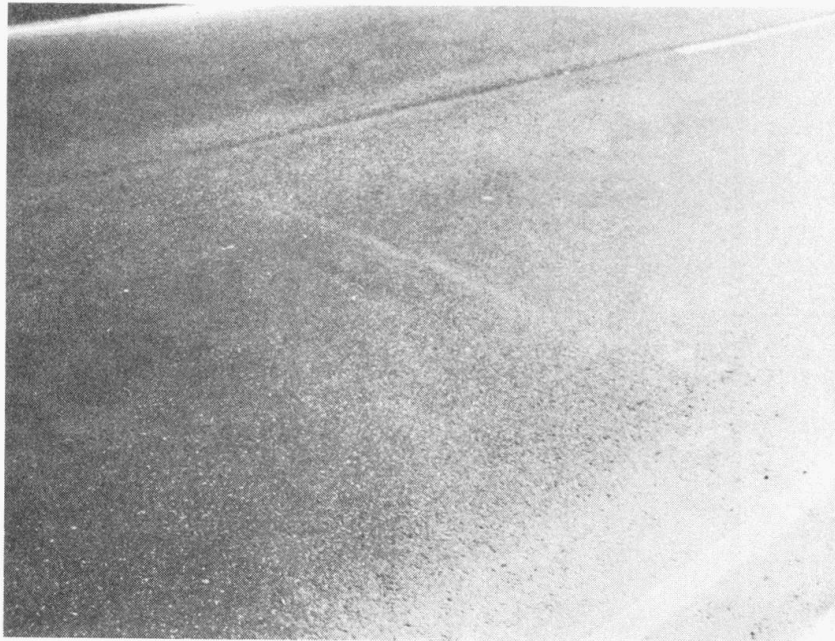
Port Mann Bridge -- After more than 4 years under heavy traffic, the condition of the pavement must be considered excellent. The only noticeable defect observed was some slight unevenness over a few of the splice plates after about 2 years in service. This condition is shown in Figure 1. A more recent inspection (after four years) indicated that transverse cracks may be forming at a few of these locations although there are none yet visible to the unaided eye. One such location is shown in Figure 2.

FIGURE 1. SLIGHT UNEVENNESS IN THE SURFACE COURSE
OVER THE SPLICE PLATES ON THE PORT MANN BRIDGE
AFTER 2-1/2 YEARS IN SERVICE

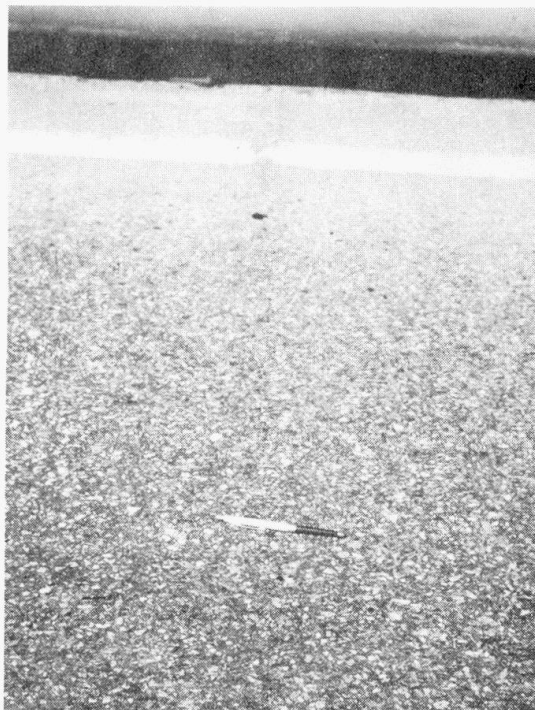
FIGURE 2. EVIDENCE OF A TRANSVERSE CRACK FORMING OVER THE SPLICE
PLATES ON THE PORT MANN BRIDGE AFTER FOUR YEARS OF SERVICE

With the exception of these few isolated spots, no other defects such as longitudinal cracking or shoving and rutting were noted. It is expected that any cracks which may form over the splice plates will be noticeable within an additional year.

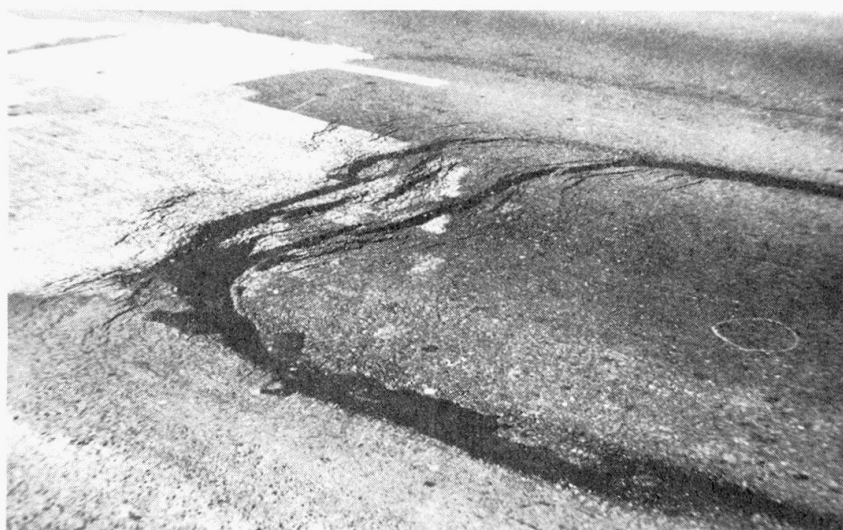
Within a few weeks after being opened to traffic, random cracks appeared in the AC surfacing. Shortly thereafter the pavement began debonding and within three months was literally shoved off the bridge. The mode of failure can be seen in Figure 3. The AC was replaced again using only an emulsion tack coat to bond the pavement to the deck plate. Within nine months the new AC pavement had again failed in the same manner as before. The pavement was replaced a second time in the same manner. This third pavement has remained in place and is performing reasonably well after almost two more years of service.

FIGURE 3. MODE OF FAILURE DUE TO DEBONDING OF THE AC PAVEMENT ON THE ULATIS CREEK BRIDGE AFTER ONLY A FEW MONTHS IN SERVICE

As was shown in Table 2 there is a wide variation in the amount and gradation of aggregate chips used. The importance of an effective bond can be determined from the experience of the AC surfacing placed on a portion of the Ulatis Creek Bridge. In this installation, only an emulsion tack coat was used to provide bond between the deck and the pavement. This lack of bond resulted in a complete failure of the pavement. Another instance of a lack of good bond was noted on the Troy Test Bridge where a heavy loading of fine stone chips was used in conjunction with an AC leveling course. After about 2 years in service, moderate cracking had occurred in the surfacing and upon removal of the pavement, little or no bond was found between the seal coat and the asphalt pavement. There was, however, sufficient shear resistance to prevent the pavement from shoving. The only other instance where the bond between the bond coat and the pavement was qualitatively checked was on the Humphreys Creek Bridge. In this instance the bond was found to be excellent.

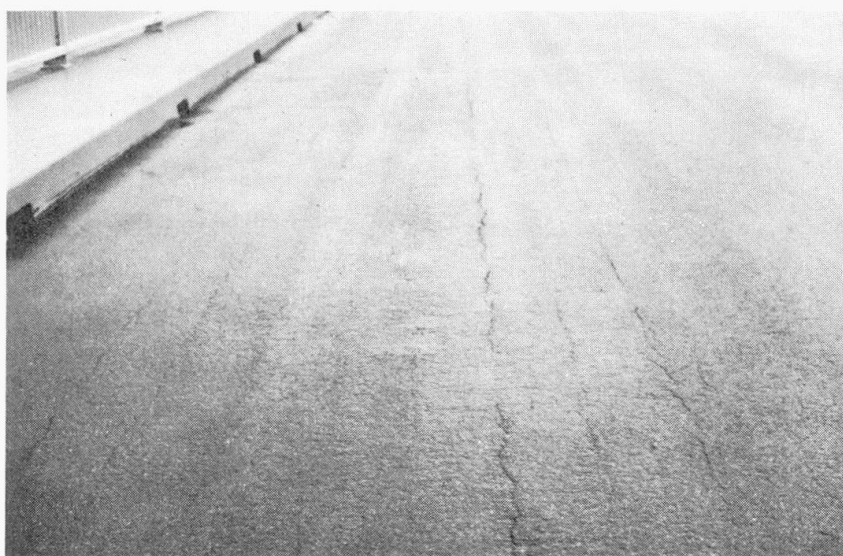
Concordia Bridge - This bridge is located within the Exposition grounds in Montreal. Half of the bridge width is used for rail traffic while the other half has little traffic at this time. The bridge was however used for all construction traffic prior to the opening of Expo '67. An inspection of this bridge was made approximately two years after completion. Numerous longitudinal cracks were formed essentially over the entire length of the bridge as shown in Figure 4. The most severe crack (shown in the center of Figure 4) is located over the web of the supporting box girder while the finer cracks are located over the stiffening ribs where they are attached to the deck plate.

FIGURE 4. LONGITUDINAL CRACKS IN THE ACPAVEMENT ON THE CONCORDIA BRIDGE AFTER TWO YEARS IN SERVICE

Cracks have been observed in the wearing course of the Concordia and Dublin Bridges. On both of these bridges the most severe longitudinal cracks occurred over the main girder webs where high negative bending movements are produced. Transverse cracks occurred over a pier on the Dublin Bridge--also an area of high negative movements. Comparable points of high negative movements are not present on the Port Mann and Humphreys Creek Bridges where no surface cracks have been observed.

While the above explanation may account for the cracks over the girders it does not fully explain the cause of cracking over the stiffening ribs. It is known that AC is subject to fatigue cracking under continuous flexing but it is not known to what extent low bond strength may contribute to the cracking.

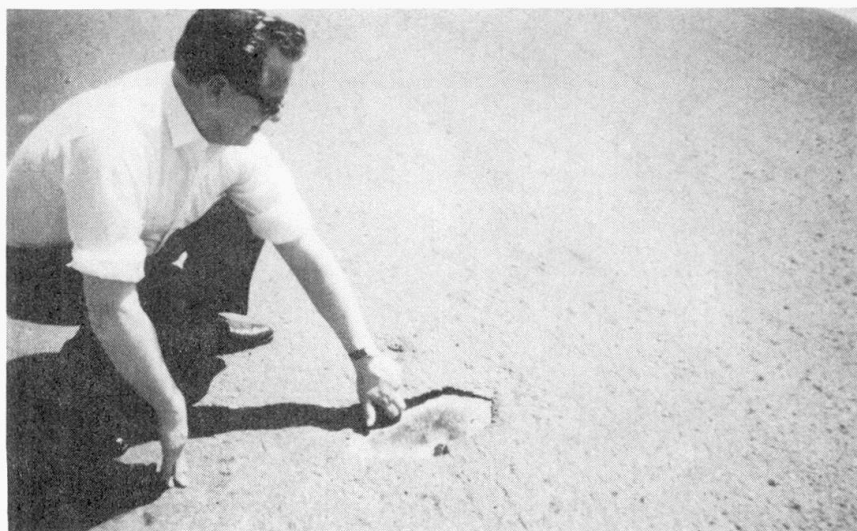
About the same time a small breakout occurred in the wearing course over a splice plate as shown in Figure 5. Although the damage is still relatively confined, the pavement adjacent to the breakout could be easily lifted up indicating essentially no bond to the deck plate. It is merely a matter of time before this defect increases in size.

FIGURE 5. BREAKOUT OF WEARING COURSE OVER SPLICE PLATE
ON CONCORDIA BRIDGE AFTER TWO YEARS OF SERVICE
