Artikel: American experiences with thick pavements on orthotropic steel deck bridges

Autor: Fondriest, F.F.

AMERICAN EXPERIENCES WITH THICK PAVEMENTS ON ORTHOTROPIC STEEL DECK BRIDGES

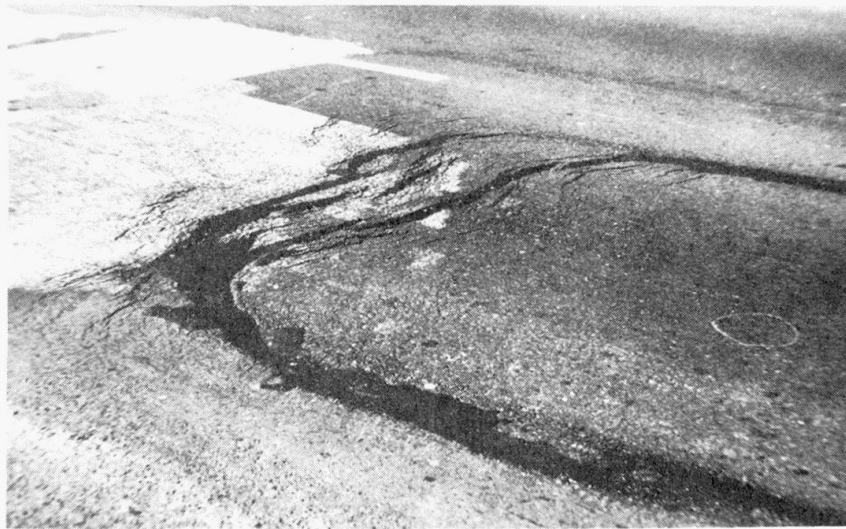
Within a few weeks after being opened to traffic, random cracks appeared in the AC surfacing. Shortly thereafter the pavement began debonding and within three months was literally shoved off the bridge. The mode of failure can be seen in Figure 3. The AC was replaced again using only an emulsion tack coat to bond the pavement to the deck plate. Within nine months the new AC pavement had again failed in the same manner as before. The pavement was replaced a second time in the same manner. This third pavement has remained in place and is performing reasonably well after almost two more years of service.

FIGURE 3. MODE OF FAILURE DUE TO DEBONDING OF THE AC PAVEMENT ON THE ULATIS CREEK BRIDGE AFTER ONLY A FEW MONTHS IN SERVICE

As was shown in Table 2 there is a wide variation in the amount and gradation of aggregate chips used. The importance of an effective bond can be determined from the experience of the AC surfacing placed on a portion of the Ulatis Creek Bridge. In this installation, only an emulsion tack coat was used to provide bond between the deck and the pavement. This lack of bond resulted in a complete failure of the pavement. Another instance of a lack of good bond was noted on the Troy Test Bridge where a heavy loading of fine stone chips was used in conjunction with an AC leveling course. After about 2 years in service, moderate cracking had occurred in the surfacing and upon removal of the pavement, little or no bond was found between the seal coat and the asphalt pavement. There was, however, sufficient shear resistance to prevent the pavement from shoving. The only other instance where the bond between the bond coat and the pavement was qualitatively checked was on the Humphreys Creek Bridge. In this instance the bond was found to be excellent.

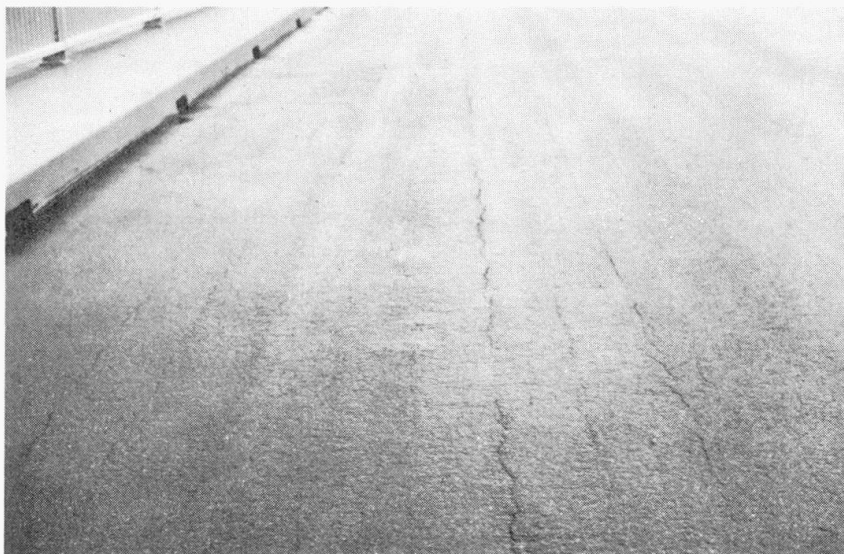
Concordia Bridge - This bridge is located within the Exposition grounds in Montreal. Half of the bridge width is used for rail traffic while the other half has little traffic at this time. The bridge was however used for all construction traffic prior to the opening of Expo '67. An inspection of this bridge was made approximately two years after completion. Numerous longitudinal cracks were formed essentially over the entire length of the bridge as shown in Figure 4. The most severe crack (shown in the center of Figure 4) is located over the web of the supporting box girder while the finer cracks are located over the stiffening ribs where they are attached to the deck plate.

FIGURE 4. LONGITUDINAL CRACKS IN THE ACPAVEMENT ON THE CONCORDIA BRIDGE AFTER TWO YEARS IN SERVICE

Cracks have been observed in the wearing course of the Concordia and Dublin Bridges. On both of these bridges the most severe longitudinal cracks occurred over the main girder webs where high negative bending movements are produced. Transverse cracks occurred over a pier on the Dublin Bridge--also an area of high negative movements. Comparable points of high negative movements are not present on the Port Mann and Humphreys Creek Bridges where no surface cracks have been observed.

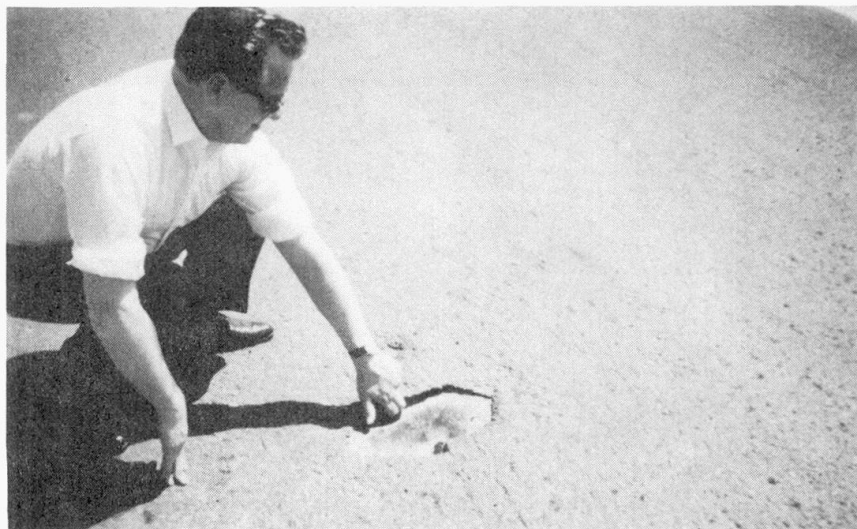
About the same time a small breakout occurred in the wearing course over a splice plate as shown in Figure 5. Although the damage is still relatively confined, the pavement adjacent to the breakout could be easily lifted up indicating essentially no bond to the deck plate. It is merely a matter of time before this defect increases in size.

FIGURE 5. BREAKOUT OF WEARING COURSE OVER SPLICE PLATE ON CONCORDIA BRIDGE AFTER TWO YEARS OF SERVICE
