**Zeitschrift:** IABSE reports of the working commissions = Rapports des commissions de travail AIPC = IVBH Berichte der Arbeitskommissionen

**Band:** 2 (1968)

**Artikel:** American experiences with thick pavements on orthotropic steel deck bridges

**Autor:** Fondriest, F.F.

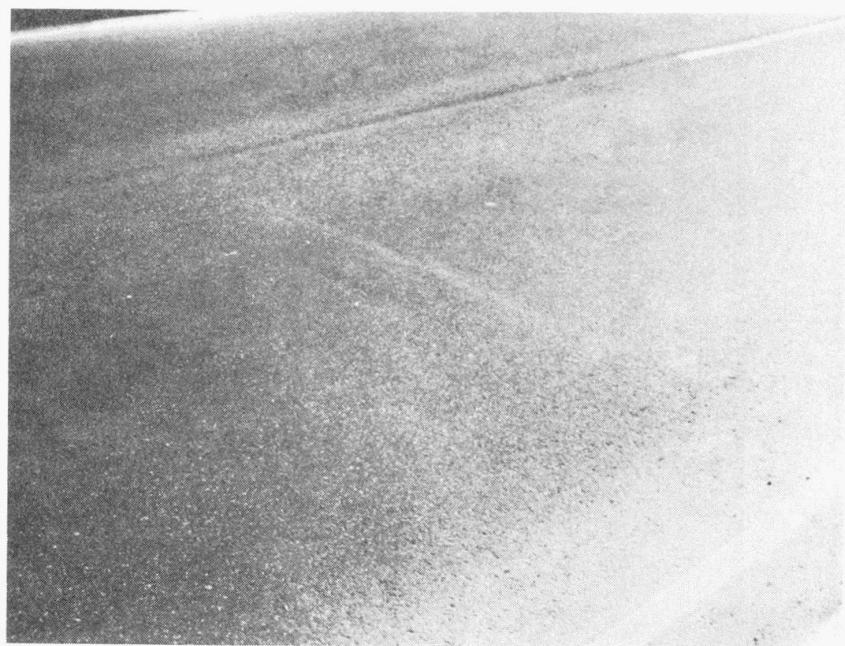
Port Mann Bridge -- After more than 4 years under heavy traffic, the condition of the pavement must be considered excellent. The only noticeable defect observed was some slight unevenness over a few of the splice plates after about 2 years in service. This condition is shown in Figure 1. A more recent inspection (after four years) indicated that transverse cracks may be forming at a few of these locations although there are none yet visible to the unaided eye. One such location is shown in Figure 2.

FIGURE 1. SLIGHT UNEVENNESS IN THE SURFACE COURSE  
OVER THE SPLICE PLATES ON THE PORT MANN BRIDGE  
AFTER 2-1/2 YEARS IN SERVICE

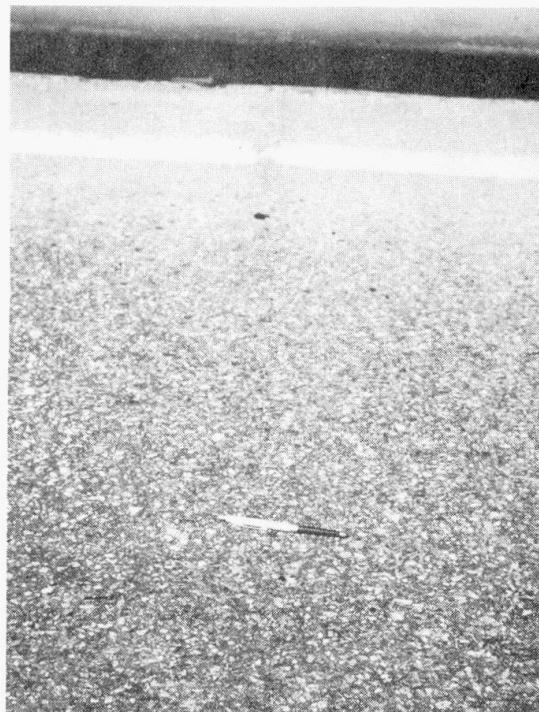
FIGURE 2. EVIDENCE OF A TRANSVERSE CRACK FORMING OVER THE SPLICE  
PLATES ON THE PORT MANN BRIDGE AFTER FOUR YEARS OF SERVICE

With the exception of these few isolated spots, no other defects such as longitudinal cracking or shoving and rutting were noted. It is expected that any cracks which may form over the splice plates will be noticeable within an additional year.

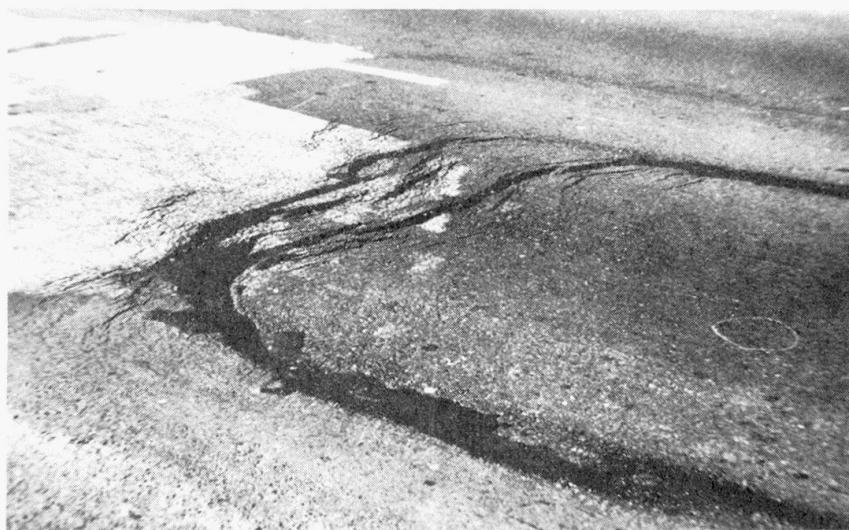
Within a few weeks after being opened to traffic, random cracks appeared in the AC surfacing. Shortly thereafter the pavement began debonding and within three months was literally shoved off the bridge. The mode of failure can be seen in Figure 3. The AC was replaced again using only an emulsion tack coat to bond the pavement to the deck plate. Within nine months the new AC pavement had again failed in the same manner as before. The pavement was replaced a second time in the same manner. This third pavement has remained in place and is performing reasonably well after almost two more years of service.

FIGURE 3. MODE OF FAILURE DUE TO DEBONDING OF THE AC PAVEMENT ON THE ULATIS CREEK BRIDGE AFTER ONLY A FEW MONTHS IN SERVICE

As was shown in Table 2 there is a wide variation in the amount and gradation of aggregate chips used. The importance of an effective bond can be determined from the experience of the AC surfacing placed on a portion of the Ulatis Creek Bridge. In this installation, only an emulsion tack coat was used to provide bond between the deck and the pavement. This lack of bond resulted in a complete failure of the pavement. Another instance of a lack of good bond was noted on the Troy Test Bridge where a heavy loading of fine stone chips was used in conjunction with an AC leveling course. After about 2 years in service, moderate cracking had occurred in the surfacing and upon removal of the pavement, little or no bond was found between the seal coat and the asphalt pavement. There was, however, sufficient shear resistance to prevent the pavement from shoving. The only other instance where the bond between the bond coat and the pavement was qualitatively checked was on the Humphreys Creek Bridge. In this instance the bond was found to be excellent.

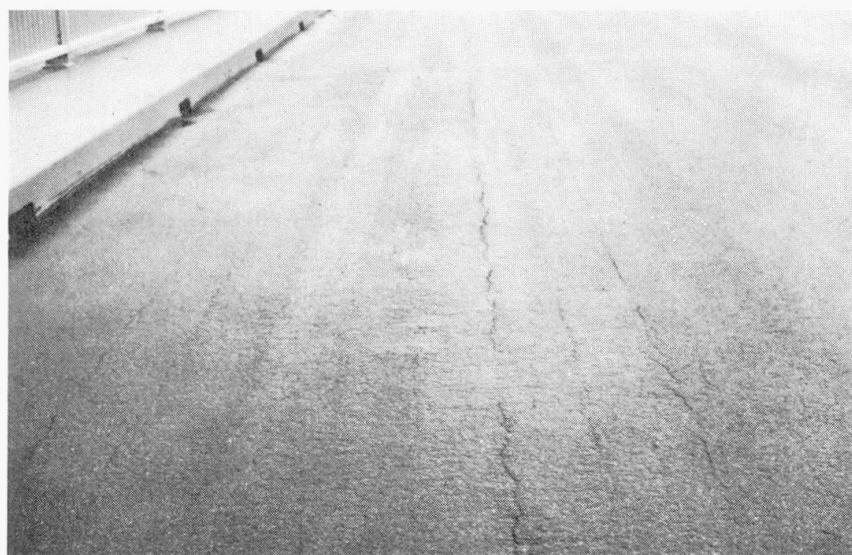
Concordia Bridge - This bridge is located within the Exposition grounds in Montreal. Half of the bridge width is used for rail traffic while the other half has little traffic at this time. The bridge was however used for all construction traffic prior to the opening of Expo '67. An inspection of this bridge was made approximately two years after completion. Numerous longitudinal cracks were formed essentially over the entire length of the bridge as shown in Figure 4. The most severe crack (shown in the center of Figure 4) is located over the web of the supporting box girder while the finer cracks are located over the stiffening ribs where they are attached to the deck plate.

FIGURE 4. LONGITUDINAL CRACKS IN THE ACPAVEMENT ON THE CONCORDIA BRIDGE AFTER TWO YEARS IN SERVICE

Cracks have been observed in the wearing course of the Concordia and Dublin Bridges. On both of these bridges the most severe longitudinal cracks occurred over the main girder webs where high negative bending movements are produced. Transverse cracks occurred over a pier on the Dublin Bridge--also an area of high negative movements. Comparable points of high negative movements are not present on the Port Mann and Humphreys Creek Bridges where no surface cracks have been observed.

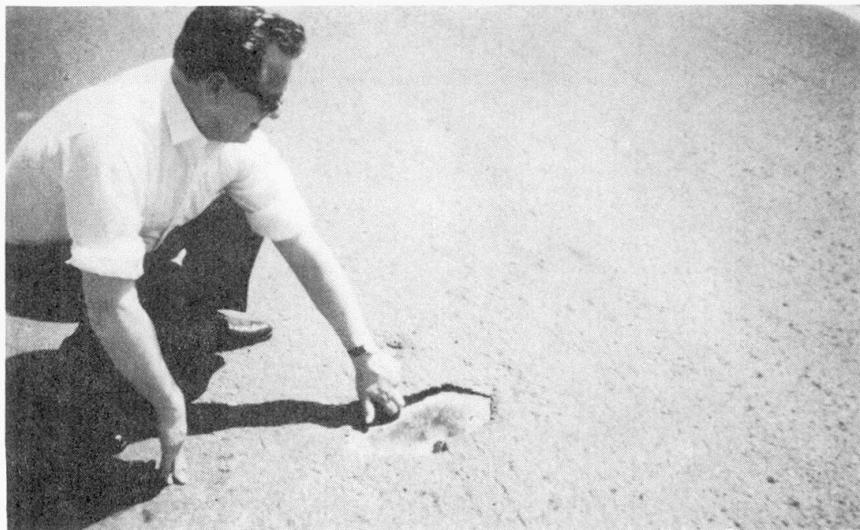
About the same time a small breakout occurred in the wearing course over a splice plate as shown in Figure 5. Although the damage is still relatively confined, the pavement adjacent to the breakout could be easily lifted up indicating essentially no bond to the deck plate. It is merely a matter of time before this defect increases in size.

FIGRE 5. BREAKOUT OF WEARING COURSE OVER SPLICE PLATE ON CONCORDIA BRIDGE AFTER TWO YEARS OF SERVICE
