**Artikel:** Surfacing on Forth Road bridge

**Autor:** Henderson, W.

## SURFACING ON FORTH ROAD BRIDGE

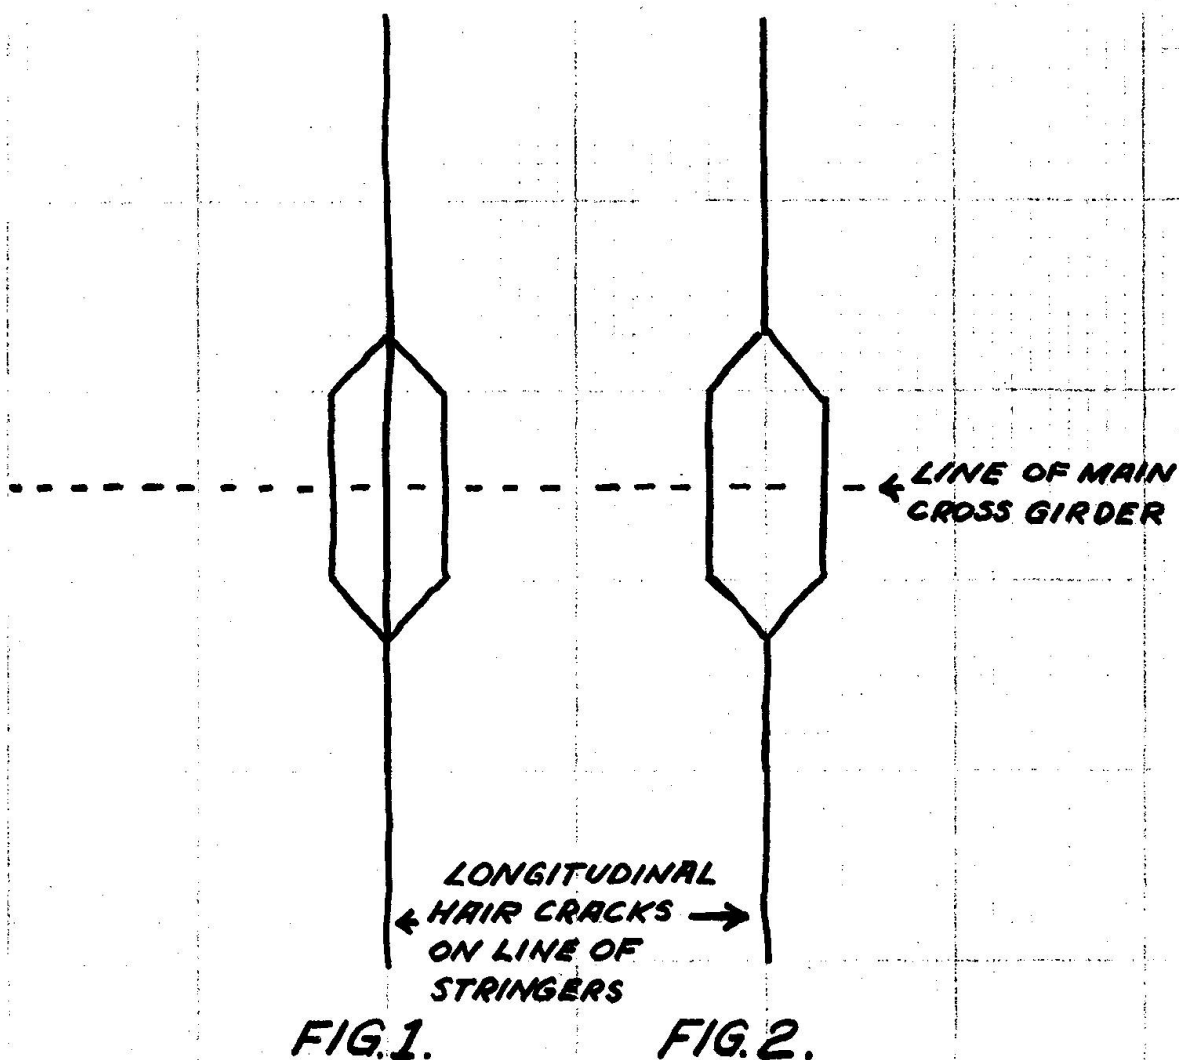
About eight months after the bridge was opened to traffic it was observed that five longitudinal cracks were beginning to appear in the slow lane, some 8 ft (2.4m) from the outer kerb. These fine cracks extended rapidly to form a more or less continuous line along the full length of the main span decked with orthotropic plates. The location of this crack coincided with the position of high negative bending at a stringer. Further fine longitudinal cracks appeared close to the kerb of the slow lane at points where the corresponding stringer passed over the main cross girder. These cracks were generally some 9" (23cm) to 18" (46cm) long. At these points the stringer webs are stiffened with bearing stiffeners and so stiffer than elsewhere.

In the case of each of the main longitudinal cracks, the tracks of vehicles straddle the stringers almost symmetrically and the location of these members is such that actual traffic takes up the position of causing maximum negative movement over this support. On these cracks, too, there was a tendency, where the stringer passes over the main cross girder and is reinforced with bearing stiffeners, for two short cracks to form on either side of the main longitudinal crack for a distance of 9" (23cm) to 18" (46cm) and then to return into it at an angle (Fig.1). In other cases the central crack terminated between the apices of these hexagons (Fig.2).

Careful examination showed that the bond between the asphalt, and the steel was not impaired. An area of asphalt was removed for inspection and it may be of some interest to note that over small patches the zinc spray applied to the steel surface pulled off with the asphalt.

Remedial measures were put in hand quickly; these consisted of making a "saw" cut  $\frac{1}{2}$ " (1.25cm) wide along the line of each crack to a depth of 1" (2.5cms). This cut was freed from dust by blowing out with compressed air and then filled by pouring in a sealant conforming with the current British Standard 2499(55), and with the American Federal Specification SS/S 164. The actual material used is a proprietary known as Expandite Pliastic 55.

This treatment has been eminently successful. The carriageway surfacing has been kept under regular surveillance and in general the sealant is serving its dual purpose of allowing flexure and at the same time preventing ingress of water. The two cuts 8' (2.4m) in from the sides of the deck are traversed from time to time by wheels which undoubtedly have had the effect of packing and consolidating the sealant into the "saw" cuts in the most effective way.
