Artikel: Surfacing on Forth Road bridge

SURFACING ON FORTH ROAD BRIDGE

W. HENDERSON
Scotland

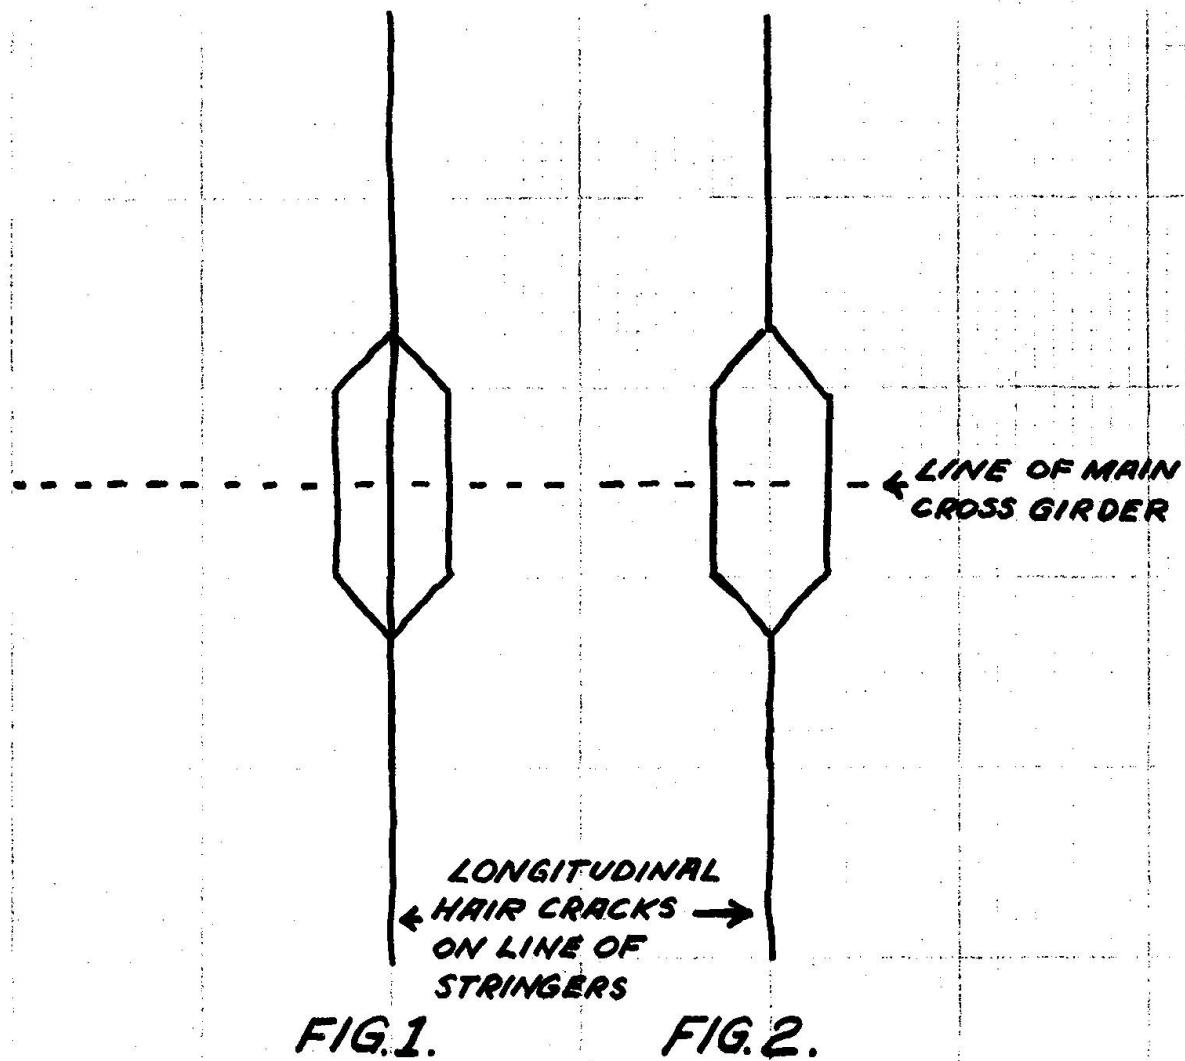
About eight months after the bridge was opened to traffic it was observed that fine longitudinal cracks were beginning to appear in the slow lane, some 8 ft (2.4m) from the outer kerb. These fine cracks extended rapidly to form a more or less continuous line along the full length of the main span decked with orthotropic plates. The location of this crack coincided with the position of high negative bending at a stringer. Further fine longitudinal cracks appeared close to the kerb of the slow lane at points where the corresponding stringer passed over the main cross girder. These cracks were generally some 9" (23cm) to 18" (46cm) long. At these points the stringer webs are stiffened with bearing stiffeners and so stiffer than elsewhere.

Some three to four months later similar fine cracks appeared some 8' (2.4m) from the kerb of the fast, less heavily used lane, again over a stringer, and close to the kerb at the point of support of the outer stringer over the cross girder.

In the case of each of the main longitudinal cracks, the tracks of vehicles straddle the stringers almost symmetrically and the location of these members is such that actual traffic takes up the position of causing maximum negative movement over this support. On these cracks, too, there was a tendency, where the stringer passes over the main cross girder and is reinforced with bearing stiffeners, for two short cracks to form on either side of the main longitudinal crack for a distance of 9" (23cm) to 18" (46cm) and then to return into it at an angle (Fig.1). In other cases the central crack terminated between the apices of these hexagons (Fig.2).

Careful examination showed that the bond between the asphalt, and the steel was not impaired. An area of asphalt was removed for inspection and it may be of some interest to note that over small patches the zinc spray applied to the steel surface pulled off with the asphalt.

Remedial measures were put in hand quickly; these consisted of making a "saw" cut ~~is~~ $\frac{1}{2}$ " (1.25cm) wide along the line of each crack to a depth of 1" (2.5cms). This cut was freed from dust by blowing out with compressed air and then filled by pouring in a sealant conforming with the current British Standard 2499(55), and with the American Federal Specification SS/S 164. The actual material used is a proprietary known as Expandise Pliastic 55.

This treatment has been eminently successful. The carriageway surfacing has been kept under regular surveillance and in general the sealant is serving its dual purpose of allowing flexure and at the same time preventing ingress of water. The two cuts 8' (2.4m) in from the sides of the deck are traversed from time to time by wheels which undoubtedly have had the effect of packing and consolidating the sealant into the "saw" cuts in the most effective way.
