**Zeitschrift:** IABSE reports of the working commissions = Rapports des commissions de travail AIPC = IVBH Berichte der Arbeitskommissionen  
**Band:** 2 (1968)  
**Artikel:** Surfacing on Forth Road bridge  
**Autor:** Henderson, W.  
**DOI:** <https://doi.org/10.5169/seals-3976>

## SURFACING ON FORTH ROAD BRIDGE

W. HENDERSON  
Scotland

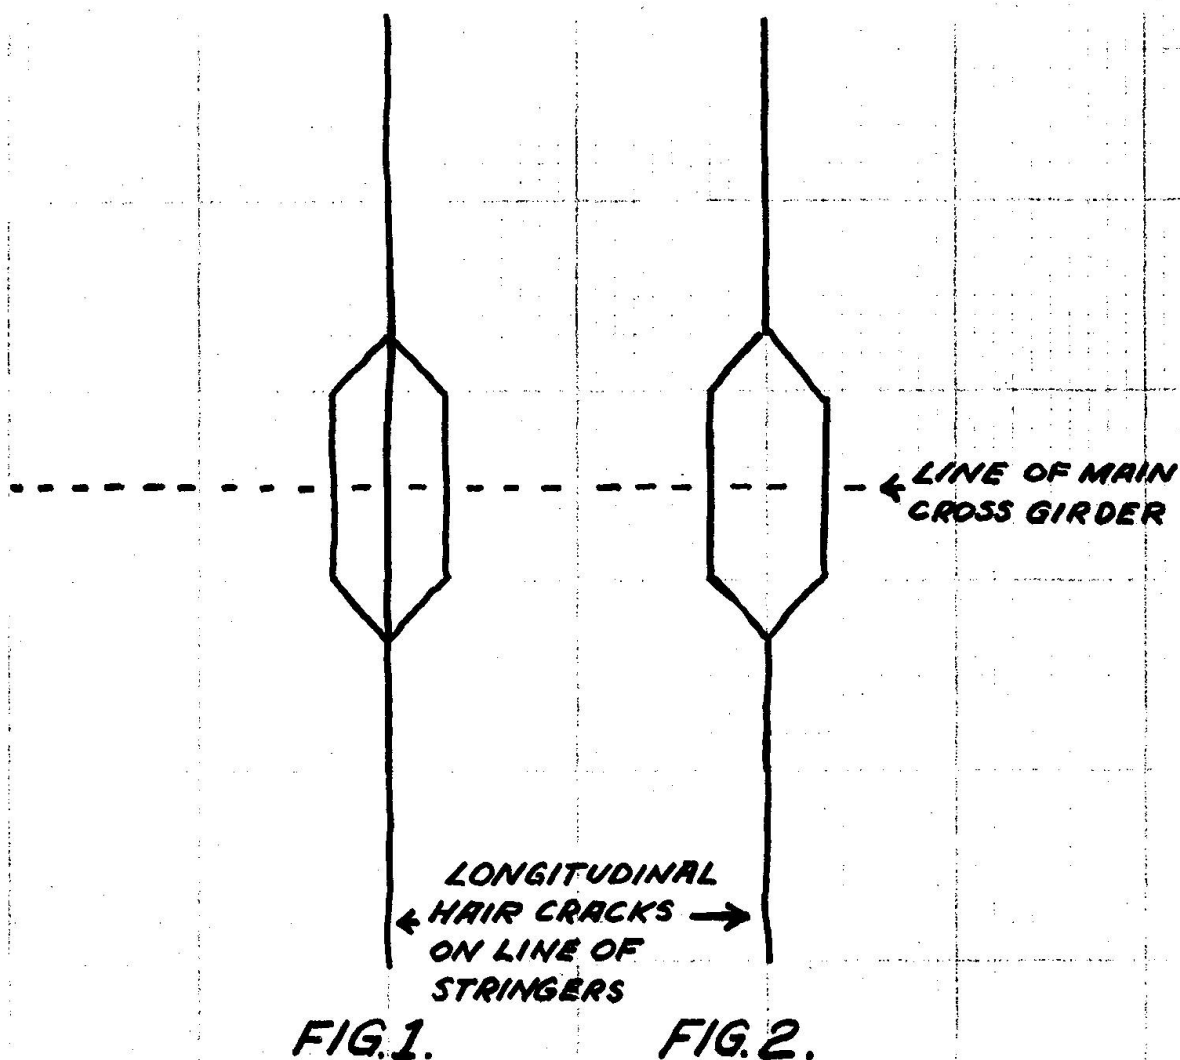
About eight months after the bridge was opened to traffic it was observed that five longitudinal cracks were beginning to appear in the slow lane, some 8 ft (2.4m) from the outer kerb. These fine cracks extended rapidly to form a more or less continuous line along the full length of the main span decked with orthotropic plates. The location of this crack coincided with the position of high negative bending at a stringer. Further fine longitudinal cracks appeared close to the kerb of the slow lane at points where the corresponding stringer passed over the main cross girder. These cracks were generally some 9" (23cm) to 18" (46cm) long. At these points the stringer webs are stiffened with bearing stiffeners and so stiffer than elsewhere.

Some three to four months later similar fine cracks appeared some 8' (2.4m) from the kerb of the fast, less heavily used lane, again over a stringer, and close to the kerb at the point of support of the outer stringer over the cross girder.

In the case of each of the main longitudinal cracks, the tracks of vehicles straddle the stringers almost symmetrically and the location of these members is such that actual traffic takes up the position of causing maximum negative movement over this support. On these cracks, too, there was a tendency, where the stringer passes over the main cross girder and is reinforced with bearing stiffeners, for two short cracks to form on either side of the main longitudinal crack for a distance of 9" (23cm) to 18" (46cm) and then to return into it at an angle (Fig.1). In other cases the central crack terminated between the apices of these hexagons (Fig.2).

Careful examination showed that the bond between the asphalt, and the steel was not impaired. An area of asphalt was removed for inspection and it may be of some interest to note that over small patches the zinc spray applied to the steel surface pulled off with the asphalt.

Remedial measures were put in hand quickly; these consisted of making a "saw" cut  $\frac{1}{2}$ " (1.25cm) wide along the line of each crack to a depth of 1" (2.5cms). This cut was freed from dust by blowing out with compressed air and then filled by pouring in a sealant conforming with the current British Standard 2499(55), and with the American Federal Specification SS/S 164. The actual material used is a proprietary known as Expandite Pliastic 55.

This treatment has been eminently successful. The carriageway surfacing has been kept under regular surveillance and in general the sealant is serving its dual purpose of allowing flexure and at the same time preventing ingress of water. The two cuts 8' (2.4m) in from the sides of the deck are traversed from time to time by wheels which undoubtedly have had the effect of packing and consolidating the sealant into the "saw" cuts in the most effective way.
