Zeitschrift: IABSE reports of the working commissions = Rapports des commissions de travail AIPC = IVBH Berichte der Arbeitskommissionen

Band: 2 (1968)

DISKUSSIONSBEITRAG
ZUM THEMA III (DÜNNE FAHRBAHNBELÄGE)

Contribution to the discussion
on Theme III (Thin Wearing Surfaces)

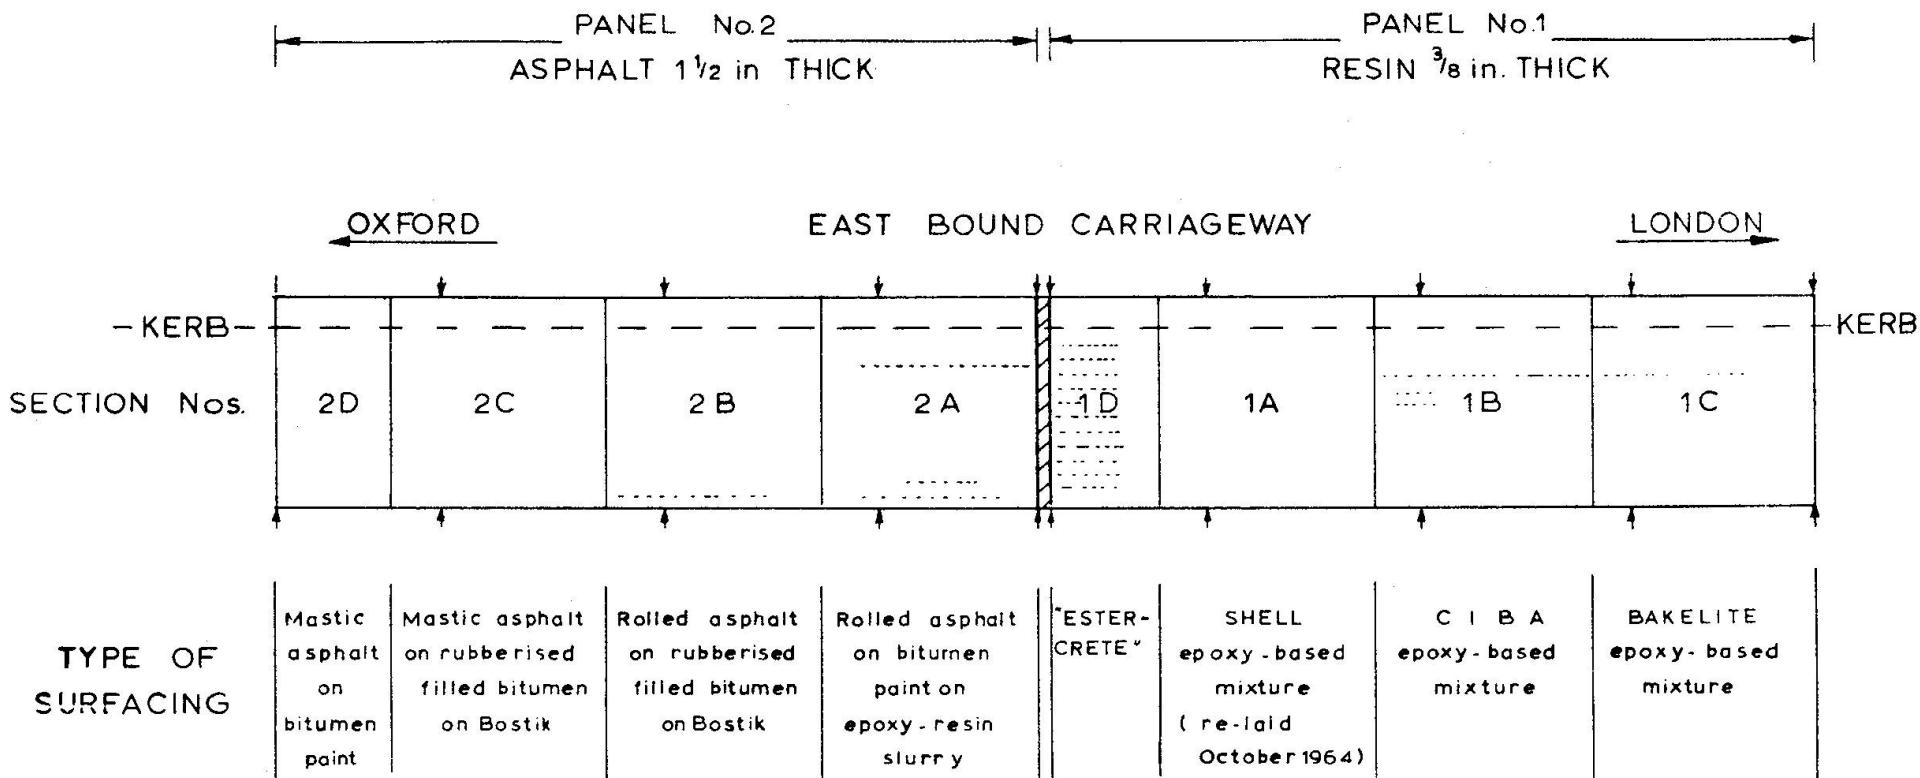
NOTE: The small arrows show position of the transverse stiffener.
The cracks visible in the surfacings in April 1965 are shown thus.....

Fig. 2 LAY-OUT DIAGRAM. SEVERN BRIDGE TEST PANELS ON TRUNK ROAD A40 (WESTERN AVENUE), DENHAM, BUCKS, NOVEMBER 1963.

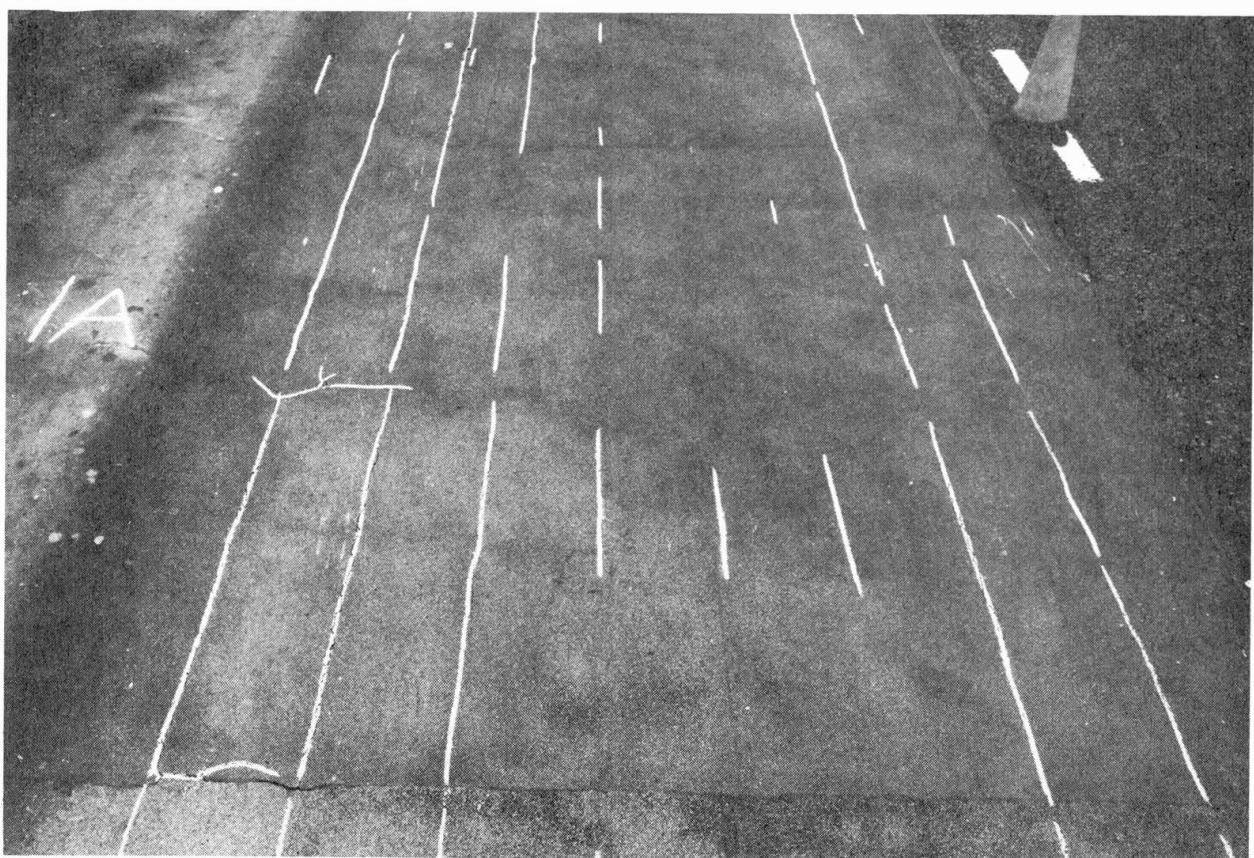
The panels were opened to traffic in November 1963. The first cracks appeared over the stiffeners in the wheel tracks on Sections 1A and 1D, early in 1964. Subsequently, there was a rapid deterioration of the condition of Section 1A, probably due to a defective constituent in the resin, and it was replaced in October 1964. The replacement was made with a fresh batch of the material to the same specification. It was more durable than the previous batch, but it deteriorated in a similar manner and was removed in April 1968. Cracks have developed in the "Estercrete" on Section 1D over all the stiffeners, but they have not widened appreciably and the material still firmly adheres to the steel.

FIG. 3 CRACKING IN EPOXY RESIN SURFACING ON SECTION 1A, NOVEMBER, 1967

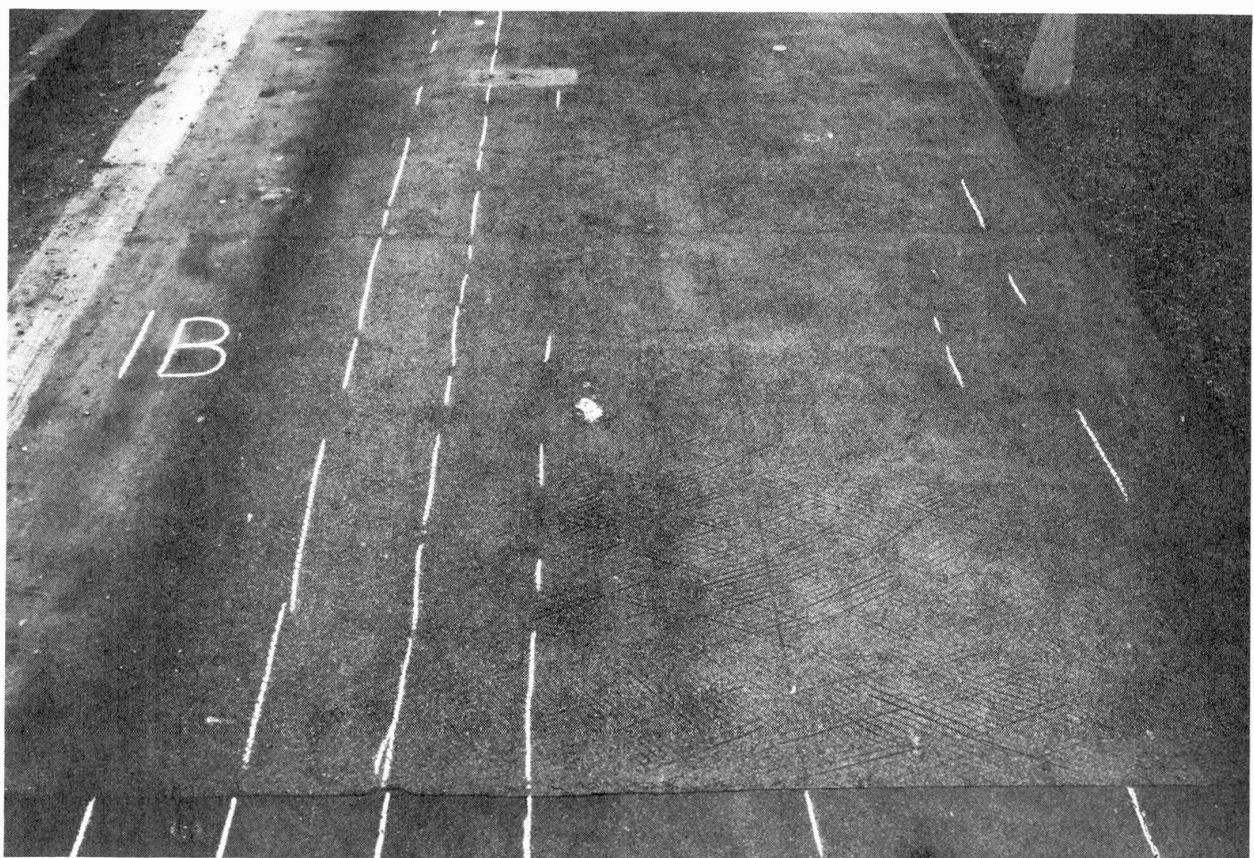
On Sections 1B and 1C the surfacing was in good condition until the beginning of 1965. Then one crack appeared over the stiffener in the nearside wheel track. Since then additional cracks have developed in both the wheel tracks, but the materials still adhere firmly to the deck between cracks. The condition of the four resin surfacings in November 1967 is shown in Figs. 3-6. As reported in a previous paper the mastic asphalt laid at the same time is still uncracked and has vindicated its selection for the deck of the Severn Bridge in 1966.

FIG. 4. CRACKING IN EPOXY RESIN SURFACING ON SECTION 1B, NOVEMBER, 1967

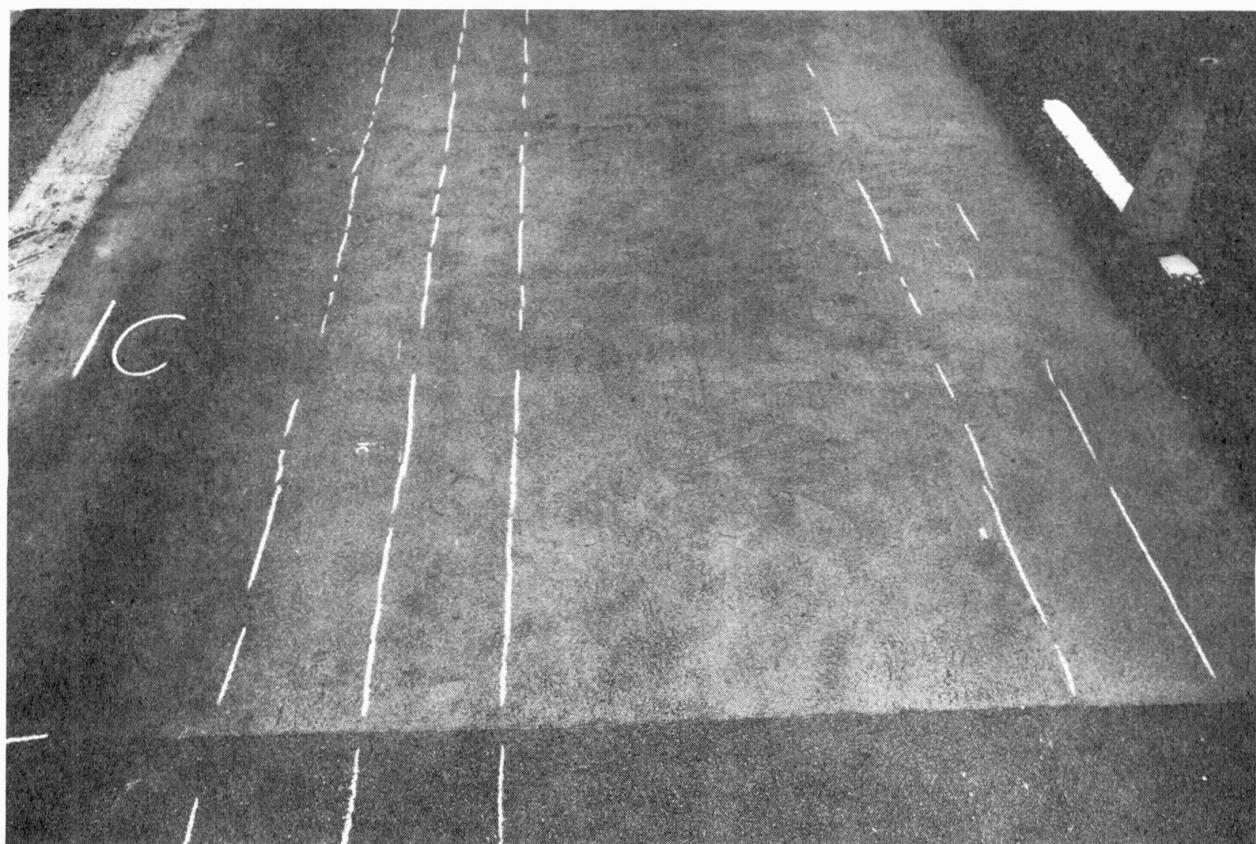
FIG. 5 CRACKING IN EPOXY RESIN SURFACING ON SECTION 1C, NOVEMBER, 1967

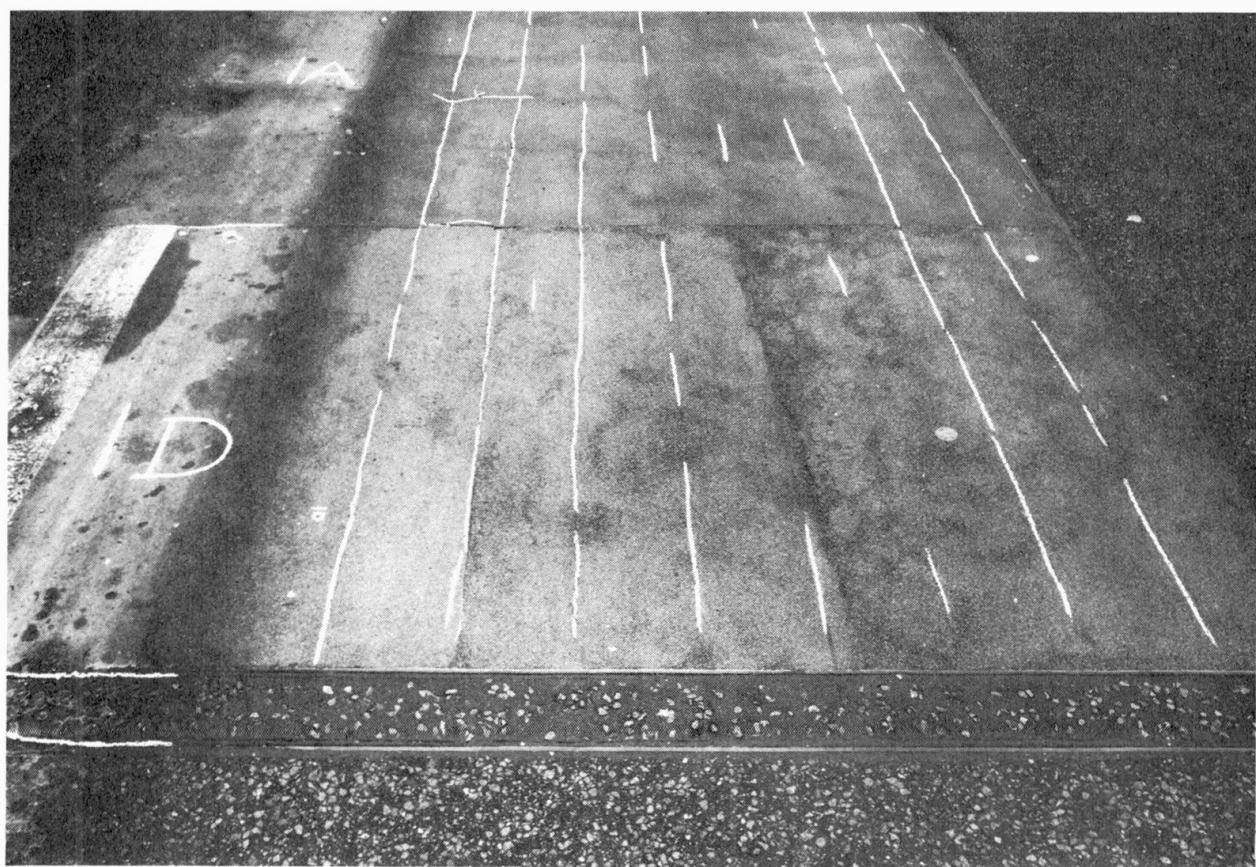
FIG. 6 CRACKING IN "ESTERCRETE" SURFACING ON SECTION 1D, NOVEMBER, 1967
