POST EARTHQUAKE CONSTRUCTION OF GEDİZ

Aybars Gürpınar

SUMMARY

The town of Gediz in Western Turkey was struck by an earthquake in March 1970. Since then the Turkish government has built a new town (New Gediz) about 8 kms from the original location. As the old town is still habitated the problem has arisen for the government to investigate and decide about the suitability for habitation of Gediz from the point of view of seismic risk. The present report is a culmination of such an investigation.

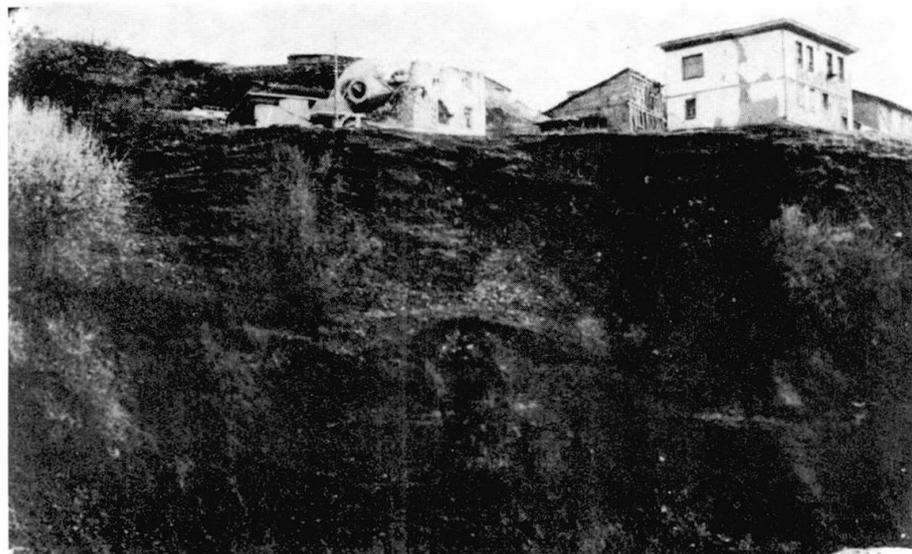
Figure 3. Ruins of a Mosque on Basaltic Formation

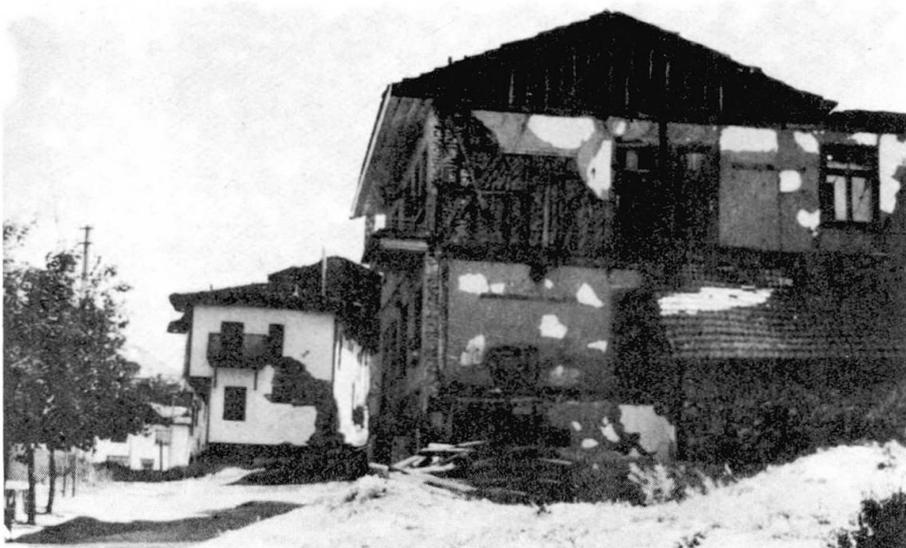
By far the most common residential type of construction in Gediz is wood frame. A typical Gediz house of this type (**Hımsı**) may be seen in Figure 4. The major deficiency of this type of construction during an earthquake is the danger of loose infill, improper diagonal bracing and poor masonry foundation. A more refined version of this type of construction may be seen in

Figure 4. Typical Wood Frame Structure (Hımsı)

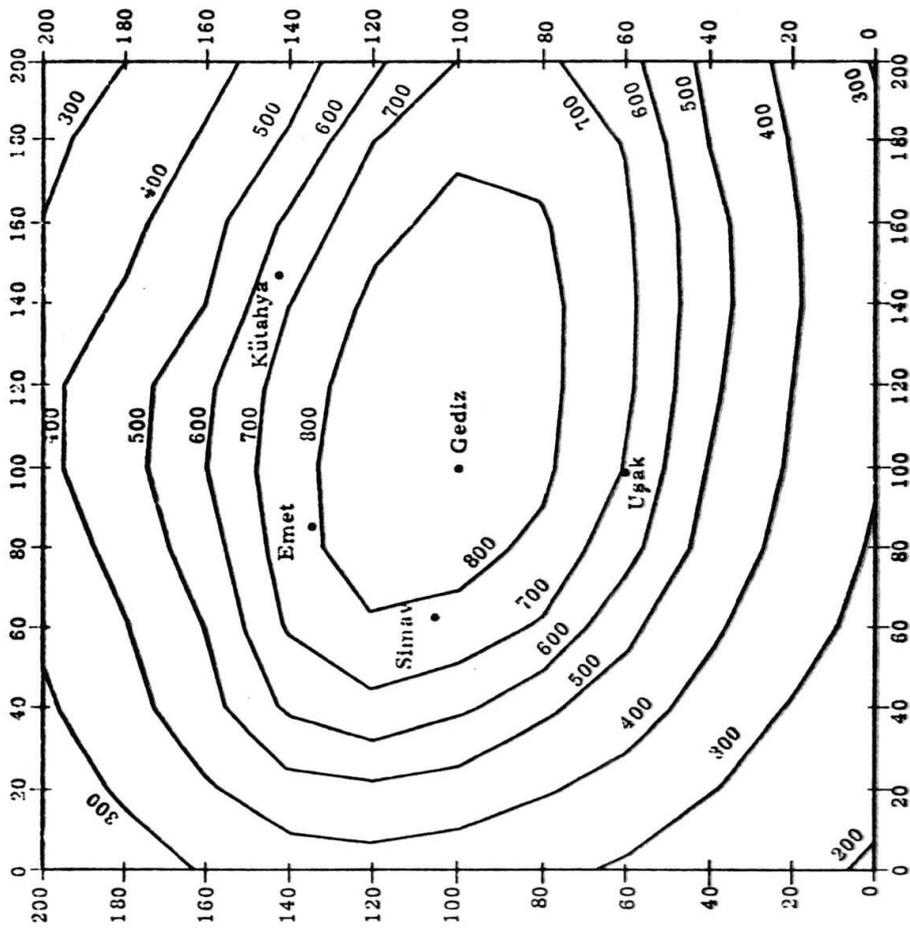
Iso-acceleration contours for 20% probability of exceedance and 50 year time period may be seen in Figure 7. Peak ground acceleration values for some towns in the region are as follows: Gediz, 850; Emet, 780; Simav, 770; Uşak, 690; and Kütahya, 640; all in gals.

It should be pointed out that New Gediz which is only 8 kms south of the old town is still within the 800 gal contour. Although Gediz has the largest peak ground acceleration value for given probability of exceedance and time period, the difference between Gediz and other towns (such as Emet and Simav) is not appreciable enough to decide against habitation in Gediz. The risk curves for 1, 20 and 50 year periods may be seen in Figure 8.

Figure 7. Iso-Acceleration Contours for $P(A) = 0.20$ 50 Years

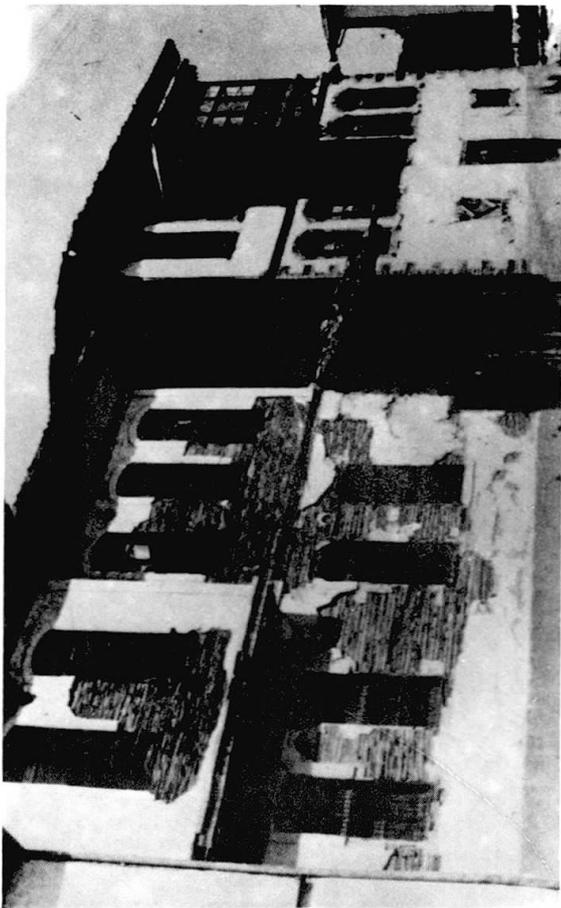
Figure 5. The first two points of deficiency are generally taken care of in this type (balıdadi) of construction.

Figure 5. Typical Wood Frame Structure (Bagdad)

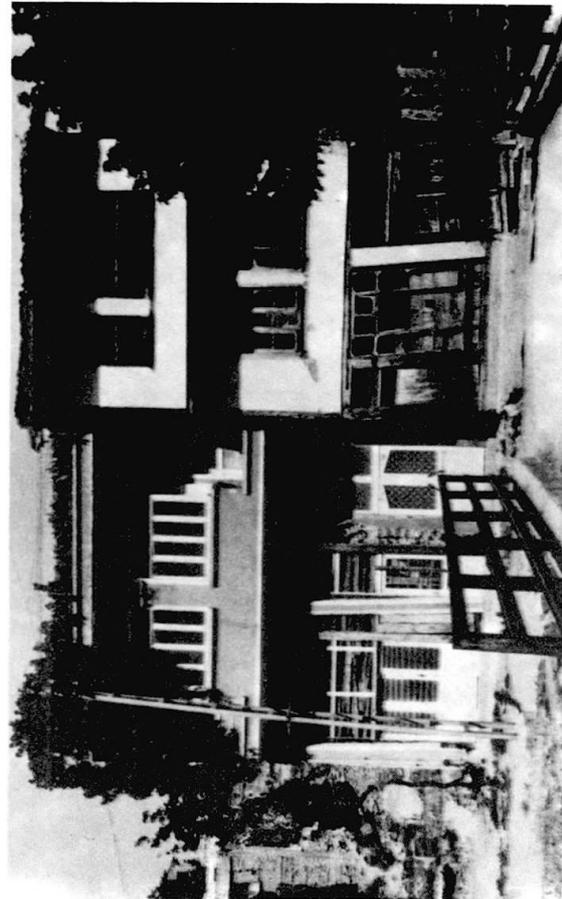
The major causes of failure for wood frame structures were spilling of loose infill material, inadequate cross bracing and poor foundation. Sidesway of one such building due to inadequate cross bracing may be seen in Figure 6. On the whole, however, wood frame structures behaved exceptionally well during the earthquake.

Figure 6. Sidesway Caused by Inadequate Cross Bracing

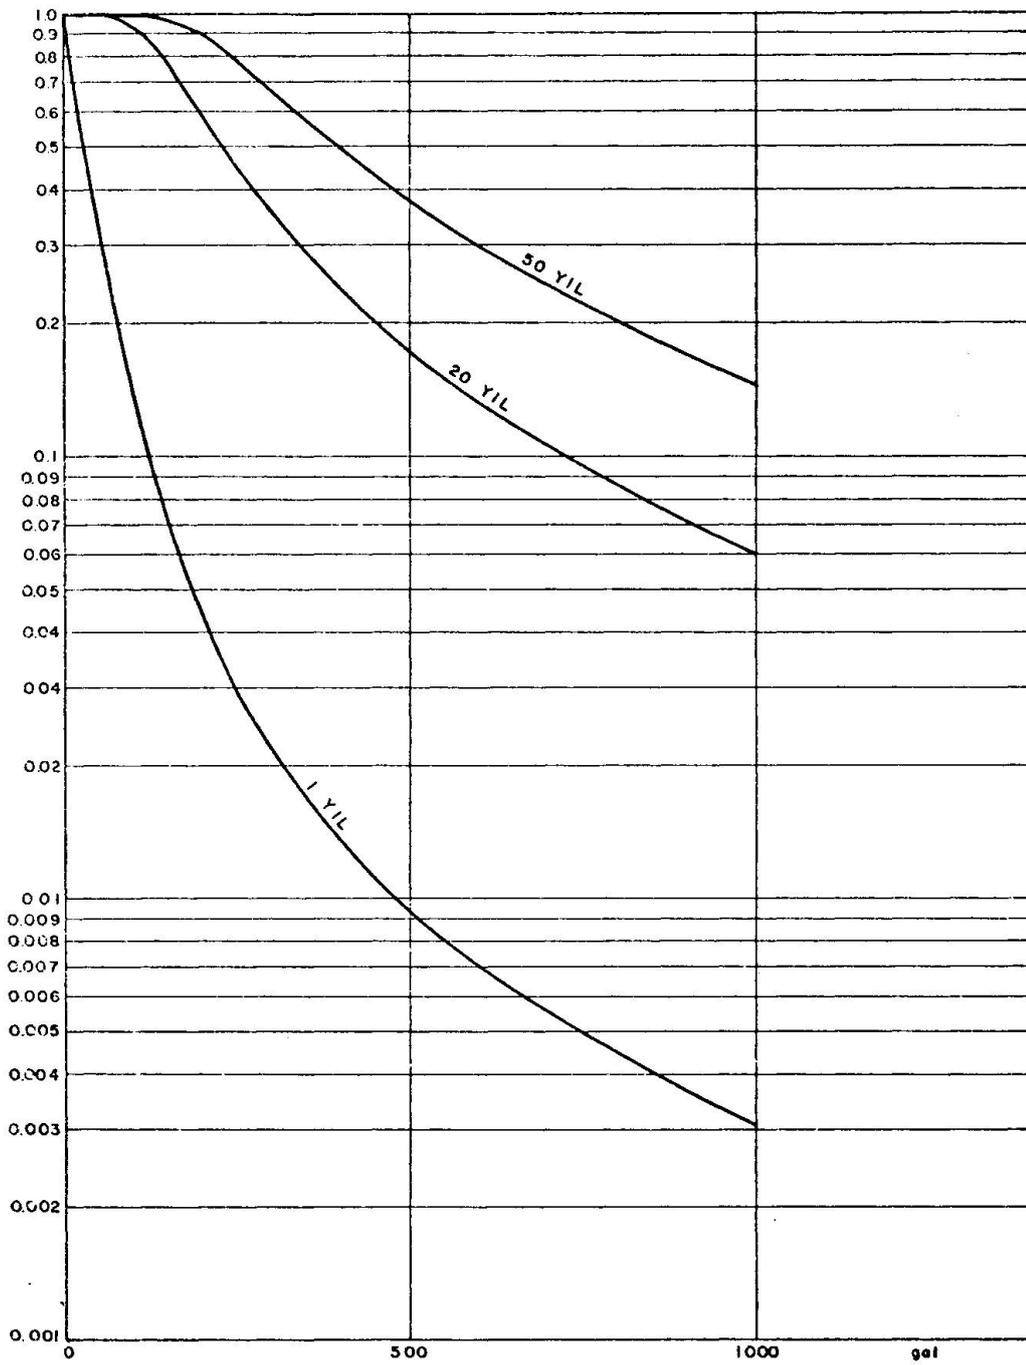
Figure 8. Seismic Risk Curves for Gediz- 1,20,50 Years
