Zeitschrift: IABSE reports of the working commissions = Rapports des commissions de travail AIPC = IVBH Berichte der Arbeitskommissionen
Band: 30 (1978)
Artikel: Repair of earthquake damaged buildings
Autor: Wyllie, Loring A.
DOI: <https://doi.org/10.5169/seals-24178>

REPAIR OF EARTHQUAKE DAMAGED BUILDINGS

Loring A. Wyllie, Jr.
Structural Engineer
H.J. Degenkolb and Associates
San Francisco, California U.S.A.

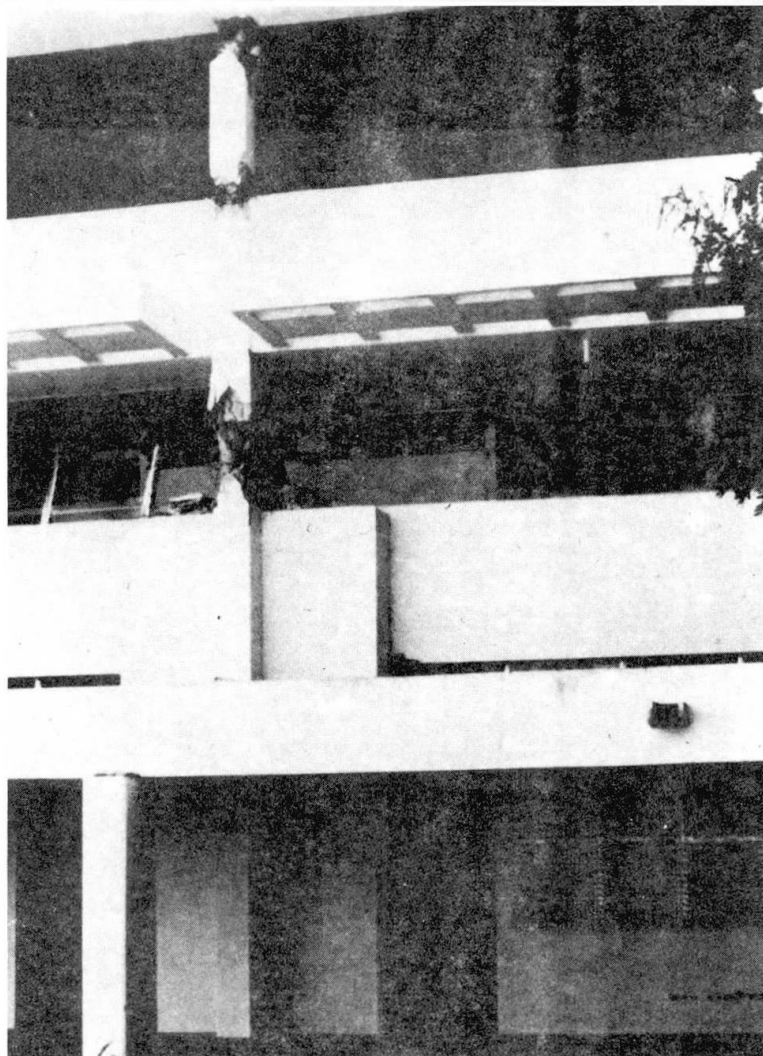
The first example involves the Colegio Teresiano on the outskirts of Managua, Nicaragua. The building is a three story concrete frame school building of a long rectangular plan, similar to schools built throughout the world. A small earthquake of magnitude 4.6 in 1968 was centered quite close to the building and caused cracking and structural distress to the columns in the first story. The building was repaired by adding a stiffened concrete wall element in the first story between classroom doors and extending up to the second floor balcony rail height. This new wall element can be seen in Figure 1.

The destructive Managua earthquake of December 23, 1972, caused considerable damage to this building, but only in the second and third floors, where considerable column damage resulted. Figure 1 was taken after this second earthquake. The new wall elements in the first floor prevented damage in that floor, but permitted the earthquake forces and motion to travel upward, causing the observed damage. The repairs had not considered the effect on the remainder of the structure. Had these or stronger walls extended to the roof, much of this damage might have been prevented.

Figure 1. Colegio Teresiano in Managua, Nicaragua, after 1972 earthquake. First story stiffening wall, which can be seen projecting outward from second floor beam, prevented first story damage but increased upper story damage.

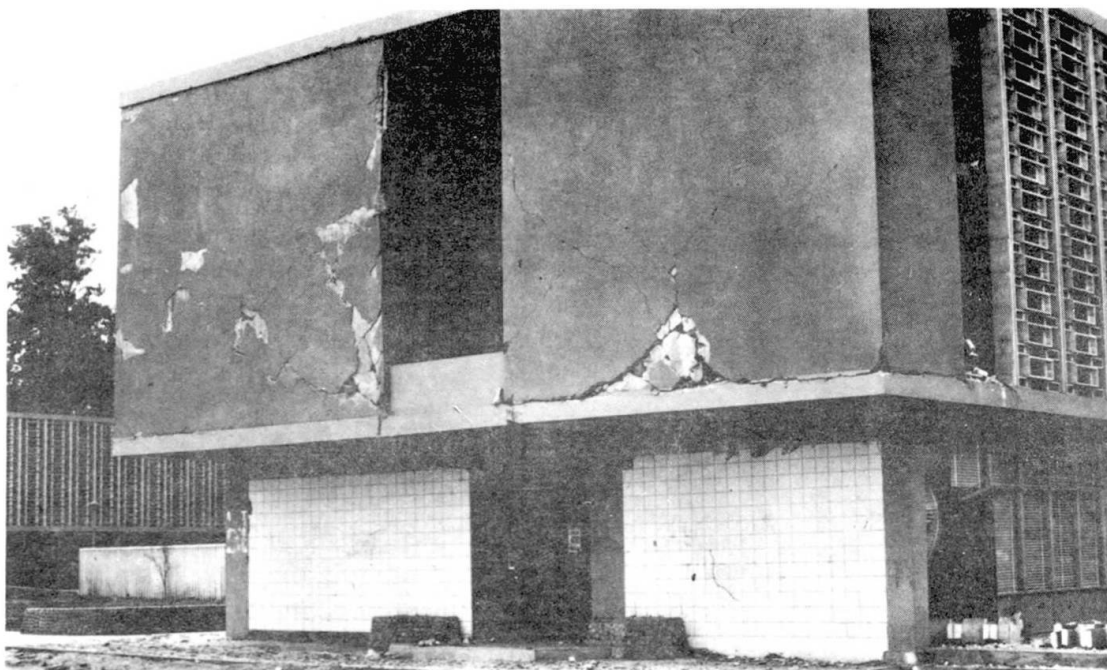
A second example shows a three story classroom building at the Agricultural University in the La Molina area of Lima, Peru. There are four identical buildings of concrete construction. The first story was originally framed without structural walls and only columns for support and bracing. Considerable wall panels and masonry partitions were present in the upper two stories. A magnitude 7.5 earthquake on October 17, 1966, caused significant damage to the first story columns, so concrete shear panels were introduced to stiffen and brace this first story.

A second earthquake of magnitude 7.6 affected these structures on October 3, 1974. Figure 2 shows the end of one of these buildings after that earthquake. There was little damage in the first story due to the previous strengthening, but that increased stiffness caused considerable damage in the upper two floors which had not been strengthened after the 1966 earthquake.

Figure 2. Classroom building at Agricultural University after 1974 earthquake. Stiffened first story had little damage due to added concrete wall panels, but upper stories had increased damage in this earthquake.
