Artikel: Repair of earthquake damaged buildings

Autor: Wyllie, Loring A.

REPAIR OF EARTHQUAKE DAMAGED BUILDINGS

Loring A. Wyllie, Jr.
Structural Engineer
H.J. Degenkolb and Associates
San Francisco, California U.S.A.

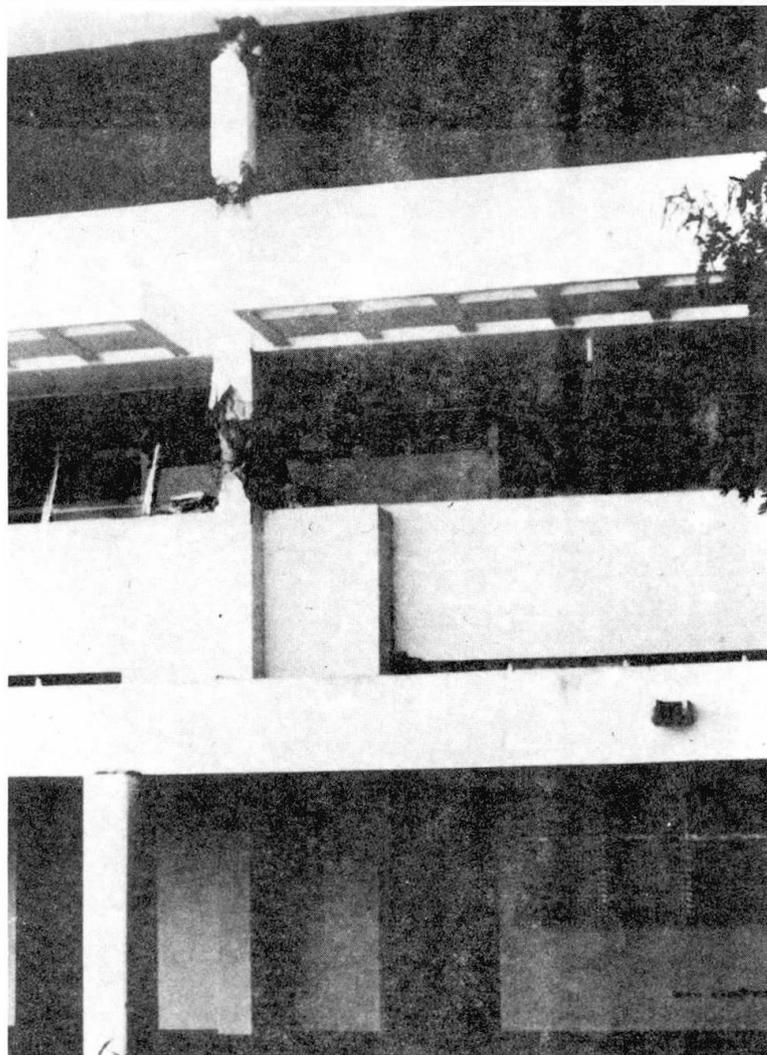
The first example involves the Colegio Teresiano on the outskirts of Managua, Nicaragua. The building is a three story concrete frame school building of a long rectangular plan, similar to schools built throughout the world. A small earthquake of magnitude 4.6 in 1968 was centered quite close to the building and caused cracking and structural distress to the columns in the first story. The building was repaired by adding a stiffened concrete wall element in the first story between classroom doors and extending up to the second floor balcony rail height. This new wall element can be seen in Figure 1.

The destructive Managua earthquake of December 23, 1972, caused considerable damage to this building, but only in the second and third floors, where considerable column damage resulted. Figure 1 was taken after this second earthquake. The new wall elements in the first floor prevented damage in that floor, but permitted the earthquake forces and motion to travel upward, causing the observed damage. The repairs had not considered the effect on the remainder of the structure. Had these or stronger walls extended to the roof, much of this damage might have been prevented.

Figure 1. Colegio Teresiano in Managua, Nicaragua, after 1972 earthquake. First story stiffening wall, which can be seen projecting outward from second floor beam, prevented first story damage but increased upper story damage.

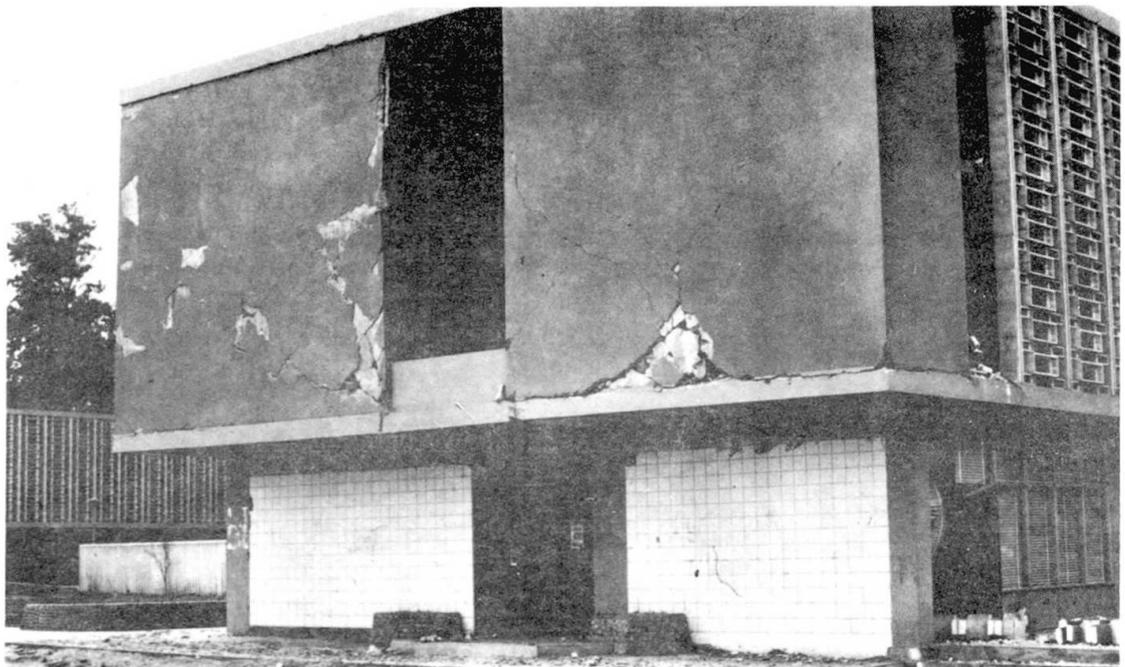
A second example shows a three story classroom building at the Agricultural University in the La Molina area of Lima, Peru. There are four identical buildings of concrete construction. The first story was originally framed without structural walls and only columns for support and bracing. Considerable wall panels and masonry partitions were present in the upper two stories. A magnitude 7.5 earthquake on October 17, 1966, caused significant damage to the first story columns, so concrete shear panels were introduced to stiffen and brace this first story.

A second earthquake of magnitude 7.6 affected these structures on October 3, 1974. Figure 2 shows the end of one of these buildings after that earthquake. There was little damage in the first story due to the previous strengthening, but that increased stiffness caused considerable damage in the upper two floors which had not been strengthened after the 1966 earthquake.

Figure 2. Classroom building at Agricultural University after 1974 earthquake. Stiffened first story had little damage due to added concrete wall panels, but upper stories had increased damage in this earthquake.
