Session III: Effects of recent earthquakes in Italy and other countries

SESSION III

Effects of Recent Earthquakes in Italy and Other Countries

STRUCTURAL BEHAVIOUR OF THE DAMAGED BUILDING DURING THE
FRIULI EARTHQUAKES BETWEEN MAY 6 AND SEPTEMBER 15, 1976

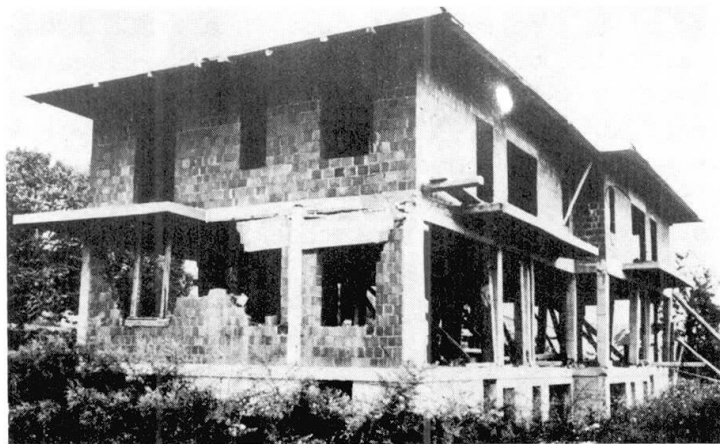
Figure 2: (after September 15th): Uncompleted building in Gemona after renewed earthquake stress. The reinforced concrete columns in the groundfloor were completely destroyed at their fixing points, connection being maintained by the reinforcement only. The massive wooden struts in the groundfloor saved the building from collapse during the second strong earthquake. The already damaged brick wall in the groundfloor was additionally strained due to the strengthening effect of the wooden struts in the open groundfloor area. The wide brick window jamb was broken out and the reinforced concrete window supports shaken from their rests.

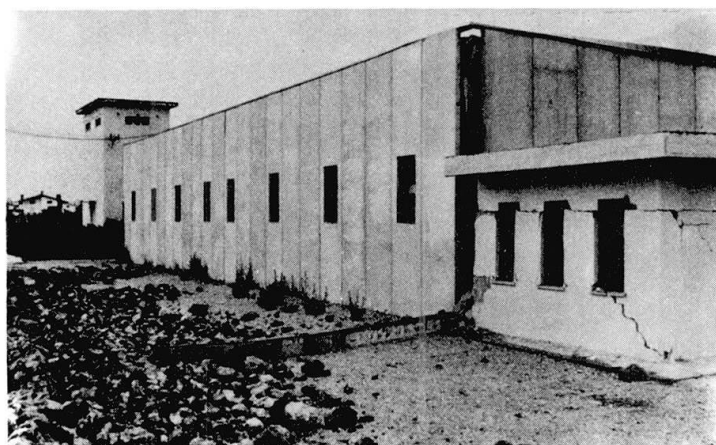
Figure 3: (after May 6th): Prefabricated shed with brick annex in Gemona. The supporting framework of the shed is undamaged. The concrete elements of the side wall, on the other hand, were slightly caved in by the impact of the rigid annex. The plastic material of the wall joints was torn by the large deformation. The roof of the annex was shorn off and pushed over at window level by the impulse load of the impact due to insufficiently wide joints.

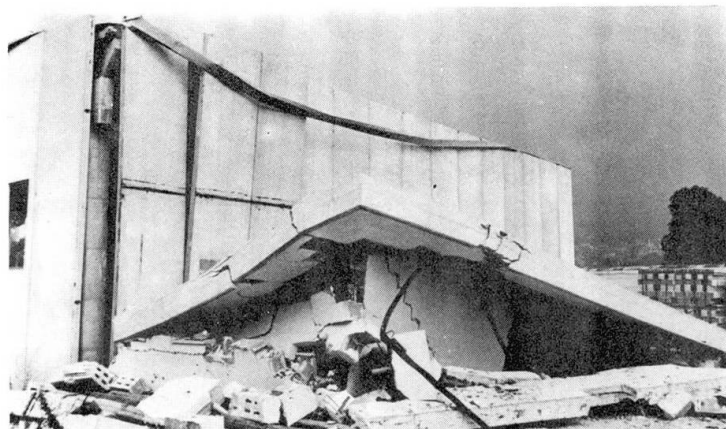
Figure 4: (after September 15th): Prefabricated shed with collapsed annex. The renewed earthquake load caused damage of the supporting framework of the shed at the fixing points of the columns and rests of the bars. The façade slabs of the side wall were severely caved in by the renewed impact: the annex itself collapsed. The increased displacement, as compared with the first earthquake, can be traced back to the reduced structural rigidity due to the destruction of one of the concrete block walls.

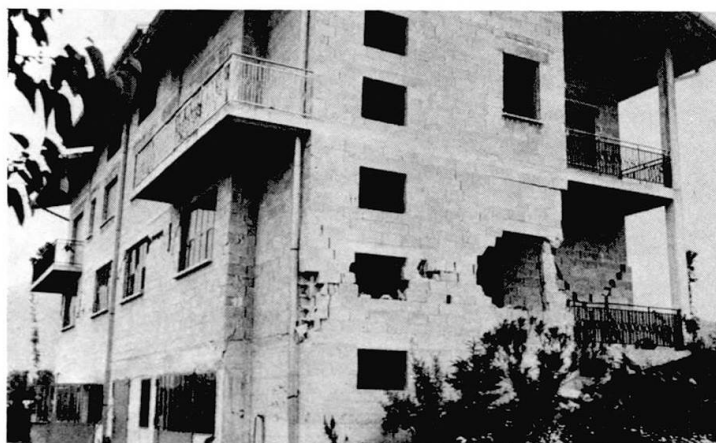
Figure 5: (after May 6th): Residential building with workshop near Artegna with a reinforced concrete cellar and two floors in concrete blocks. The side walls by the entrance incurred gaping X-shaped diagonal cracks due to the high shear stress. These cracks led to partial collapse of the masonry. The highly strained window jambs on the longitudinal façade were badly cracked.

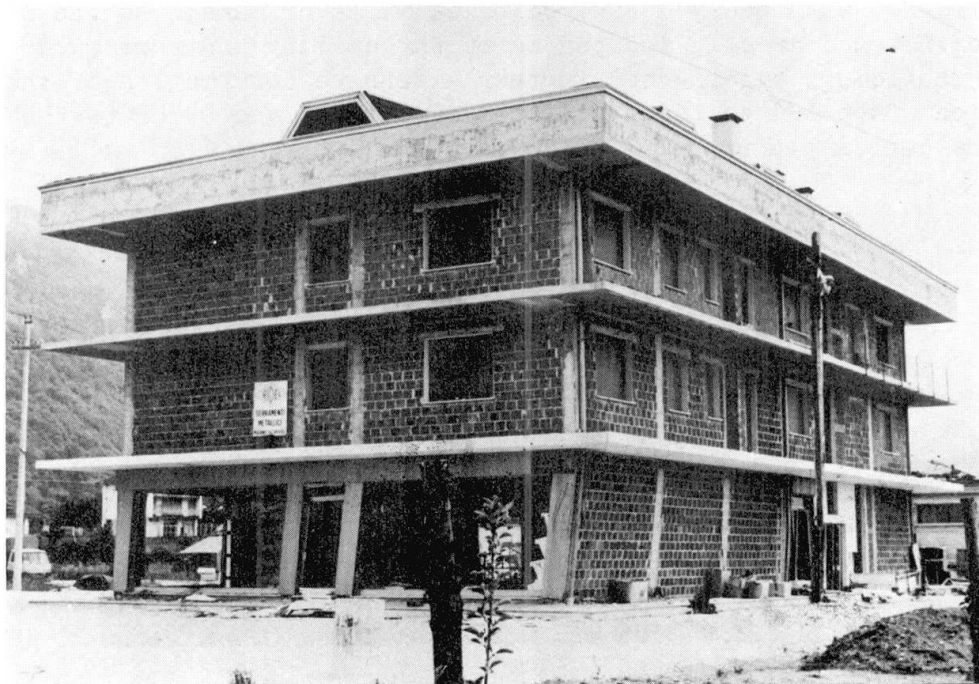
Figure 7: (after May 6th): Residential building with shop near Artegna. Reinforced concrete frame building with brick partitioning in the two upper storeys. In the groundfloor, open on three sides, only the rear longitudinal wall and the staircase are braced. The destruction was concentrated on the groundfloor where a rotating motion of approximately 40 cm maximum displacement occurred around the staircase core. The brick walls of the staircase were badly destroyed, while those of the upper floors remained undamaged.

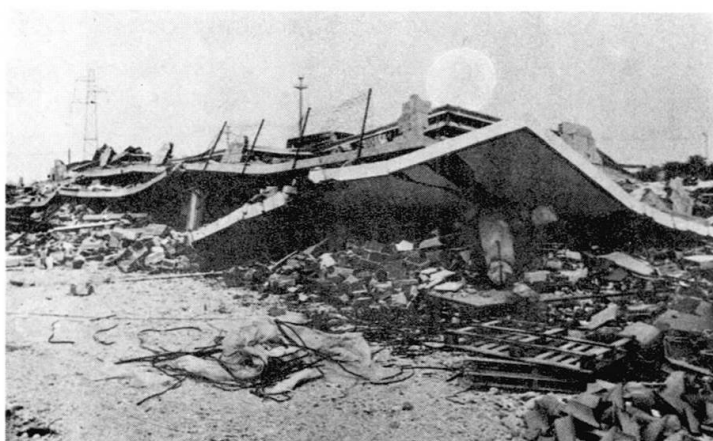
Figure 8: (after September 15th): Wreckage of the residential and business house near Artegna. The groundfloor of the building collapsed during the earthquake of September 11th. Through the impact, the undamaged living storeys also collapsed. The destroyed fixing points of the reinforced concrete columns in the groundfloor as well as the cracked brick walls of the staircase were not enough to carry the renewed strong earthquake stress. The experts had hoped, despite the doubts of the owner, to be able to repair the building.

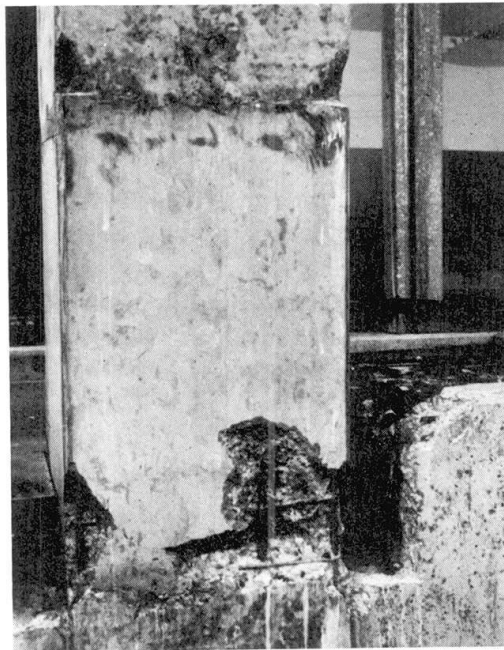
Where damage was limited to only a part of the supporting structure or to cracked brick walls, that part was restored as far as possible to its original condition (Figure 9). The object was not only to make the structure reusable but also to reestablish the original carrying capacity against earthquake load. These measures were not intended to improve the carrying capacity, since the existing protection against earthquakes was considered adequate. Naturally, the renewed earthquake load was concentrated on the same building parts and the same damage occurred (Figure 9). The repair work which had been undertaken, however, did have the effect of preventing more extensive destruction and offered, therefore a sufficient protection against collapse.

Figure 9: (after September 15th): Foot of a column in the Fantoni furniture factory in Rivoli di Osoppo. By repairing the cracked column foot it was hoped to restore the original carrying capacity. The renewed earthquake load caused the same damage as the first shock, the repaired fixing points of the columns were again cracked and the concrete crumbled in the most highly stressed areas.

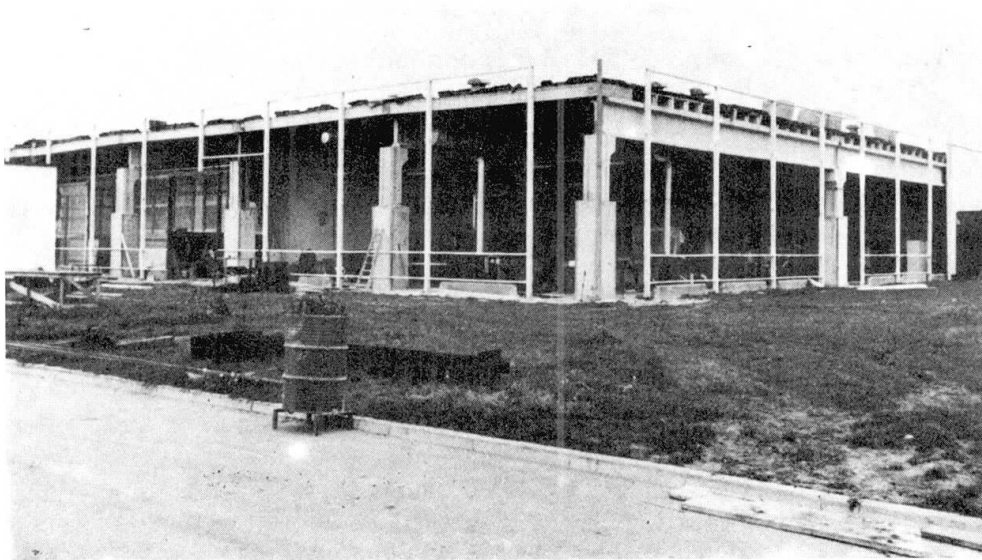
Figure 12: (after September 15th): Factory building near Artegna, after repair, without further earthquake damage. In order to increase the carrying capacity, the concrete columns were surrounded with a 15 cm strong concrete sheath. The earthquake load was reduced by replacing the heavy concrete façade elements by a light metal façade.

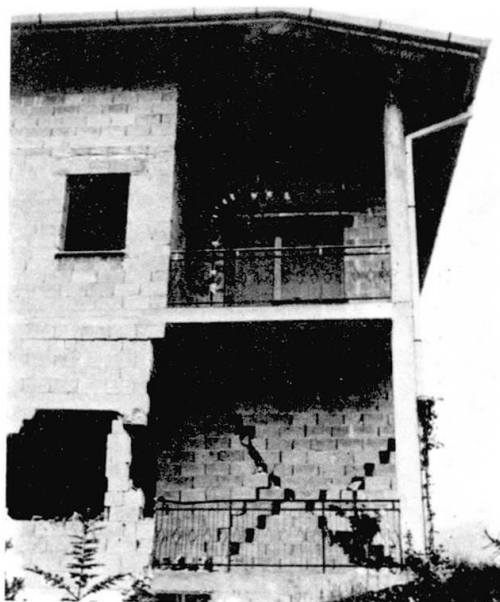
Figure 13: Dwelling house with workshop near Artegna. Basement in reinforced concrete and the upper stories in masonry without framing. Typical diagonal cross cracks in a wall of the ground floor.

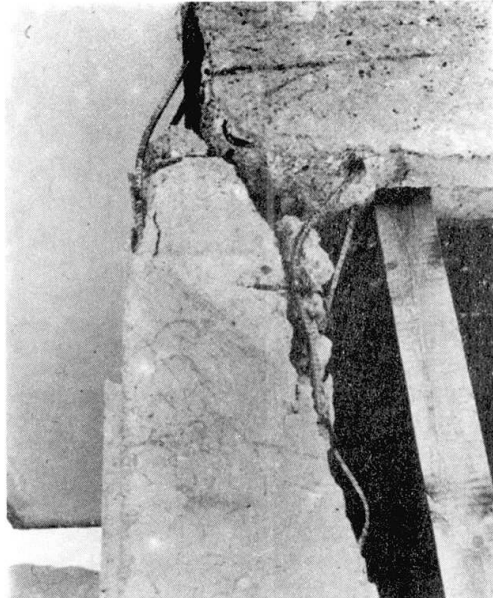
Figure 14: Shearing-off of a column at its connection with the crossbeam due to insufficient stirrups.

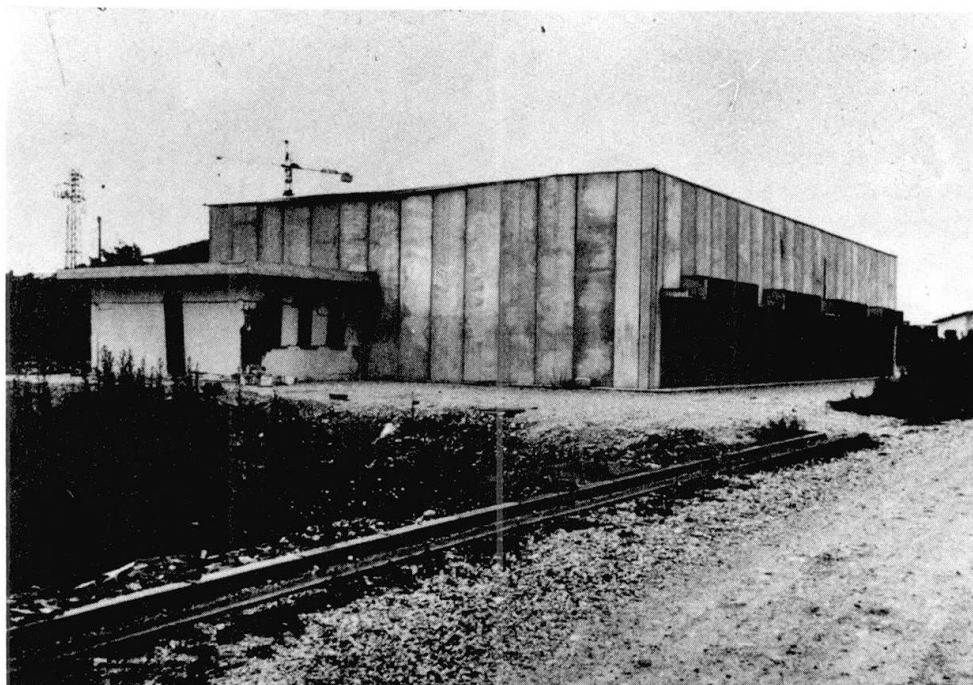
Figure 16: Prefabricated storage shed with brick annex in Gemona. Side wall panels slightly caved in by impact with rigid annex. Upper part of the annex shorn off and pushed over by the impact force due to insufficiently wide joints.

This problem can be overcome by arranging the joints as to divide the structure into sections, each with its own clearly distinct vibration behaviour. The joints should be made adequately wide since numerous uncertainties make an exact calculation impossible. It must be taken into consideration that, for example, the deformation usually provided for in a homogenous supporting structure can turn out to be considerably larger due to the formation of cracks or plastification. An adequate freedom of movement, therefore, allows for greater plastification and a larger capacity to carry earthquake stress.

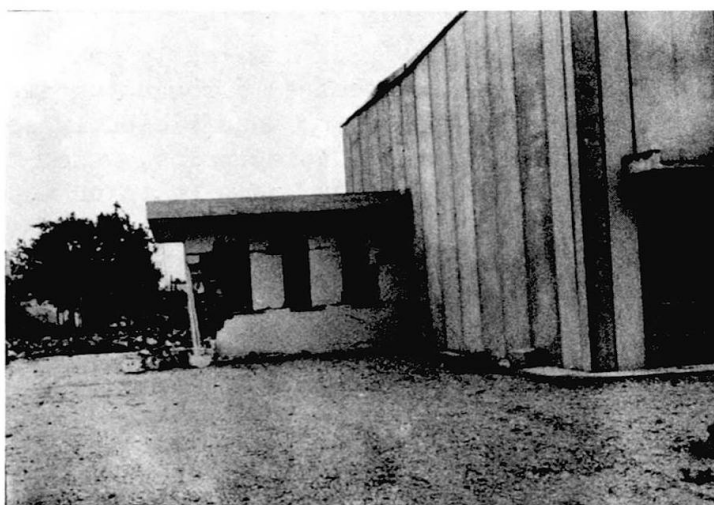
Figure 18: Prefabricated storage shed in Gemona as shown before. The supporting frames and the wall panels generally not damaged because of energy absorption in the material of the joints between the single panels.

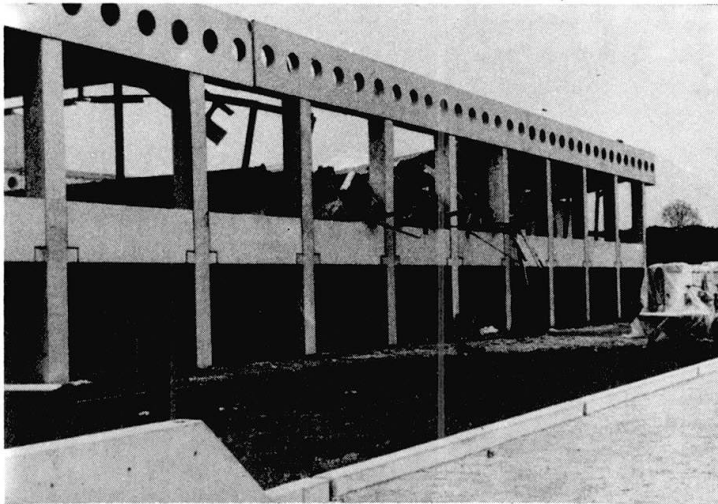
Figure 19: Heavily damaged prefabricated factory shed near Osoppo with roof girders fallen down. Friction joints insufficient to provide structural stability.

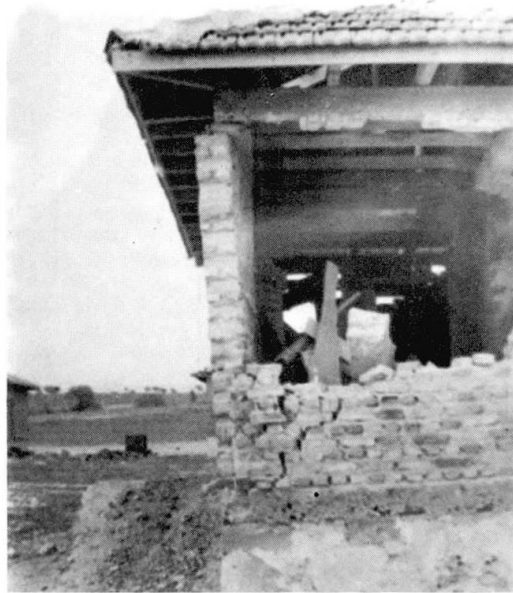
Figure-3 Corner Damage due to Earthquake

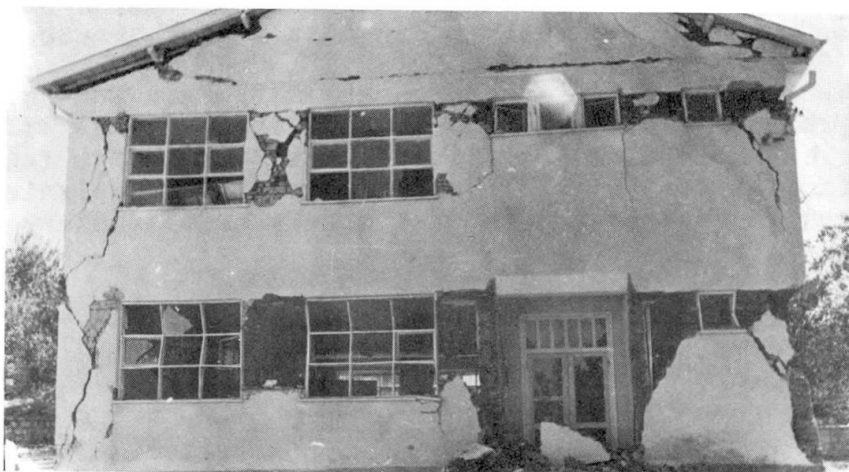
Figure-5 Typical Failure of Brick Masonry

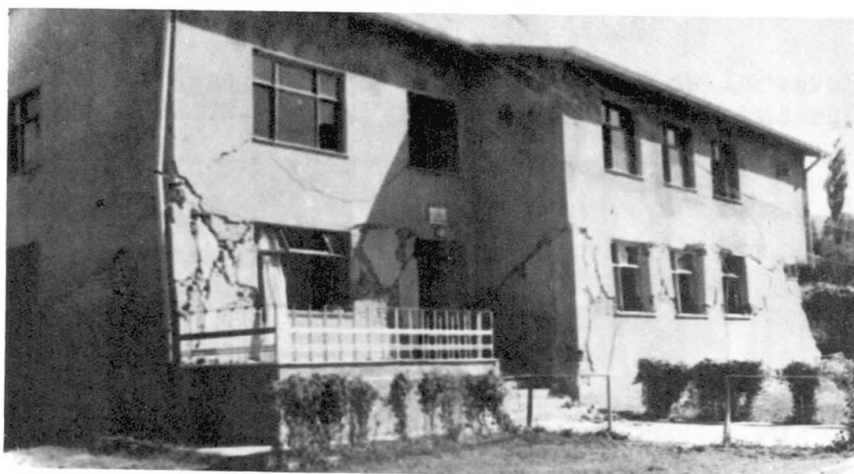
Figure-6 Typical Failure of Brick Masonry

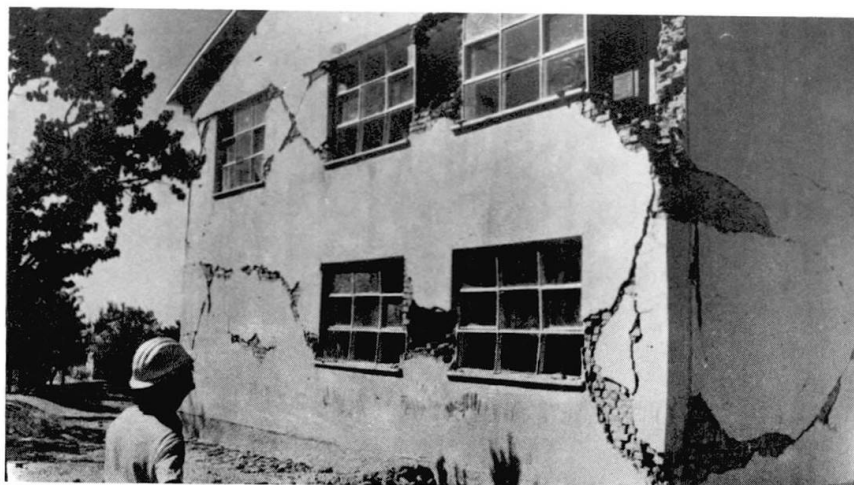
Figure-7 Typical Failure of Brick Masonry

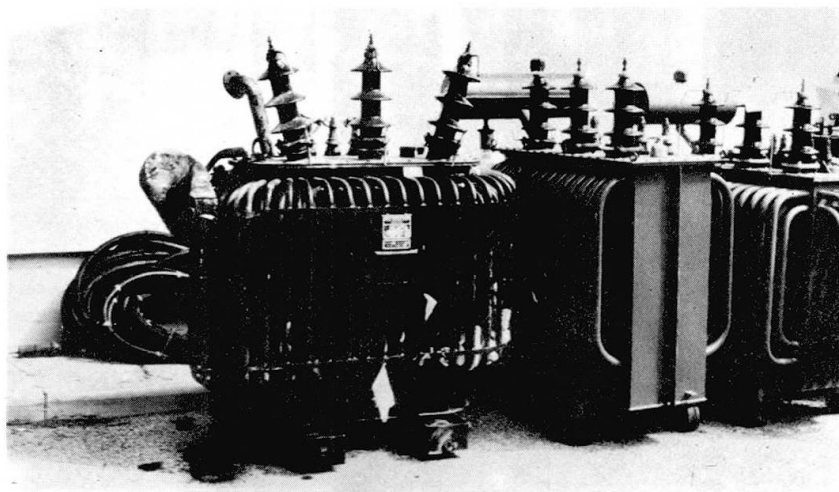
Fig 1. Damaged and new distribution transformers.

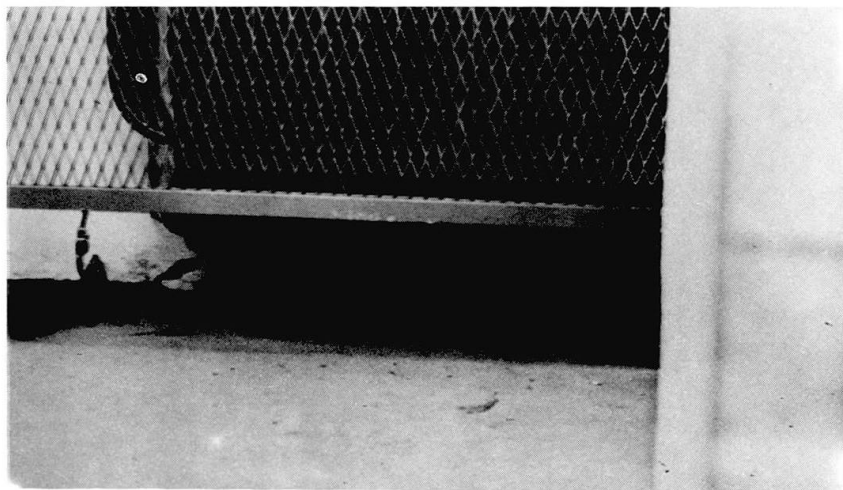
Fig 3. The transformer inside the cabin has moved during the earthquake; one of the back wheels fell into the oil drainage well.

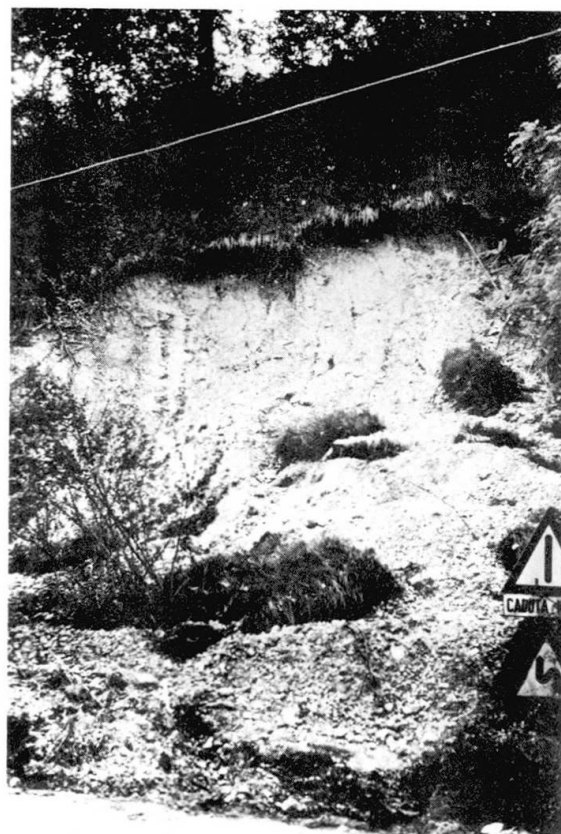
Fig 5. Small landslide by the road at Cornino.

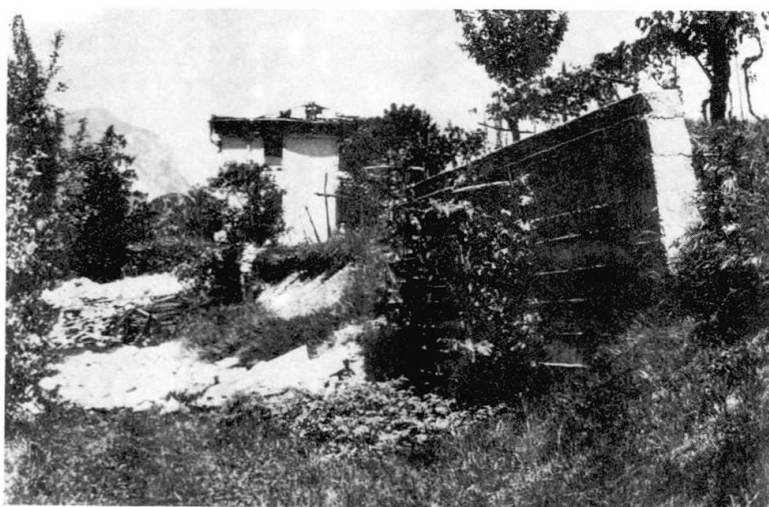
Fig. 7. Duomo Gemona; Failure of the retaining wall.

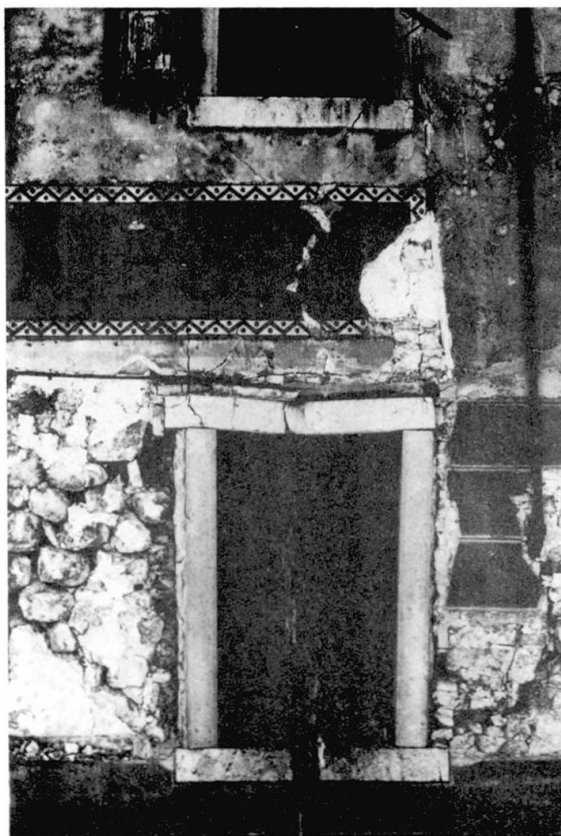
Fig. 8 Collapse mechanism of masonry wall at Gemona.

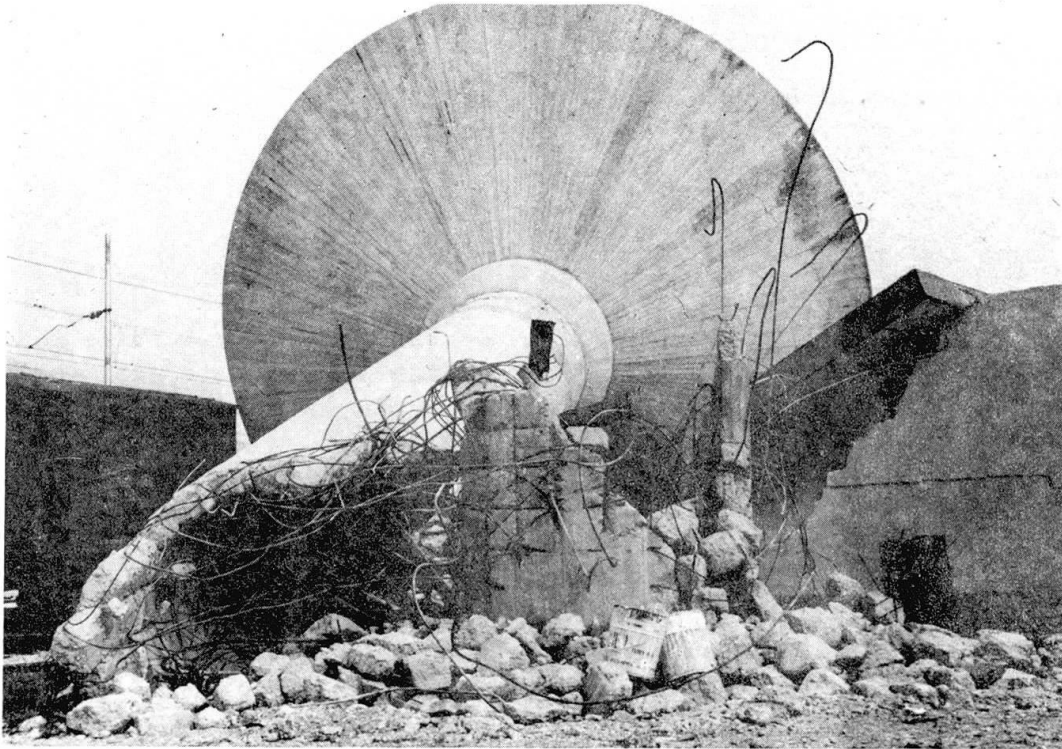
Figure 1: Destroyed watertower at Gemona railway station
