Zeitschrift: IABSE reports of the working commissions = Rapports des commissions de travail AIPC = IVBH Berichte der Arbeitskommissionen

Rubrik: Session III: Effects of recent earthquakes in Italy and other countries

Effects of Recent Earthquakes in Italy and Other Countries

STRUCTURAL BEHAVIOUR OF THE DAMAGED BUILDING DURING THE
FRIULI EARTHQUAKES BETWEEN MAY 6 AND SEPTEMBER 15, 1976

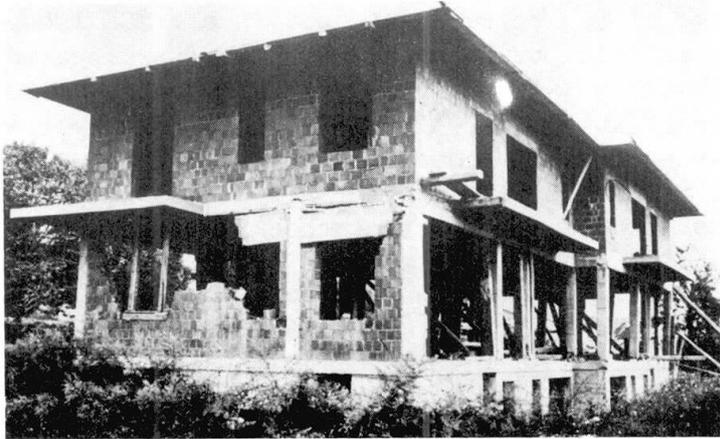
Figure 2: (after September 15th): Uncompleted building in Gemona after renewed earthquake stress. The reinforced concrete columns in the groundfloor were completely destroyed at their fixing points, connection being maintained by the reinforcement only. The massive wooden struts in the groundfloor saved the building from collapse during the second strong earthquake. The already damaged brick wall in the groundfloor was additionally strained due to the strenghtening effect of the wooden struts in the open groundfloor area. The wide brick window jamb was broken out and the reinforced concrete window supports shaken from their rests.

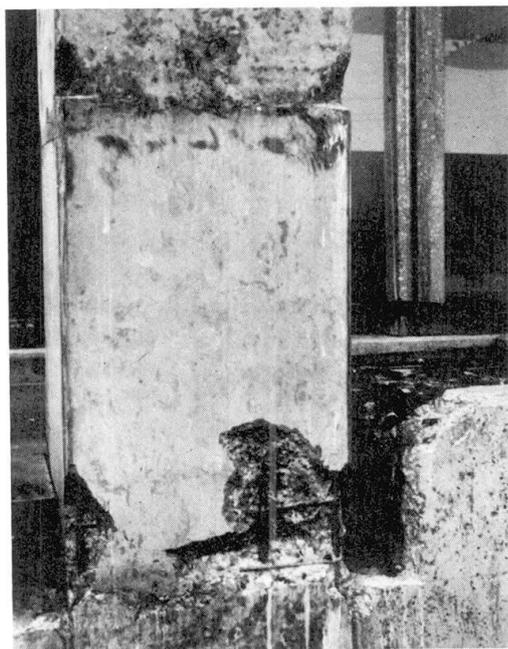
Figure 9: (after September 15th): Foot of a column in the Fantoni furniture factory in Rivoli di Osoppo. By repairing the cracked column foot it was hoped to restore the original carrying capacity. The renewed earthquake load caused the same damage as the first shock, the repaired fixing points of the columns were again cracked and the concrete crumbled in the most highly stressed areas.

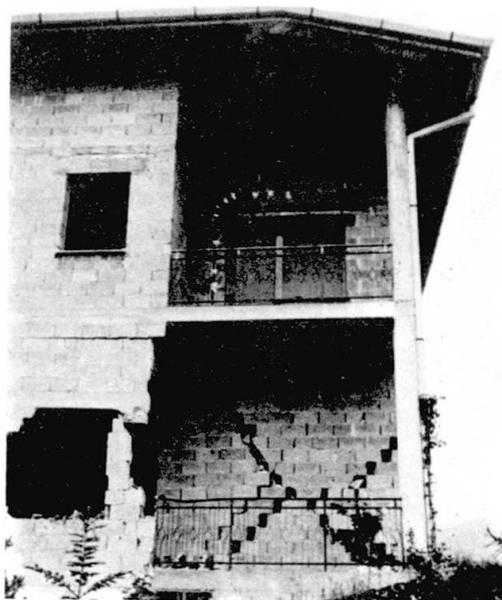
Figure 13: Dwelling house with workshop near Artegna. Basement in reinforced concrete and the upper stories in masonry without framing. Typical diagonal cross cracks in a wall of the ground floor.

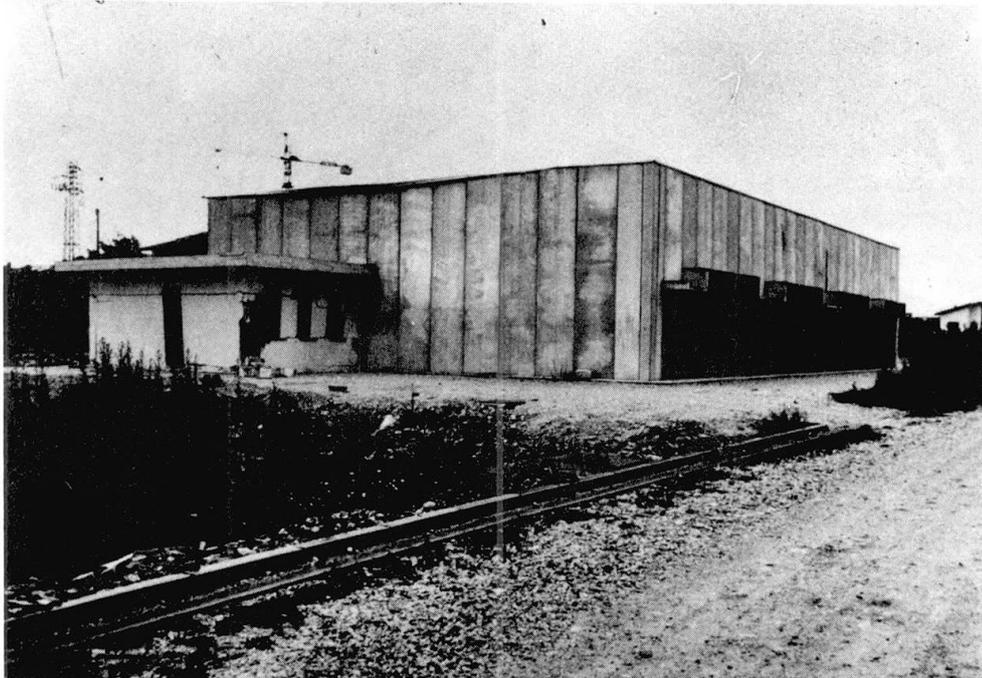
Figure 16: Prefabricated storage shed with brick annex in Gemona. Side wall panels slightly caved in by impact with rigid annex. Upper part of the annex shorn off and pushed over by the impact force due to insufficiently wide joints.

This problem can be overcome by arranging the joints as to divide the structure into sections, each with its own clearly distinct vibration behaviour. The joints should be made adequately wide since numerous uncertainties make an exact calculation impossible. It must be taken into consideration that, for example, the deformation usually provided for in a homogenous supporting structure can turn out to be considerably larger due to the formation of cracks or plastification. An adequate freedom of movement, therefore, allows for greater plastification and a larger capacity to carry earthquake stress.

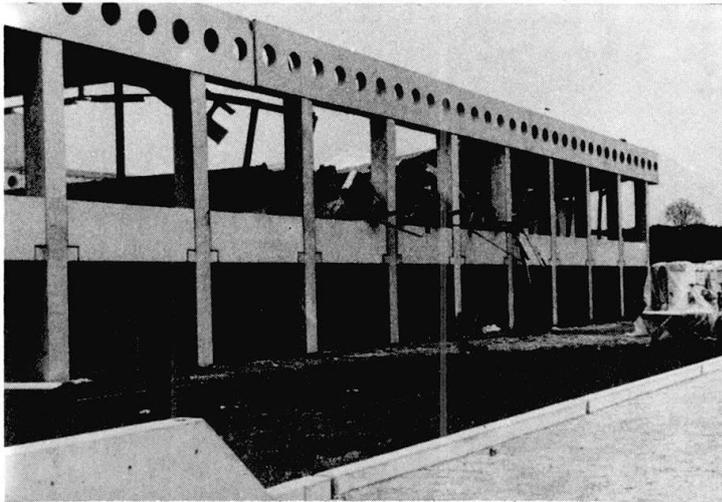
Figure 19: Heavily damaged prefabricated factory shed near Osoppo with roof girders fallen down. Friction joints insufficient to provide structural stability.

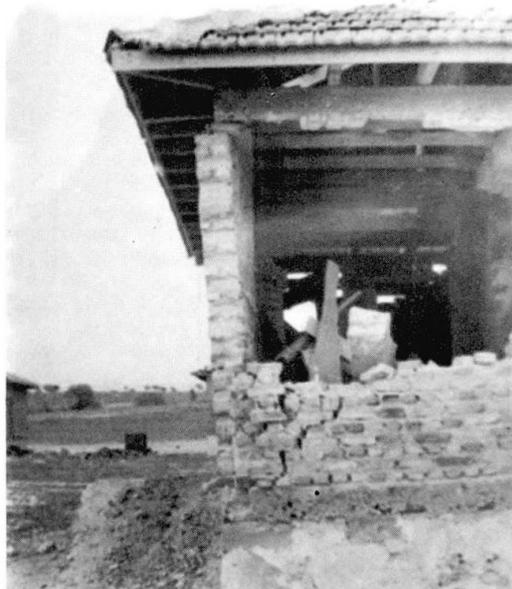
Figure-3 Corner Damage due to Earthquake

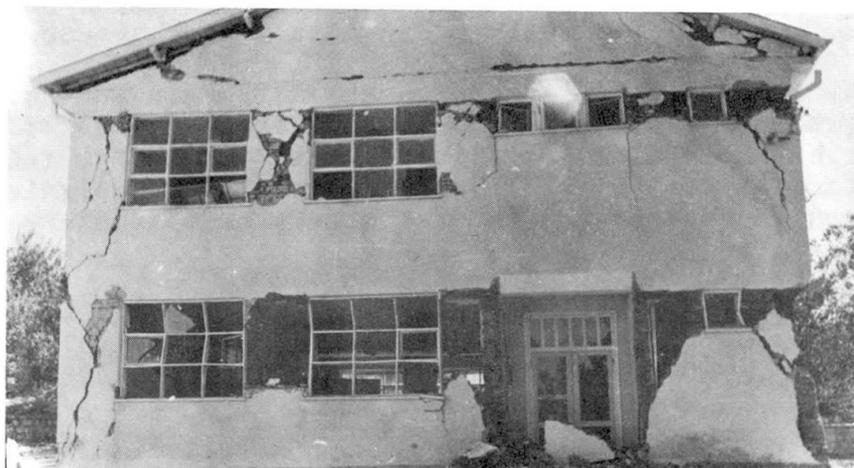
Figure-5 Typical Failure of Brick Masonry

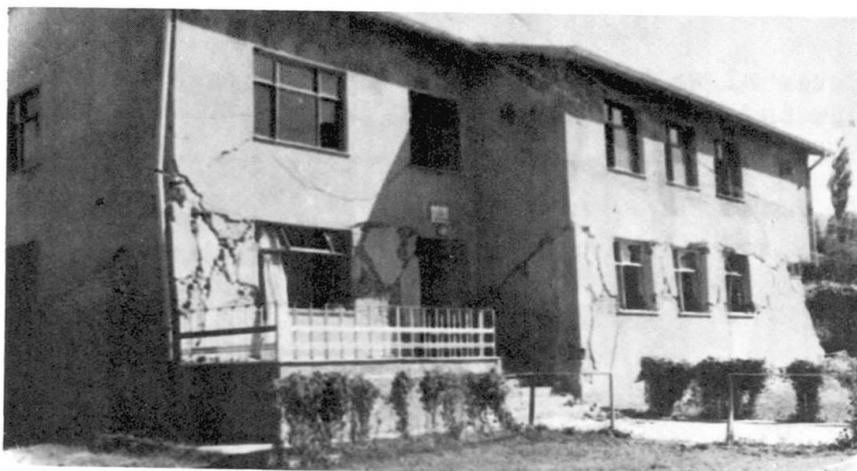
Figure-6 Typical Failure of Brick Masonry

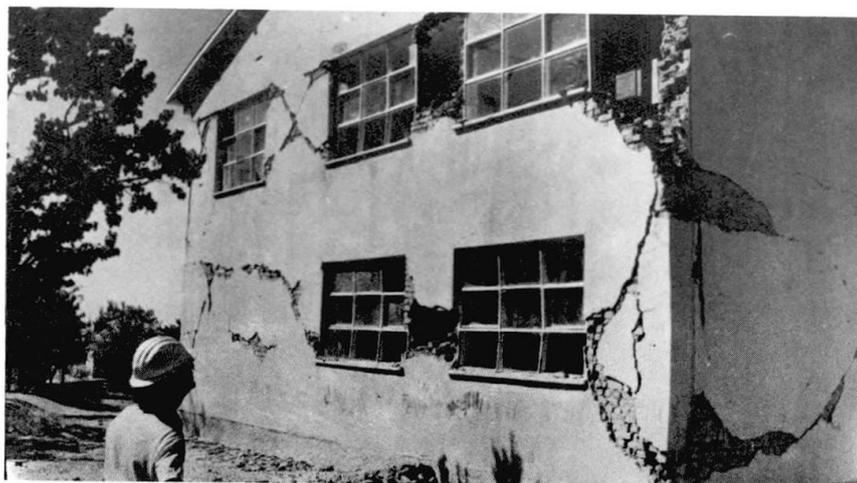
Figure-7 Typical Failure of Brick Masonry

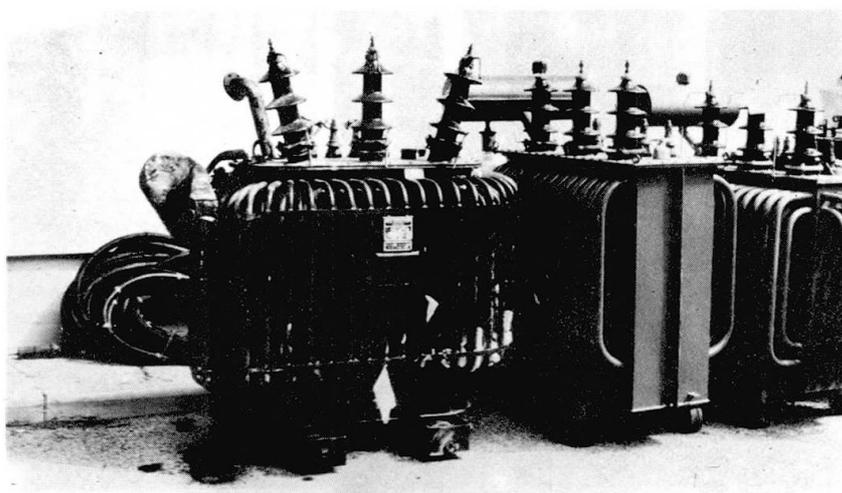
Fig 1. Damaged and new distribution transformers.

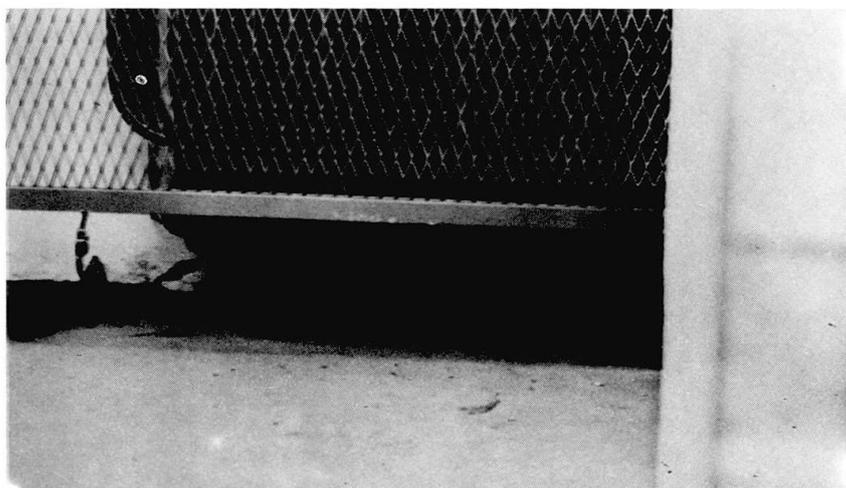
Fig 3. The transformer inside the cabin has moved during the earthquake; one of the back wheels fell into the oil drainage well.

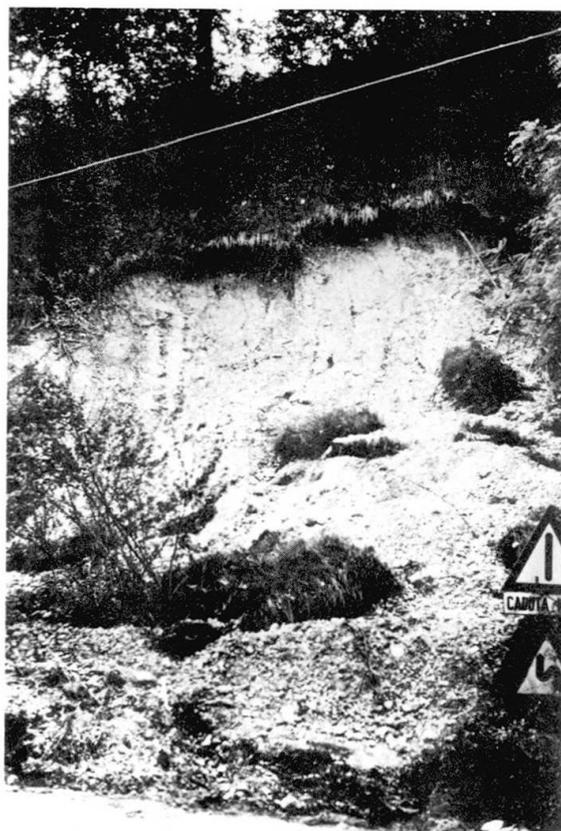
Fig 5. Small landslide by the road at Cornino.

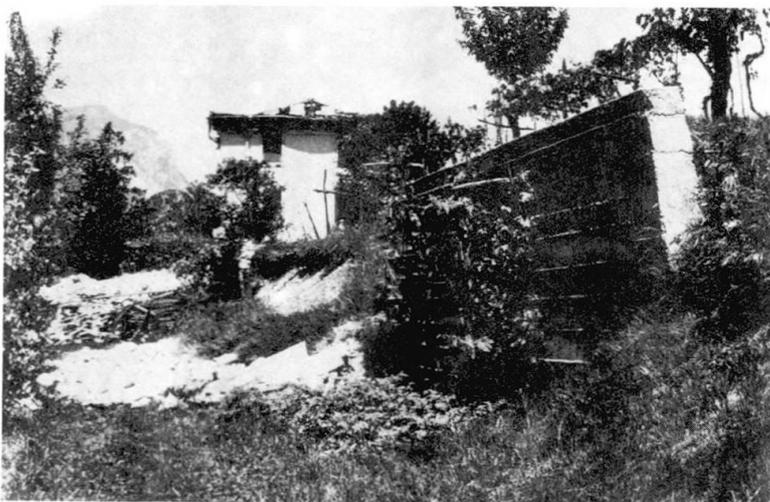
Fig. 7. Duomo Gemona; Failure of the retaining wall.

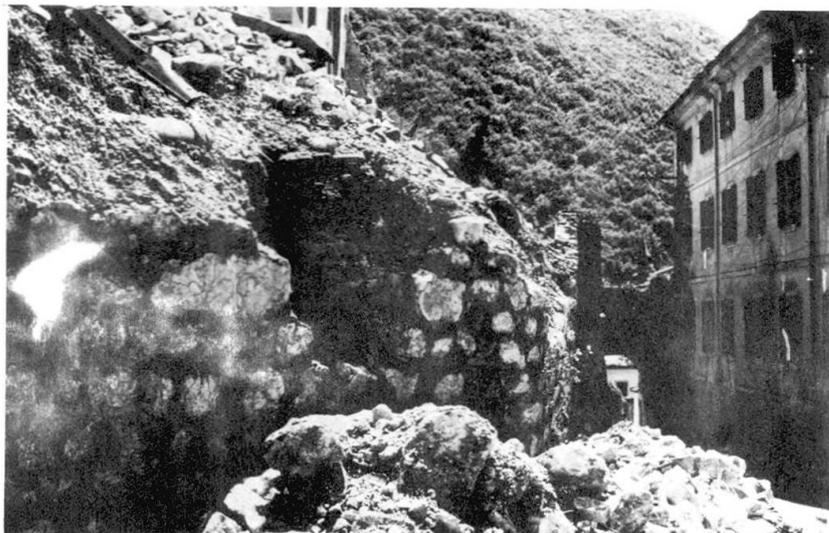
large as in the valley. The slip vectors, however, were large enough to cause the failure of retaining walls. Figure 6 was taken from Gemona. The low strength masonry wall could not resist the slip vector as did the concrete wall sitting next to it.

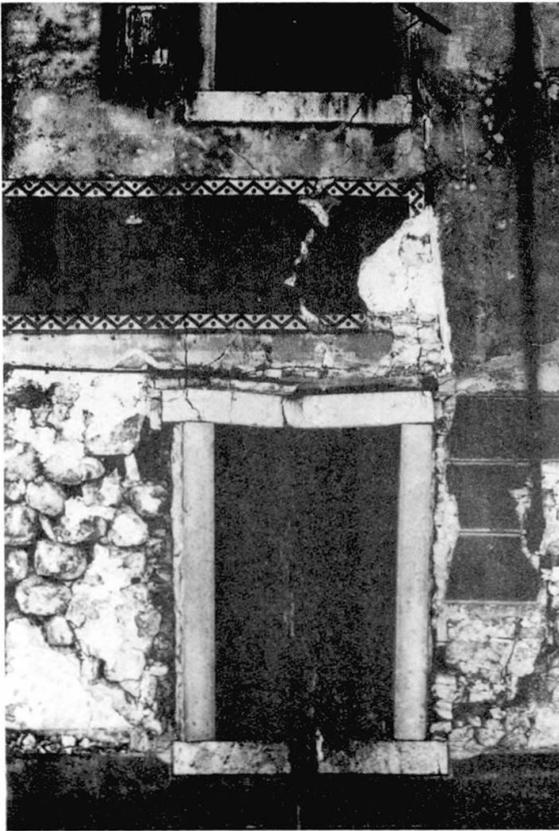
Fig. 8 Collapse mechanism of masonry wall at Gemona.

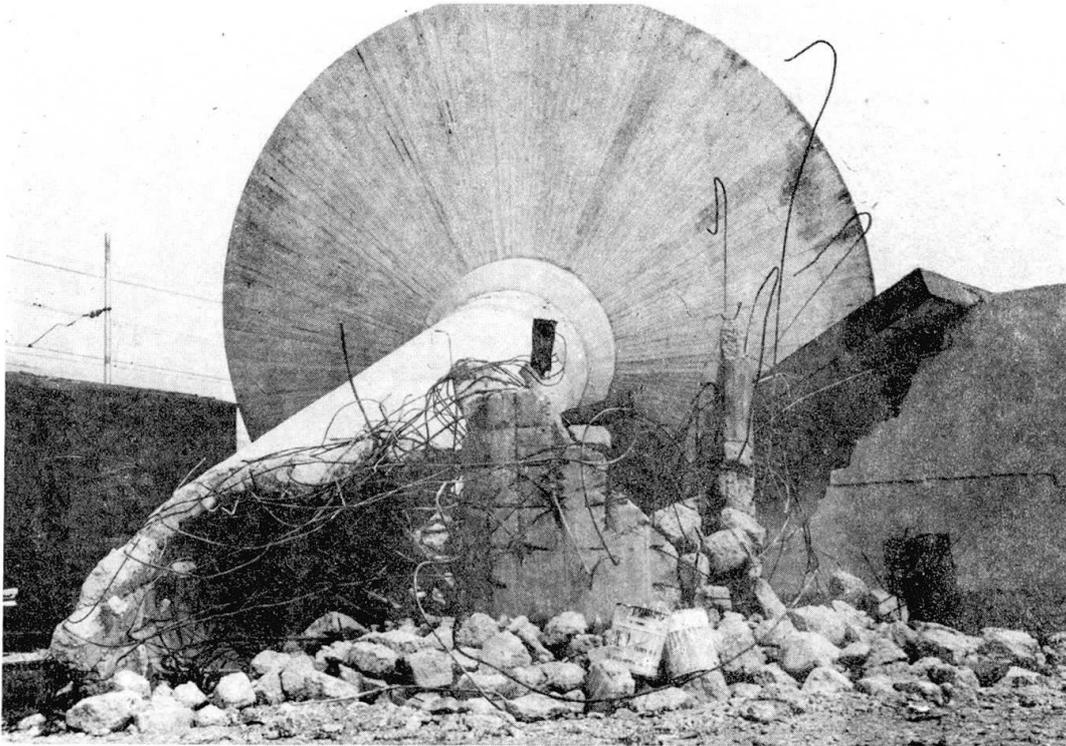
Figure 1: Destroyed watertower at Gemona railway station
