STRUCTURAL BEHAVIOUR OF THE DAMAGED BUILDING DURING THE
FRIULI EARTHQUAKES BETWEEN MAY 6 AND SEPTEMBER 15, 1976

by Ewald Heimgartner, Structural Engineer ETHZ/SIA

BASLER & HOFMANN

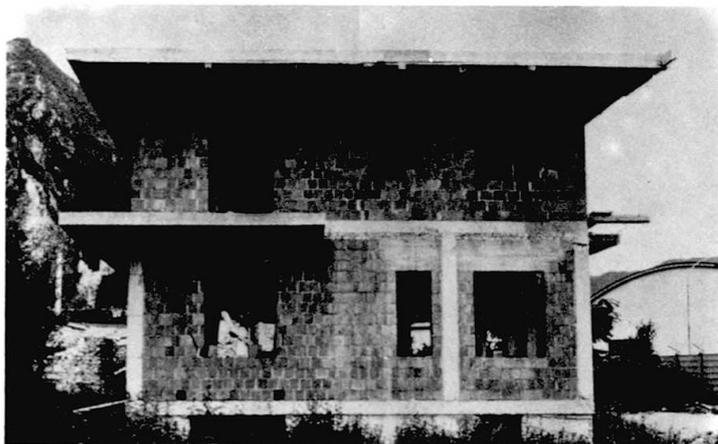
Figure 1: (after May 6th): Uncompleted building in Gemona with groundfloor open on three sides and living floor above. The supporting framework of the groundfloor consists of reinforced concrete columns, partitioned on one of the narrow sides by brick walls. The upper floor is exclusively brick. Due to the earthquake load, the building rotated around the partitioned transverse wall in the groundfloor. The fixing points of the columns were badly damaged in the cellar and groundfloor ceilings. The brick walls on the transverse side on the groundfloor were slightly cracked: the upper floor remained undamaged.

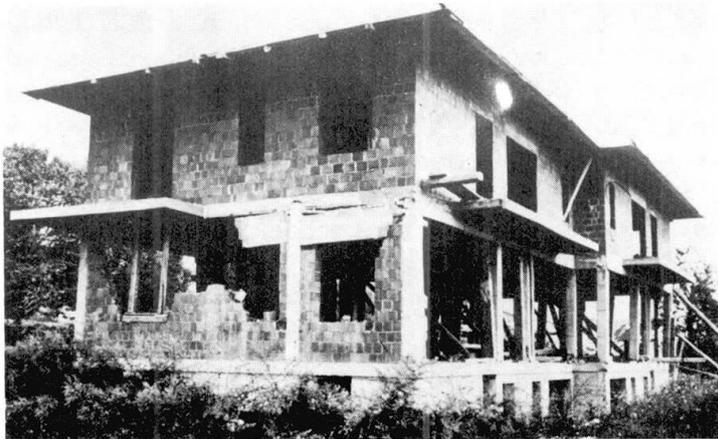
Figure 2: (after September 15th): Uncompleted building in Gemona after renewed earthquake stress. The reinforced concrete columns in the groundfloor were completely destroyed at their fixing points, connection being maintained by the reinforcement only. The massive wooden struts in the groundfloor saved the building from collapse during the second strong earthquake. The already damaged brick wall in the groundfloor was additionally strained due to the strenghtening effect of the wooden struts in the open groundfloor area. The wide brick window jamb was broken out and the reinforced concrete window supports shaken from their rests.

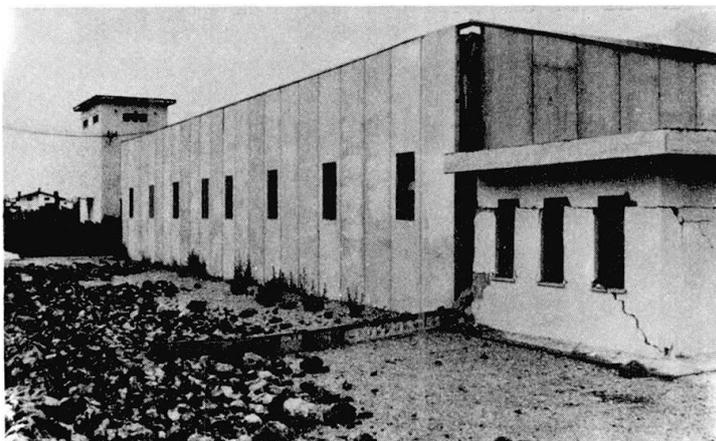
Figure 3: (after May 6th): Prefabricated shed with brick annex in Gemona. The supporting framework of the shed is undamaged. The concrete elements of the side wall, on the other hand, were slightly caved in by the impact of the rigid annex. The plastic material of the wall joints was torn by the large deformation. The roof of the annex was shorn off and pushed over at window level by the impulse load of the impact due to insufficiently wide joints.

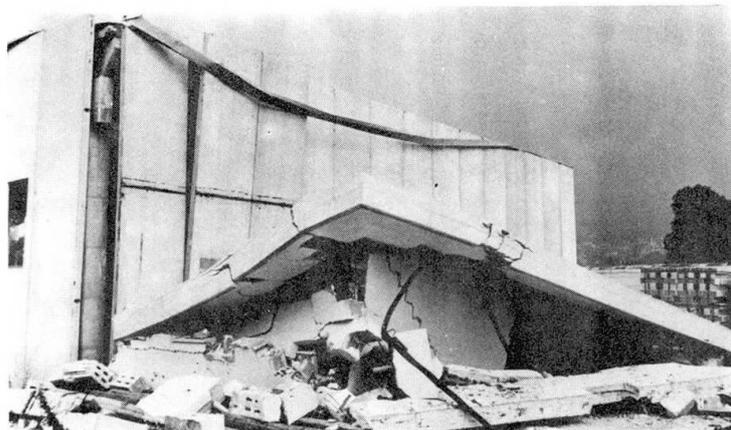
Figure 4: (after September 15th): Prefabricated shed with collapsed annex. The renewed earthquake load caused damage of the supporting framework of the shed at the fixing points of the columns and rests of the bars. The façade slabs of the side wall were severely caved in by the renewed impact: the annex itself collapsed. The increased displacement, as compared with the first earthquake, can be traced back to the reduced structural rigidity due to the destruction of one of the concrete block walls.

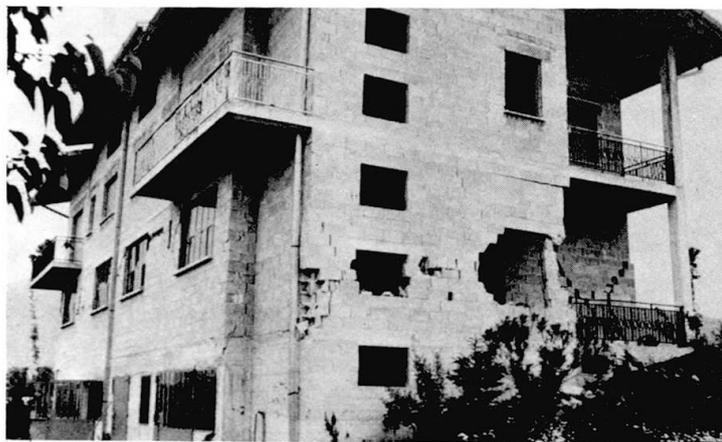
Figure 5: (after May 6th): Residential building with workshop near Artegna with a reinforced concrete cellar and two floors in concrete blocks. The side walls by the entrance incurred gaping X-shaped diagonal cracks due to the high shear stress. These cracks led to partial collapse of the masonry. The highly strained window jambs on the longitudinal façade were badly cracked.

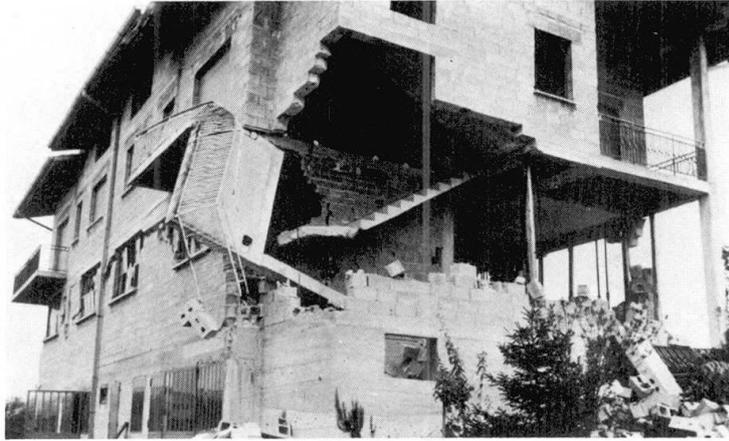
Figure 6: (after September 15th: Residential building with workshop near Artegna after renewed earthquake stress. The side wall in the middle floor collapsed under further earthquake load. The door and window jambs on the longitudinal walls shattered and partially collapsed. The shear resistance of these concrete block walls was minimal due to failure of the mortar joints to prevent the layers from shifting.

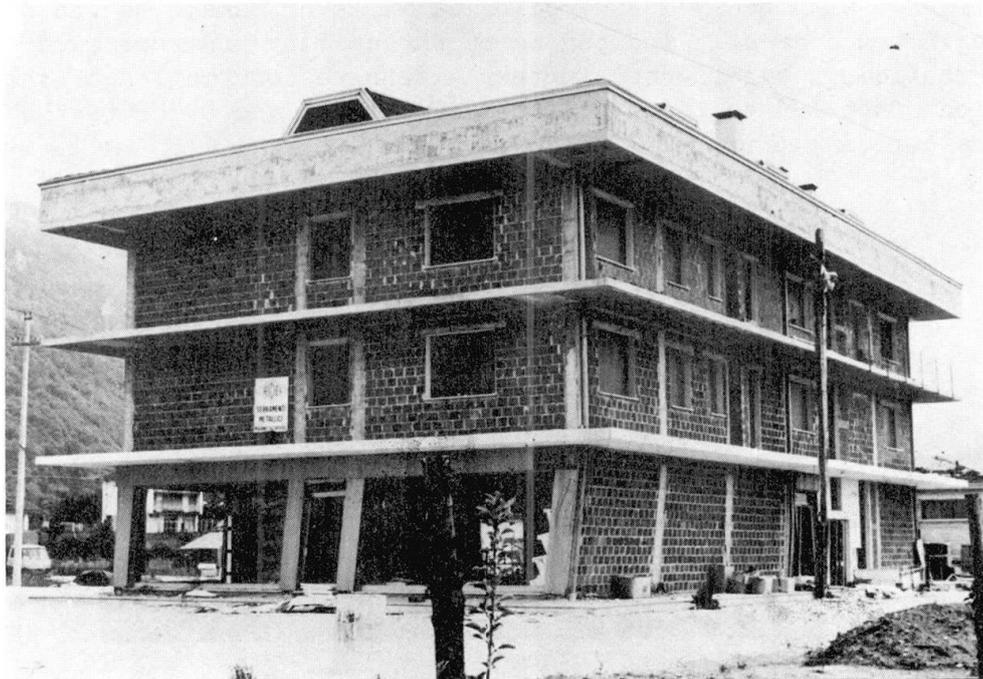
Figure 7: (after May 6th): Residential building with shop near Artegna. Reinforced concrete frame building with brick partitioning in the two upper storeys. In the groundfloor, open on three sides, only the rear longitudinal wall and the staircase are braced. The destruction was concentrated on the groundfloor where a rotating motion of approximately 40 cm maximum displacement occurred around the staircase core. The brick walls of the staircase were badly destroyed, while those of the upper floors remained undamaged.

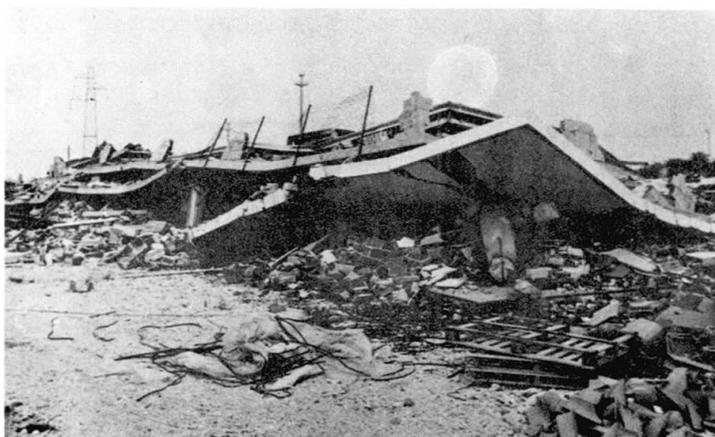
Figure 8: (after September 15th): Wreckage of the residential and business house near Artegna. The groundfloor of the building collapsed during the earthquake of September 11th. Through the impact, the undamaged living storeys also collapsed. The destroyed fixing points of the reinforced concrete columns in the groundfloor as well as the cracked brick walls of the staircase were not enough to carry the renewed strong earthquake stress. The experts had hoped, despite the doubts of the owner, to be able to repair the building.

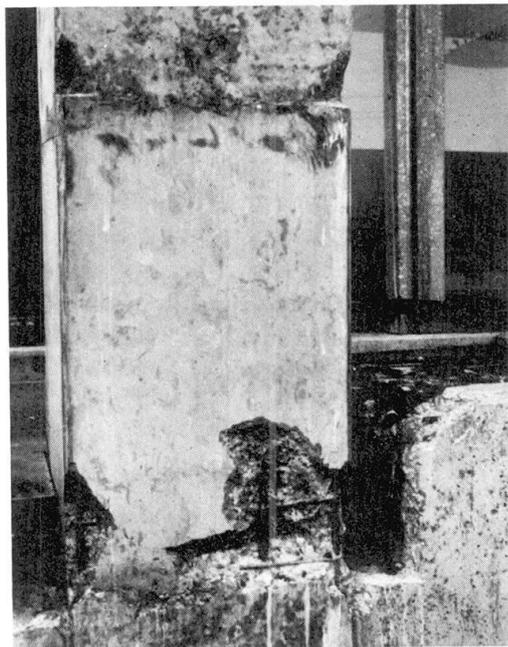
Figure 9: (after September 15th): Foot of a column in the Fantoni furniture factory in Rivoli di Osoppo. By repairing the cracked column foot it was hoped to restore the original carrying capacity. The renewed earthquake load caused the same damage as the first shock, the repaired fixing points of the columns were again cracked and the concrete crumbled in the most highly stressed areas.

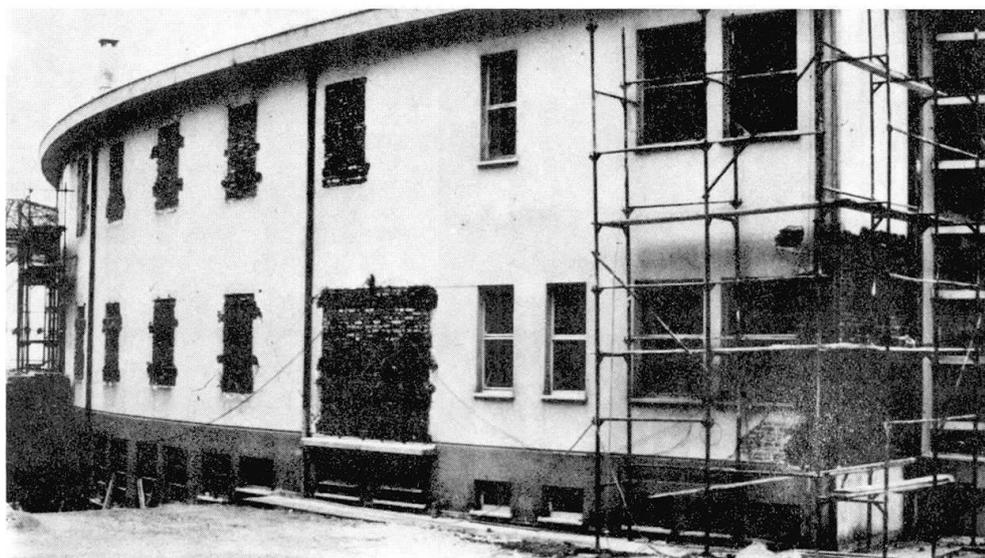
Figure 10: (after September 15th): Business building SBUELZ in Tricesimo. To strengthen the carrying capacity, the door and window openings were walled in. The vibration behaviour of the building was so improved that, during renewed earthquake stress hardly any further damage occurred as opposed to the destruction which occurred during the earthquake of May 6th.

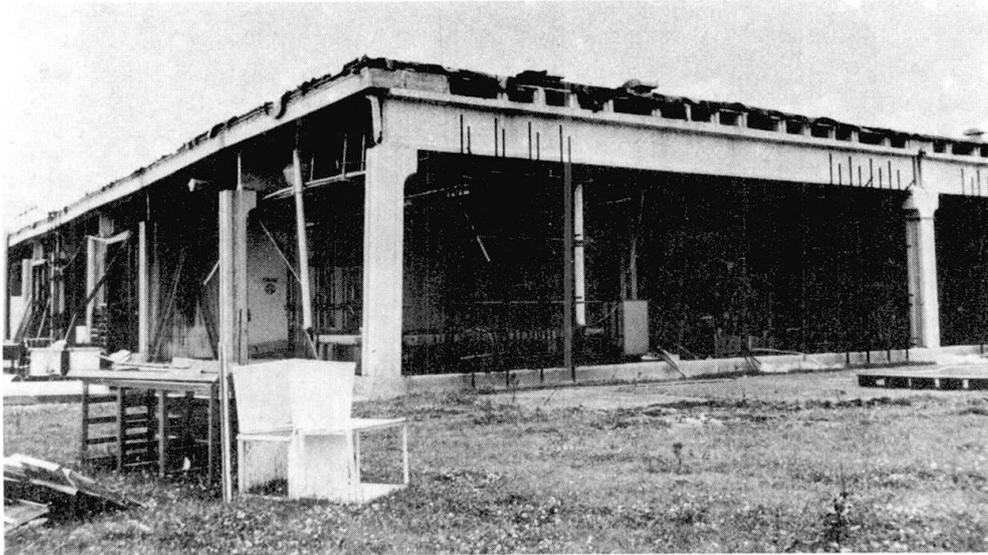
Figure 11: (after May 6th): Factory building near Artegna. Severe displacement of the prefabricated reinforced concrete framework together with distortion of the foundation and tilting of a corner column. A large number of the only lightly secured reinforced concrete façade elements were thrown off.

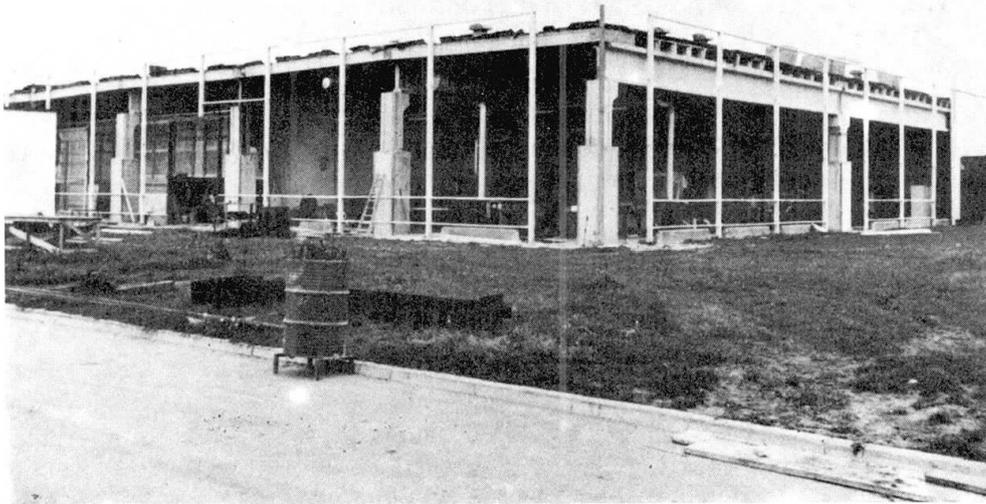
Figure 12: (after September 15th): Factory building near Artegna, after repair, without further earthquake damage. In order to increase the carrying capacity, the concrete columns were surrounded with a 15 cm strong concrete sheath. The earthquake load was reduced by replacing the heavy concrete façade elements by a light metal façade.

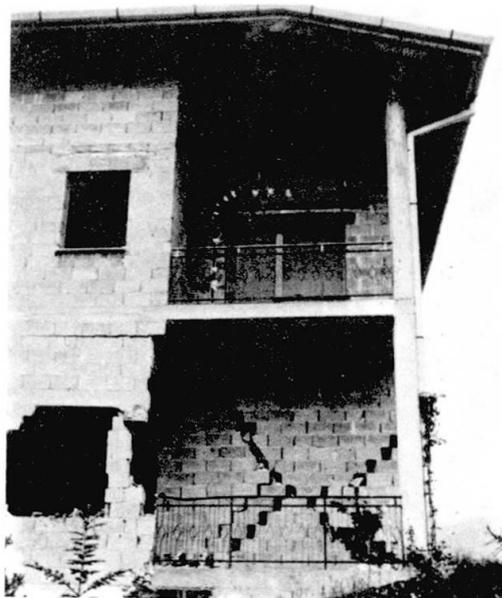
Walls and partitions consisting of brick and masonry are both rigid and brittle. Where the walls are insufficiently strong or where many openings exist, the masonry walls are no longer able to absorb horizontal forces. When overstrained, these walls crack mostly crosswise under 45° (Figure 13), the crack spreading, either along the mortar joints or in the bricks. Because of the brittle nature of masonry constructions, the cracks widen, joints gape open or the walls concerned even collapse. In a skeleton construction, the reinforced concrete framework can in certain cases continue to uphold the weight of the buildings. For purely masonry construction, on the other hand, at least a partial collapse of the building is unavoidable.

Figure 13: Dwelling house with workshop near Artegna. Basement in reinforced concrete and the upper stories in masonry without framing. Typical diagonal cross cracks in a wall of the ground floor.

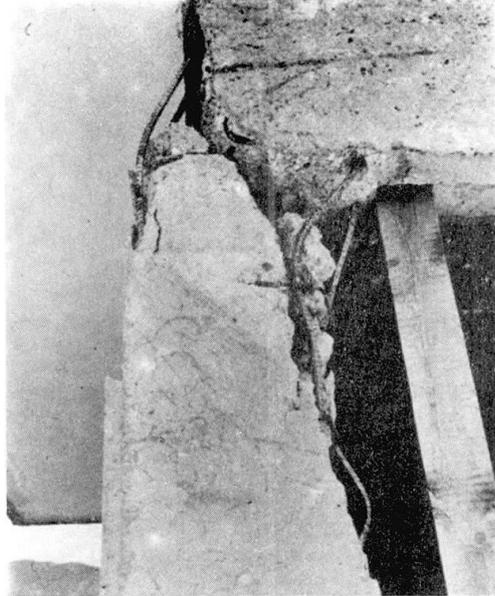
Figure 14: Shearing-off of a column at its connection with the crossbeam due to insufficient stirrups.

The ability of the resulting plastic joint to rotate is, however, increased and a shear failure prevented.

In the event that it is impossible to design the columns, taking actual earthquake forces into consideration, then at least the plastic deformation of the columns in all directions must be guaranteed. The movements should not be hindered by any secondary elements. An improved building method for the prevention of collapse could, therefore, be to shape the columns in a manner that the plastic hinges, necessary to absorb energy, are formed in the crossbeams.

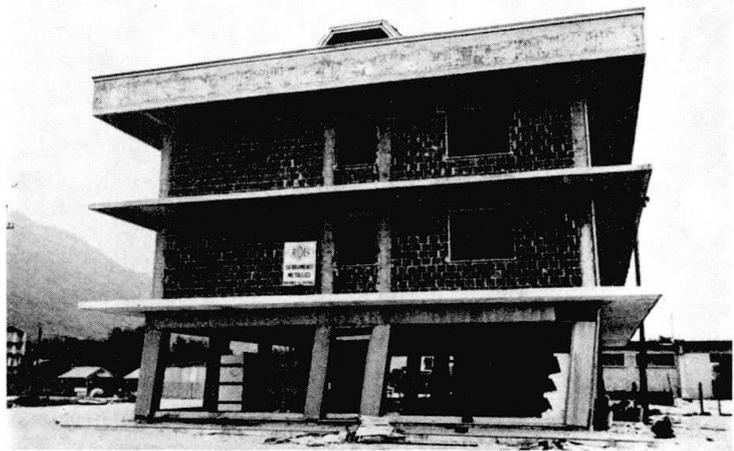
Figure 15:

Open or only slightly stiffened ground floors, mostly for commercial use, are particularly vulnerable. The locally severe destruction in the area of such weak spots caused the collapse of entire buildings or made their demolition necessary, even with otherwise only minor damage, because restoration would have been too difficult (Figure 15).

Three-storey dwelling house with shop in the ground floor near Artegna. Reinforced concrete frame with brick partitioning walls in the upper floors and mostly open ground floor. Plastic hinges at bottom and top of the ground floor reinforced concrete columns caused large deformations. No damage in the upper floors.

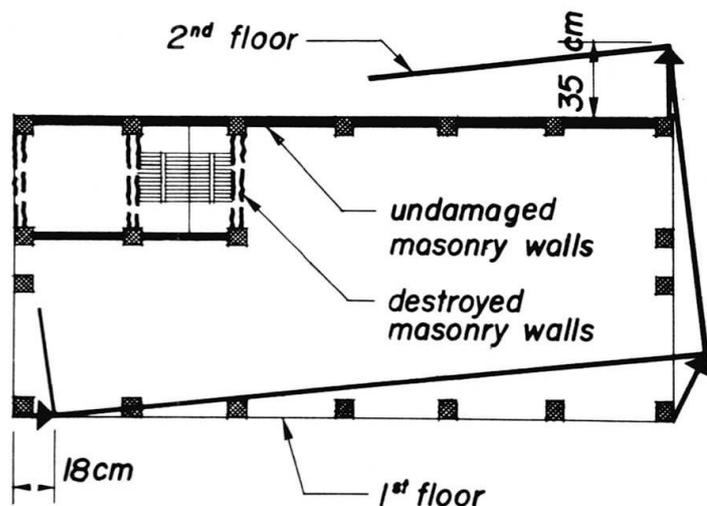
From the point of view of the structural system, many symmetrical structures suffered damage due to the additional twisting motion of the building around its vertical axis. As a result of the superimposed movement, some parts of the building are relieved whilst others are considerably more deformed than they would be due to translational movements only. Torsional loads are caused by the unsymmetrical layout of the structural system, but also by contingencies arising in the rigidity and execution of partitioning walls and additional fittings (Figure 15). The consequences of torsional strain can only be met by appropriate consideration in the design including provision for sufficient torsional rigidity of the building. Due to the incalculable influence of secondary elements, which are not designed to carry vertical loads, an asymmetry in the ground plan can hardly be excluded.

The ground plan of the dwelling house with the open ground floor shown before. Twisting of the building around the staircase stiffened with masonry walls.

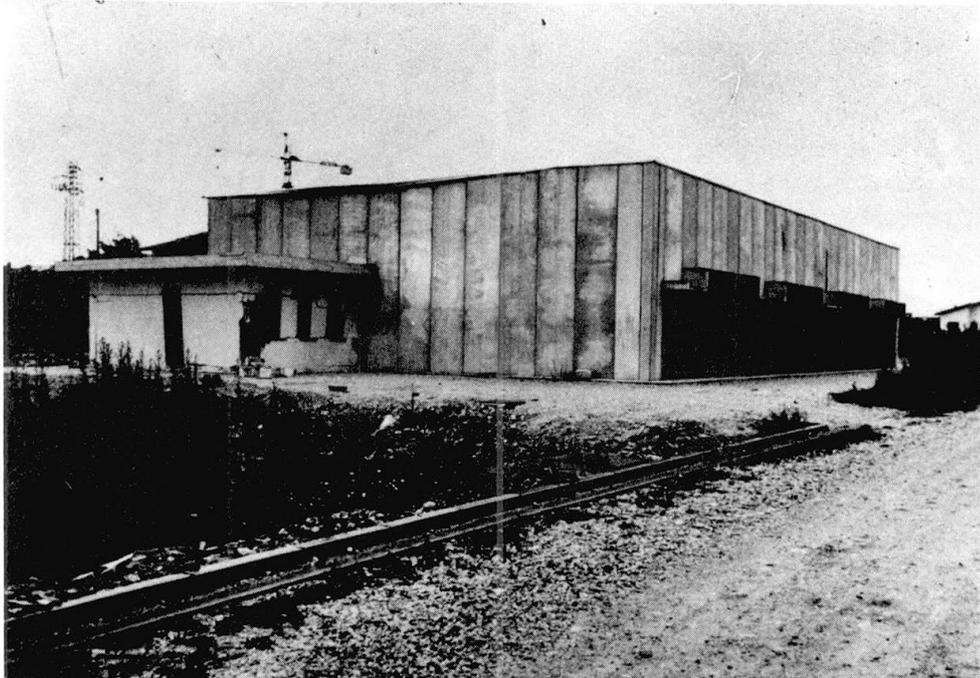
Severe damage could be located in structures composed of building sections with greatly differing rigidity due to diverse types of construction (for instance, reinforced concrete frame and pure brick) or which varied considerably in their design (Figure 16). This damage occurred because the individual deformation of each component was obstructed.

Figure 16: Prefabricated storage shed with brick annex in Gemona. Side wall panels slightly caved in by impact with rigid annex. Upper part of the annex shorn off and pushed over by the impact force due to insufficiently wide joints.

This problem can be overcome by arranging the joints as to divide the structure into sections, each with its own clearly distinct vibration behaviour. The joints should be made adequately wide since numerous uncertainties make an exact calculation impossible. It must be taken into consideration that, for example, the deformation usually provided for in a homogenous supporting structure can turn out to be considerably larger due to the formation of cracks or plastification. An adequate freedom of movement, therefore, allows for greater plastification and a larger capacity to carry earthquake stress.

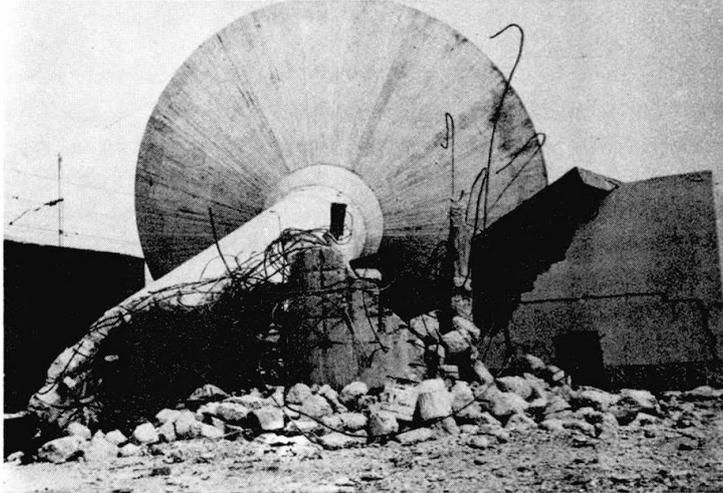
Figure 17: Overturned water tower belonging to the Italian State Railways in Gemona station. Foot of the shaft completely destroyed and concrete shattered.

Special structures (e.g., bridges and water-towers) (Figure 17), because of their unusual form and distribution of mass, necessitate a dynamic analysis which takes the vibration behaviour of the structure and the real properties of an anticipated earthquake into consideration.

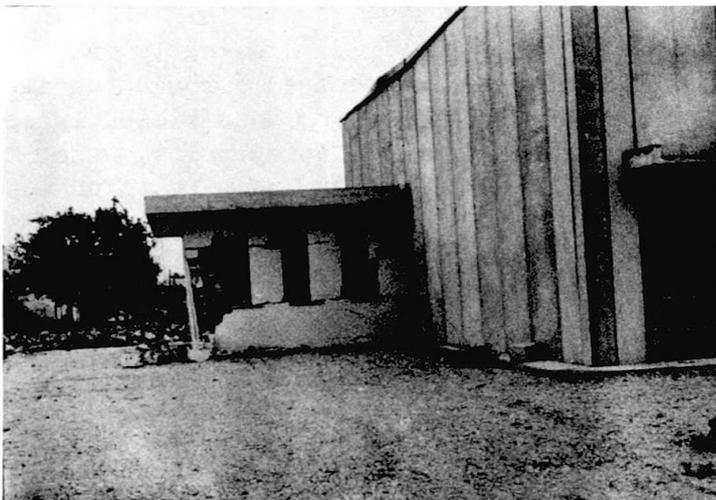
Figure 18: Prefabricated storage shed in Gemona as shown before. The supporting frames and the wall panels generally not damaged because of energy absorption in the material of the joints between the single panels.

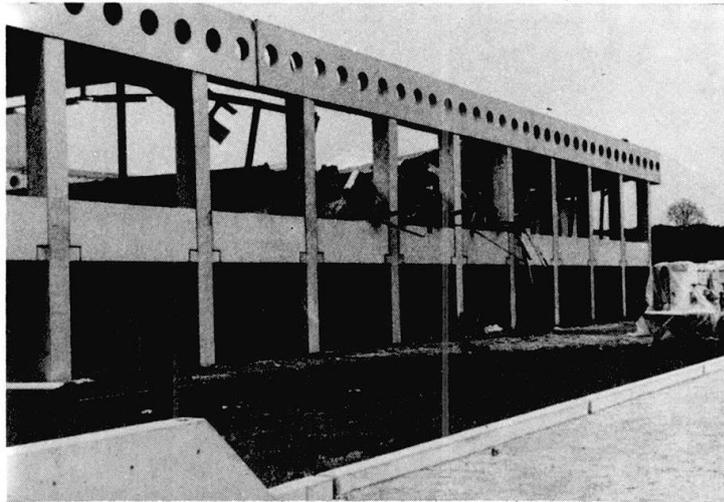
If prefabricated structures are designed only in accordance with the Standards laid down for earthquake forces or these forces are overlooked altogether, then the result is greatly underdimensioned connections of the structure elements. Load bearing connexions should be properly designed against the expected dynamic forces. Purely friction-type joints are no longer sufficient to transfer the forces that arise, even from only weak earthquake loads (Figure 19).

Figure 19: Heavily damaged prefabricated factory shed near Osoppo with roof girders fallen down. Friction joints insufficient to provide structural stability.

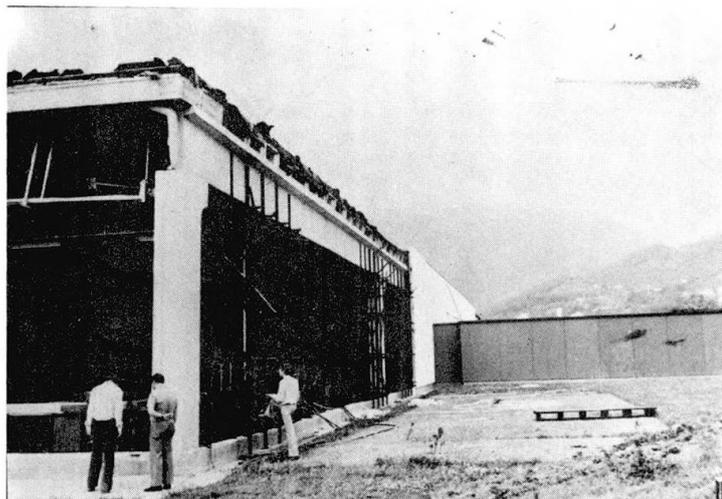
Building parts (such as prefabricated façade slabs and dividing walls and fittings, particularly machines, storage racks and pipes), which are not part of the supporting structure, are usually either directly or indirectly connected to it. Due to the action of the earthquake, much damage occurred through the displacement or collapse of façade slabs which were unconnected or insufficiently secured (Figure 20). The actual displacement occurring at the fixation point, which can be considerably larger than the one of the ground shock, must be taken into consideration in the fixation of secondary elements.

Figure 20: Prefabricated factory shed near Artegna. Wall panels fallen out during the earthquake because of insufficient fixation.
