**Artikel:** Structural behaviour of the damaged building during the Friuli earthquakes between May 6 and September 15, 1976

**Autor:** Heimgartner, Ewald

STRUCTURAL BEHAVIOUR OF THE DAMAGED BUILDING DURING THE  
FRIULI EARTHQUAKES BETWEEN MAY 6 AND SEPTEMBER 15, 1976

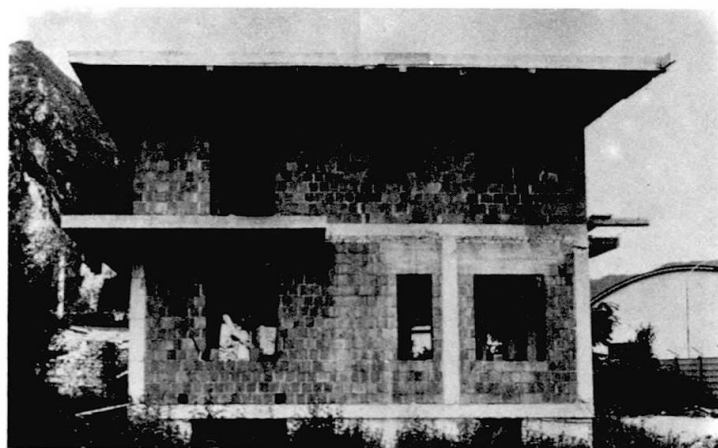
Figure 1: (after May 6th): Uncompleted building in Gemona with groundfloor open on three sides and living floor above. The supporting framework of the groundfloor consists of reinforced concrete columns, partitioned on one of the narrow sides by brick walls. The upper floor is exclusively brick. Due to the earthquake load, the building rotated around the partitioned transverse wall in the groundfloor. The fixing points of the columns were badly damaged in the cellar and groundfloor ceilings. The brick walls on the transverse side on the groundfloor were slightly cracked: the upper floor remained undamaged.

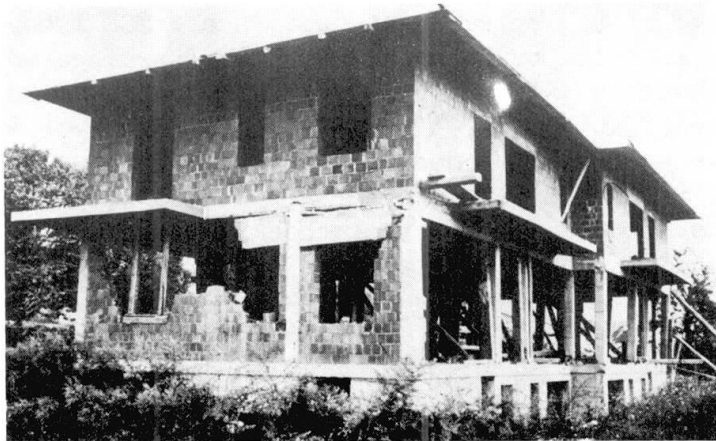
Figure 2: (after September 15th): Uncompleted building in Gemona after renewed earthquake stress. The reinforced concrete columns in the groundfloor were completely destroyed at their fixing points, connection being maintained by the reinforcement only. The massive wooden struts in the groundfloor saved the building from collapse during the second strong earthquake. The already damaged brick wall in the groundfloor was additionally strained due to the strenghtening effect of the wooden struts in the open groundfloor area. The wide brick window jamb was broken out and the reinforced concrete window supports shaken from their rests.

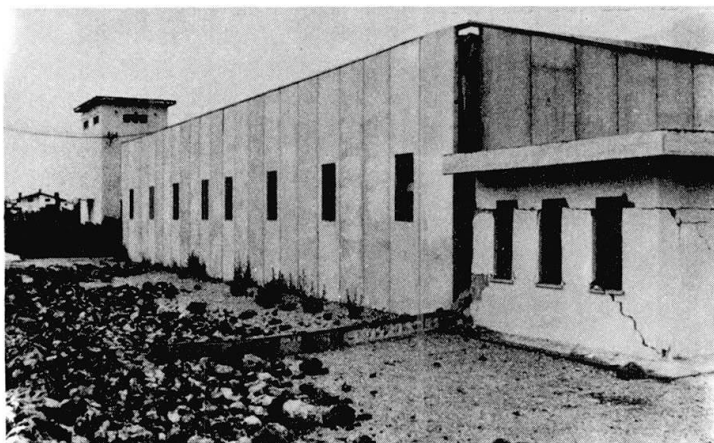
Figure 3: (after May 6th): Prefabricated shed with brick annex in Gemona. The supporting framework of the shed is undamaged. The concrete elements of the side wall, on the other hand, were slightly caved in by the impact of the rigid annex. The plastic material of the wall joints was torn by the large deformation. The roof of the annex was shorn off and pushed over at window level by the impulse load of the impact due to insufficiently wide joints.

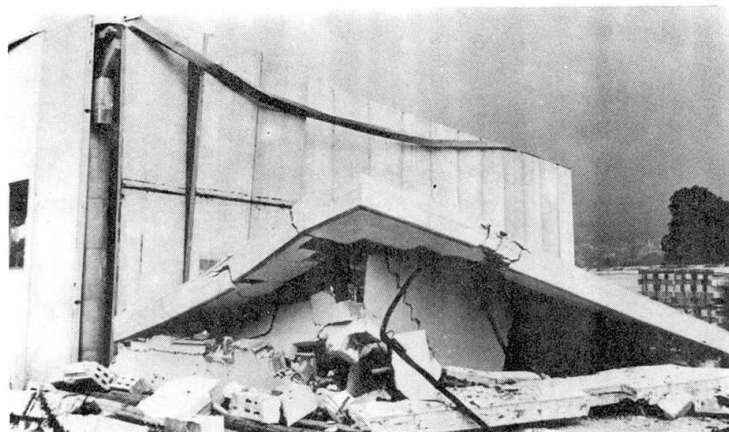
Figure 4: (after September 15th): Prefabricated shed with collapsed annex. The renewed earthquake load caused damage of the supporting framework of the shed at the fixing points of the columns and rests of the bars. The façade slabs of the side wall were severely caved in by the renewed impact: the annex itself collapsed. The increased displacement, as compared with the first earthquake, can be traced back to the reduced structural rigidity due to the destruction of one of the concrete block walls.

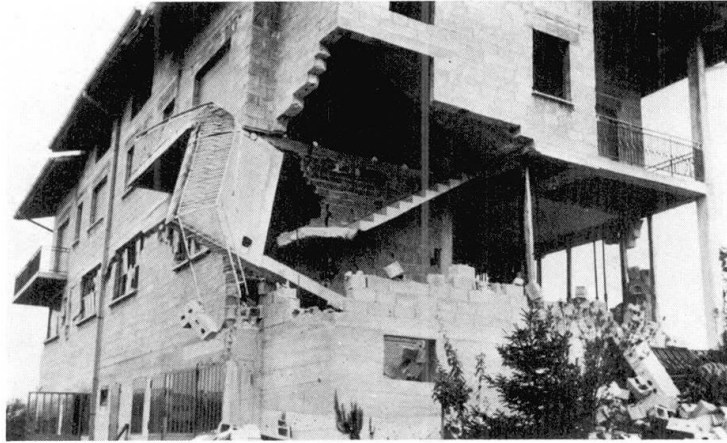
Figure 6: (after September 15th: Residential building with workshop near Artegna after renewed earthquake stress. The side wall in the middle floor collapsed under further earthquake load. The door and window jambs on the longitudinal walls shattered and partially collapsed. The shear resistance of these concrete block walls was minimal due to failure of the mortar joints to prevent the layers from shifting.

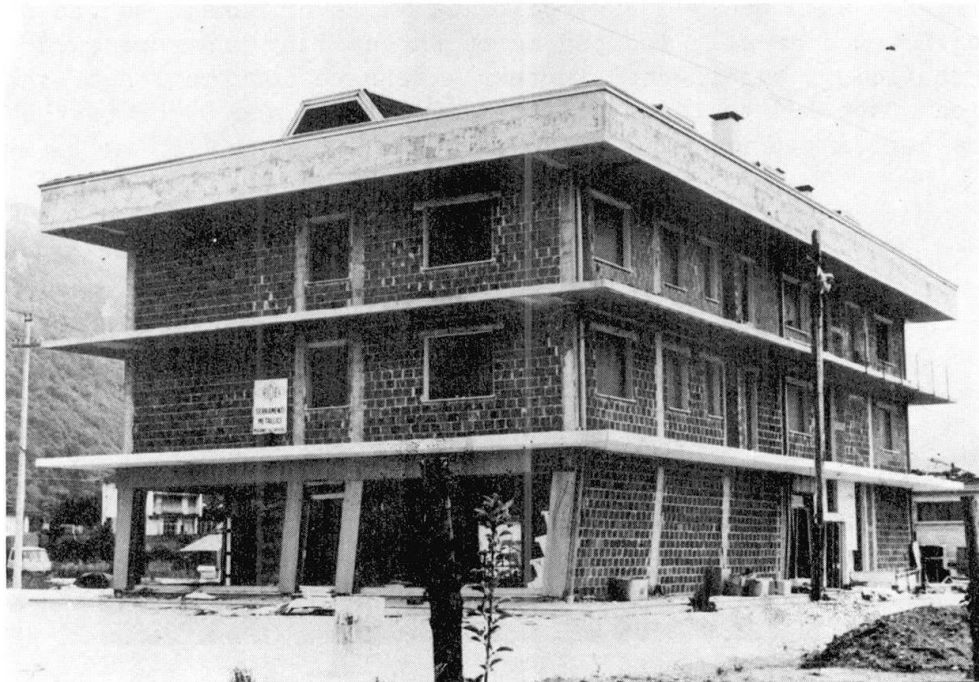
Figure 7: (after May 6th): Residential building with shop near Artegna. Reinforced concrete frame building with brick partitioning in the two upper storeys. In the groundfloor, open on three sides, only the rear longitudinal wall and the staircase are braced. The destruction was concentrated on the groundfloor where a rotating motion of approximately 40 cm maximum displacement occurred around the staircase core. The brick walls of the staircase were badly destroyed, while those of the upper floors remained undamaged.

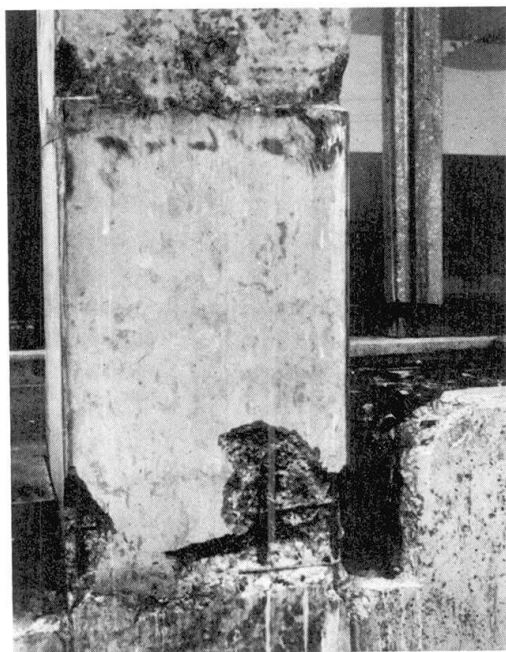
Figure 9: (after September 15th): Foot of a column in the Fantoni furniture factory in Rivoli di Osoppo. By repairing the cracked column foot it was hoped to restore the original carrying capacity. The renewed earthquake load caused the same damage as the first shock, the repaired fixing points of the columns were again cracked and the concrete crumbled in the most highly stressed areas.

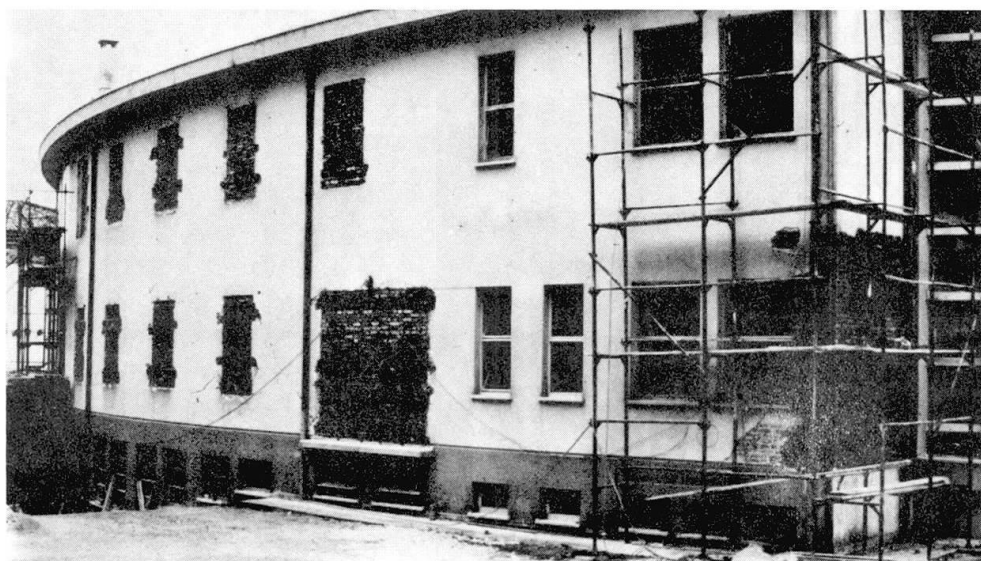
Figure 10: (after September 15th): Business building SBUELZ in Tricesimo. To strengthen the carrying capacity, the door and window openings were walled in. The vibration behaviour of the building was so improved that, during renewed earthquake stress hardly any further damage occurred as opposed to the destruction which occurred during the earthquake of May 6th.

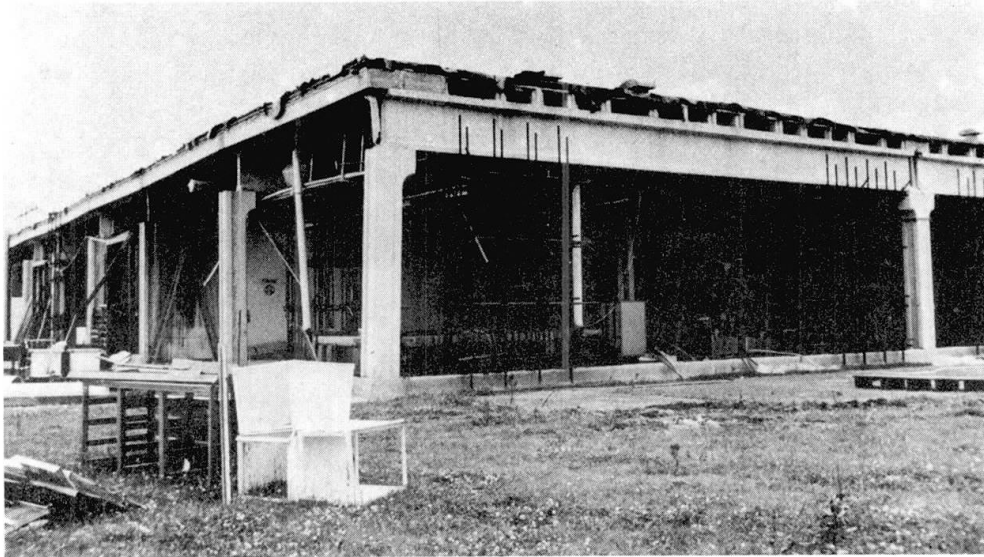
Figure 11: (after May 6th): Factory building near Artegna. Severe displacement of the prefabricated reinforced concrete framework together with distortion of the foundation and tilting of a corner column. A large number of the only lightly secured reinforced concrete façade elements were thrown off.

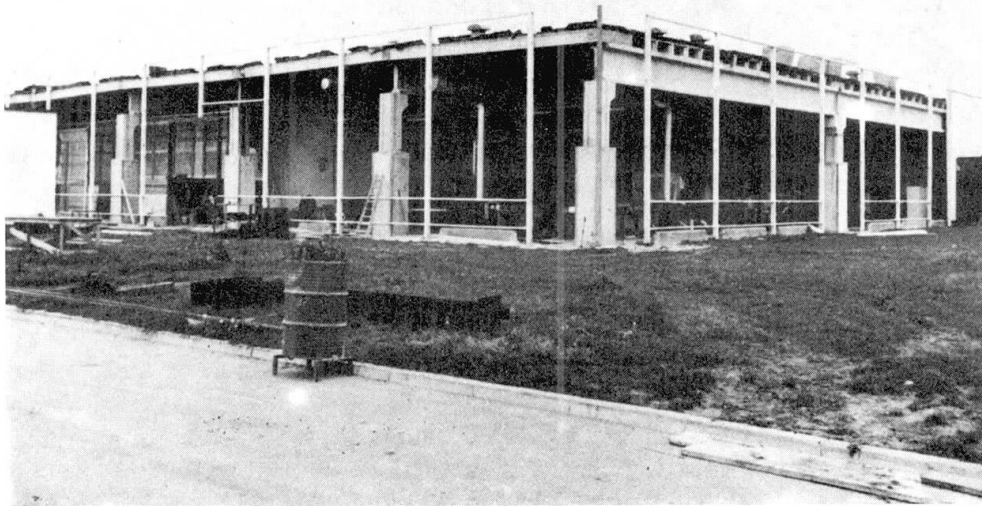
Figure 12: (after September 15th): Factory building near Artegna, after repair, without further earthquake damage. In order to increase the carrying capacity, the concrete columns were surrounded with a 15 cm strong concrete sheath. The earthquake load was reduced by replacing the heavy concrete façade elements by a light metal façade.

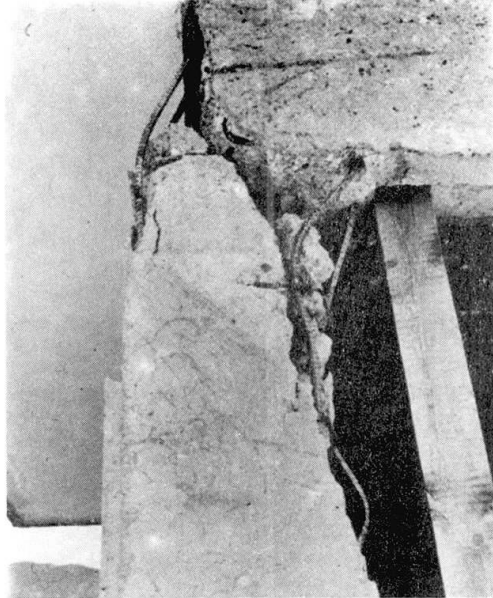
Figure 14: Shearing-off of a column at its connection with the crossbeam due to insufficient stirrups.

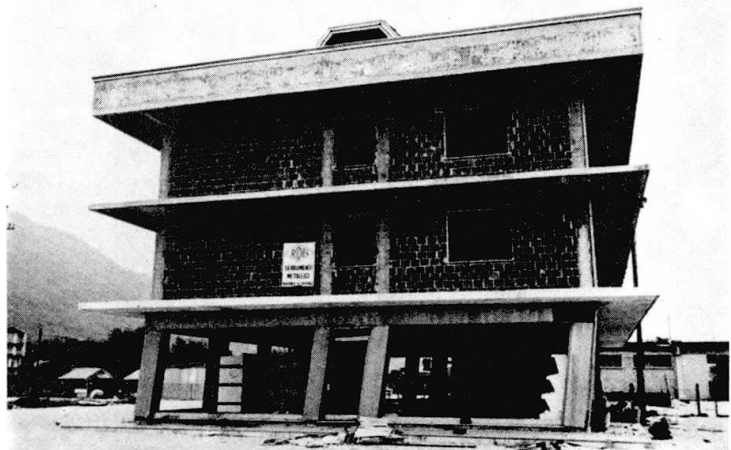
Figure 15:

Three-storey dwelling house with shop in the ground floor near Artegna. Reinforced concrete frame with brick partitioning walls in the upper floors and mostly open ground floor. Plastic hinges at bottom and top of the ground floor reinforced concrete columns caused large deformations. No damage in the upper floors.

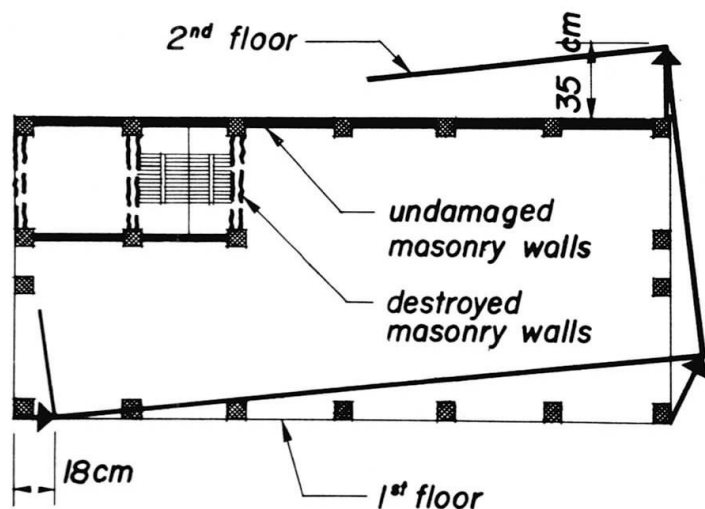
The ground plan of the dwelling house with the open ground floor shown before. Twisting of the building around the staircase stiffened with masonry walls.

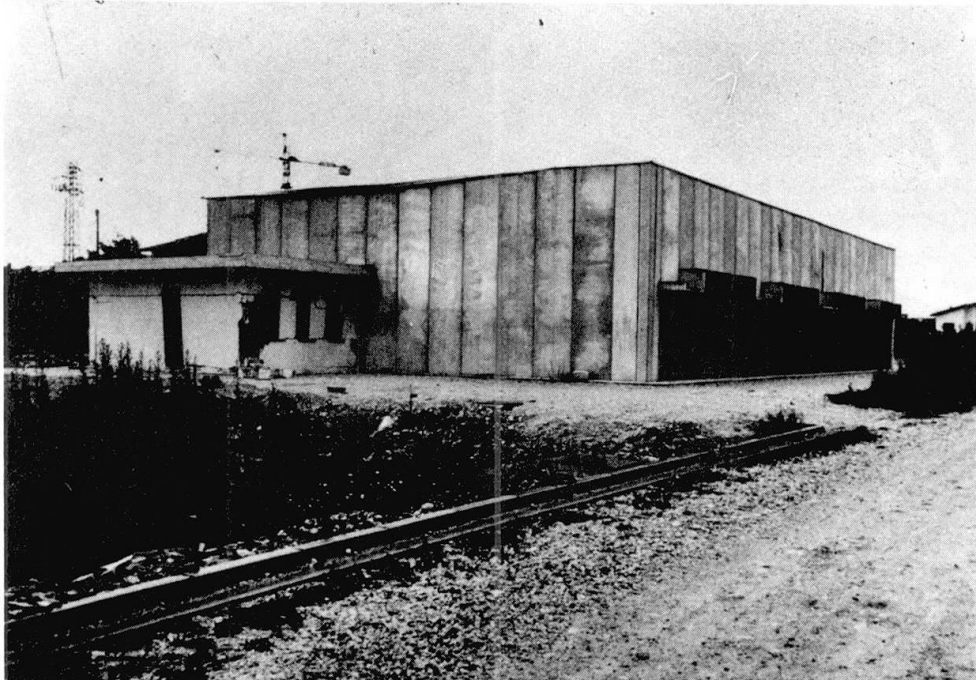
Figure 16: Prefabricated storage shed with brick annex in Gemona. Side wall panels slightly caved in by impact with rigid annex. Upper part of the annex shorn off and pushed over by the impact force due to insufficiently wide joints.

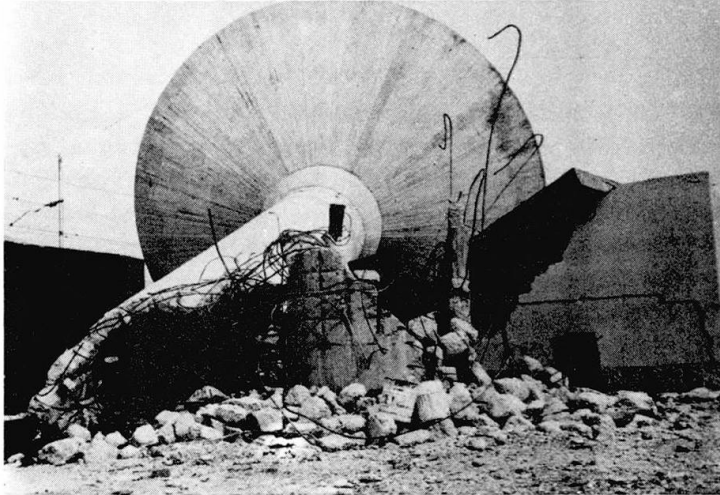
Figure 17: Overturned water tower belonging to the Italian State Railways in Gemona station. Foot of the shaft completely destroyed and concrete shattered.

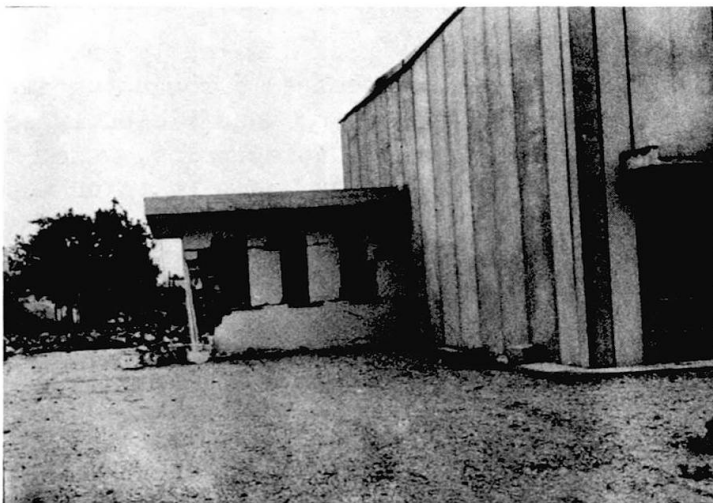
Figure 18: Prefabricated storage shed in Gemona as shown before. The supporting frames and the wall panels generally not damaged because of energy absorption in the material of the joints between the single panels.

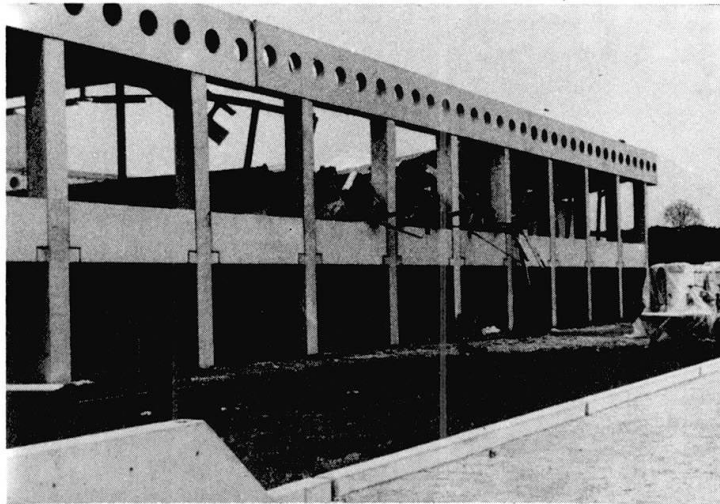
Figure 19: Heavily damaged prefabricated factory shed near Osoppo with roof girders fallen down. Friction joints insufficient to provide structural stability.

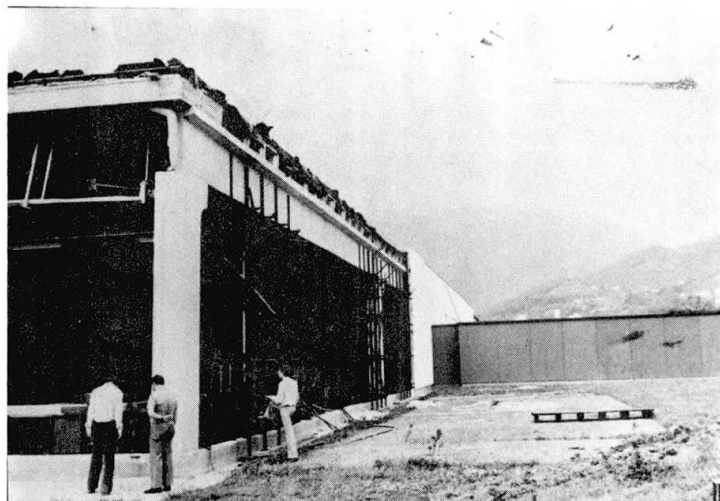
Figure 20: Prefabricated factory shed near Artegna. Wall panels fallen out during the earthquake because of insufficient fixation.
