STRUCTURAL BEHAVIOUR OF THE DAMAGED BUILDING DURING THE
FRIULI EARTHQUAKES BETWEEN MAY 6 AND SEPTEMBER 15, 1976

by Ewald Heimgartner, Structural Engineer ETHZ/SIA

BASLER & HOFMANN

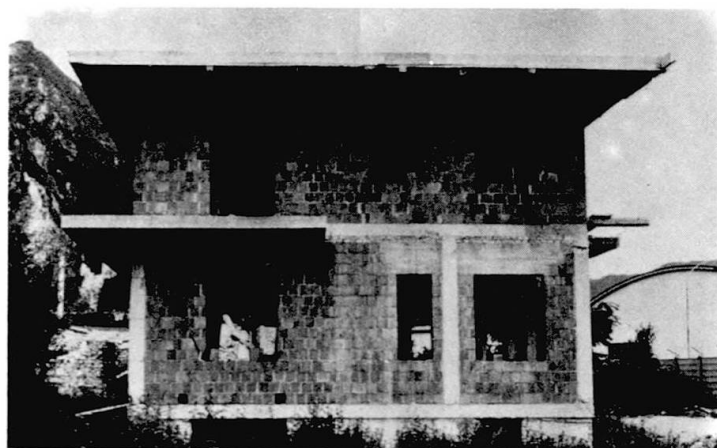
Figure 1: (after May 6th): Uncompleted building in Gemona with groundfloor open on three sides and living floor above. The supporting framework of the groundfloor consists of reinforced concrete columns, partitioned on one of the narrow sides by brick walls. The upper floor is exclusively brick. Due to the earthquake load, the building rotated around the partitioned transverse wall in the groundfloor. The fixing points of the columns were badly damaged in the cellar and groundfloor ceilings. The brick walls on the transverse side on the groundfloor were slightly cracked: the upper floor remained undamaged.

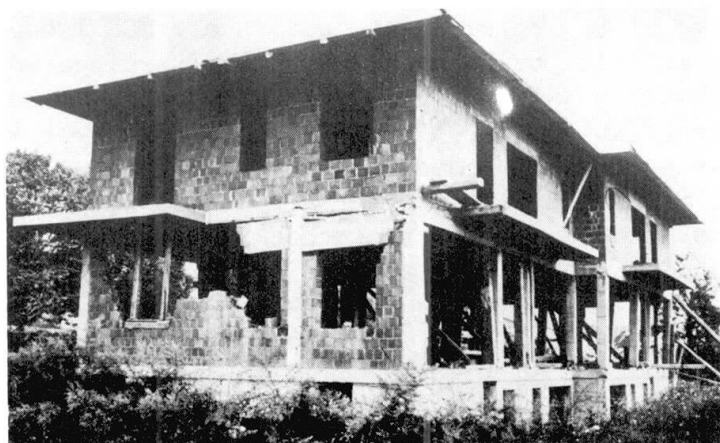
Figure 2: (after September 15th): Uncompleted building in Gemona after renewed earthquake stress. The reinforced concrete columns in the groundfloor were completely destroyed at their fixing points, connection being maintained by the reinforcement only. The massive wooden struts in the groundfloor saved the building from collapse during the second strong earthquake. The already damaged brick wall in the groundfloor was additionally strained due to the strenghtening effect of the wooden struts in the open groundfloor area. The wide brick window jamb was broken out and the reinforced concrete window supports shaken from their rests.

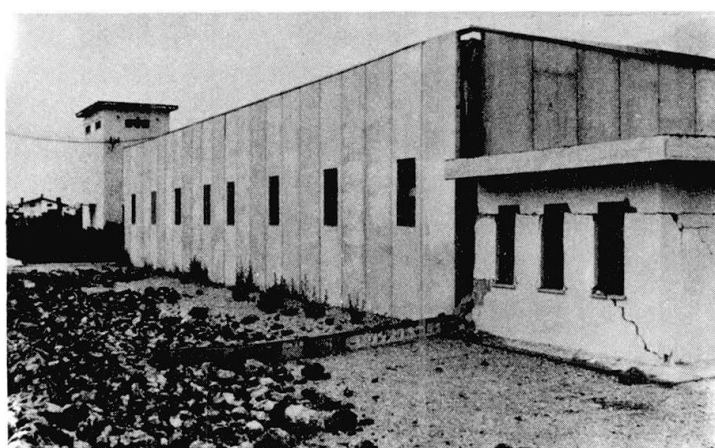
Figure 3: (after May 6th): Prefabricated shed with brick annex in Gemona. The supporting framework of the shed is undamaged. The concrete elements of the side wall, on the other hand, were slightly caved in by the impact of the rigid annex. The plastic material of the wall joints was torn by the large deformation. The roof of the annex was shorn off and pushed over at window level by the impulse load of the impact due to insufficiently wide joints.

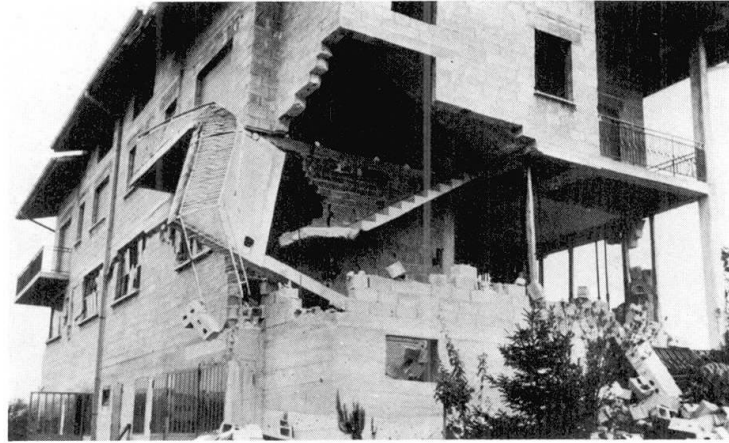
Figure 6: (after September 15th: Residential building with workshop near Artegna after renewed earthquake stress. The side wall in the middle floor collapsed under further earthquake load. The door and window jambs on the longitudinal walls shattered and partially collapsed. The shear resistance of these concrete block walls was minimal due to failure of the mortar joints to prevent the layers from shifting.

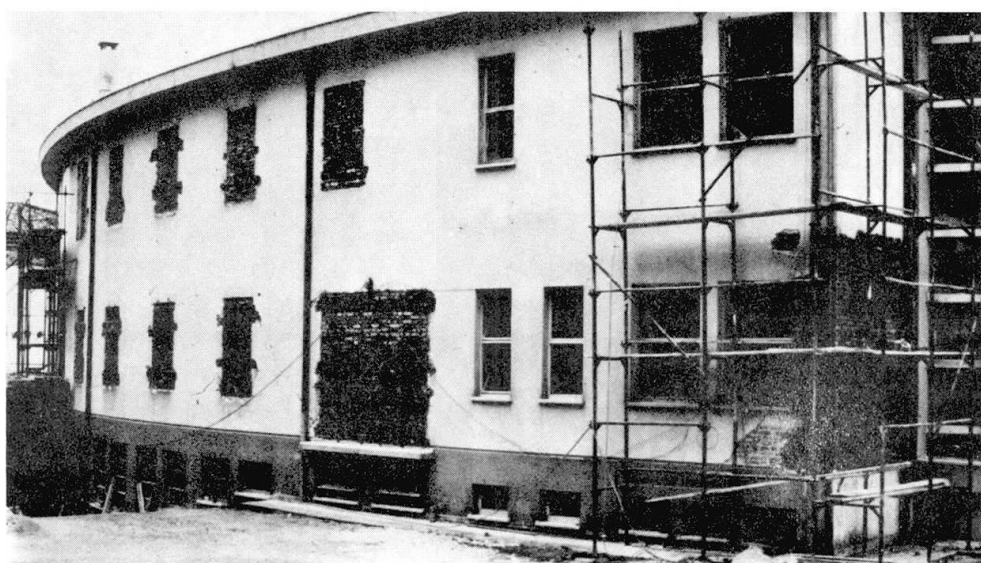
Figure 10: (after September 15th): Business building SBUELZ in Tricesimo. To strengthen the carrying capacity, the door and window openings were walled in. The vibration behaviour of the building was so improved that, during renewed earthquake stress hardly any further damage occurred as opposed to the destruction which occurred during the earthquake of May 6th.

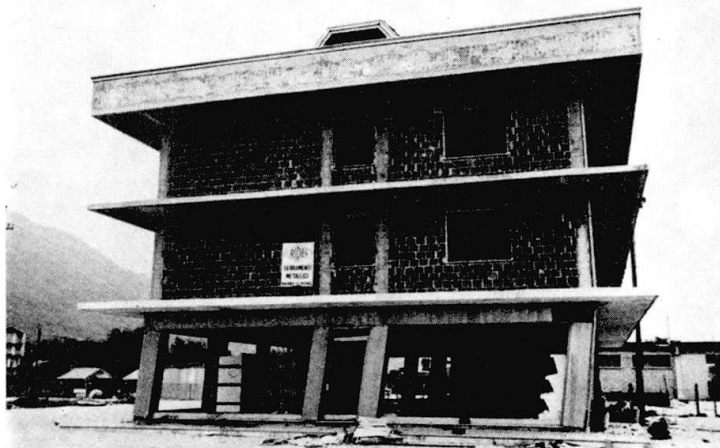
Figure 15:

Three-storey dwelling house with shop in the ground floor near Artegna. Reinforced concrete frame with brick partitioning walls in the upper floors and mostly open ground floor. Plastic hinges at bottom and top of the ground floor reinforced concrete columns caused large deformations. No damage in the upper floors.

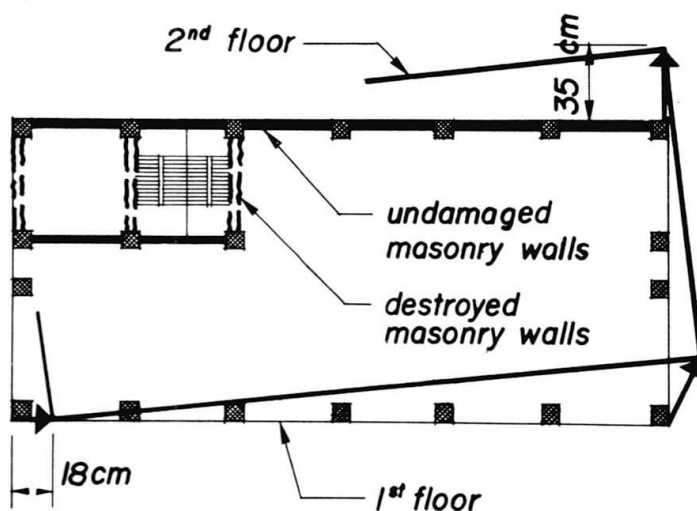
The ground plan of the dwelling house with the open ground floor shown before. Twisting of the building around the staircase stiffened with masonry walls.

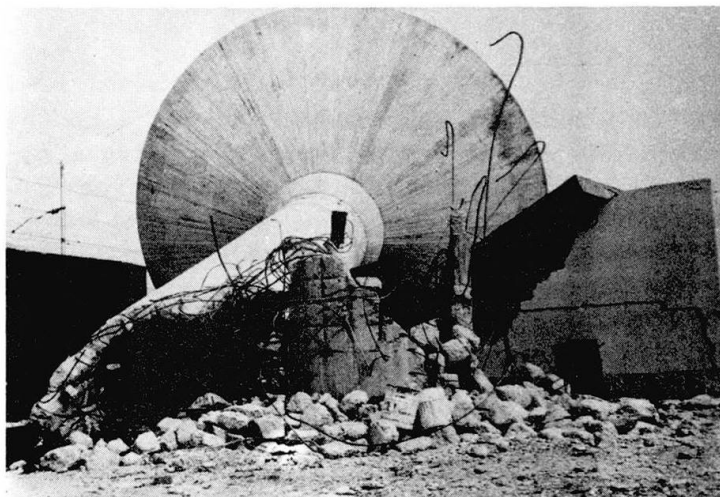
Figure 17: Overturned water tower belonging to the Italian State Railways in Gemona station. Foot of the shaft completely destroyed and concrete shattered.

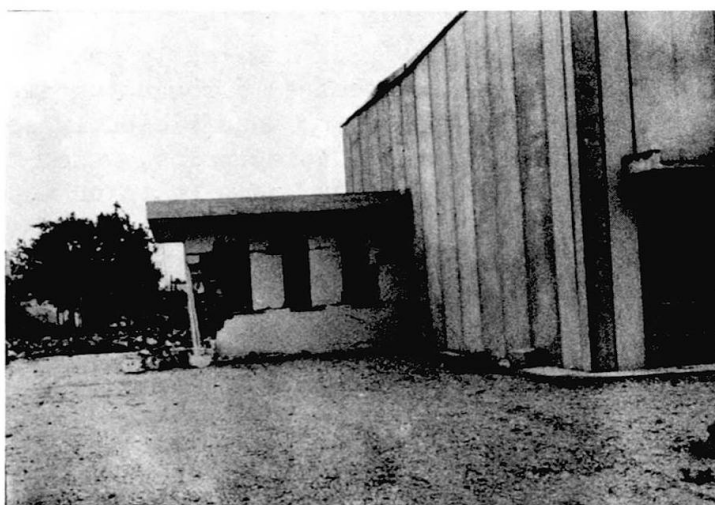
Figure 18: Prefabricated storage shed in Gemona as shown before. The supporting frames and the wall panels generally not damaged because of energy absorption in the material of the joints between the single panels.

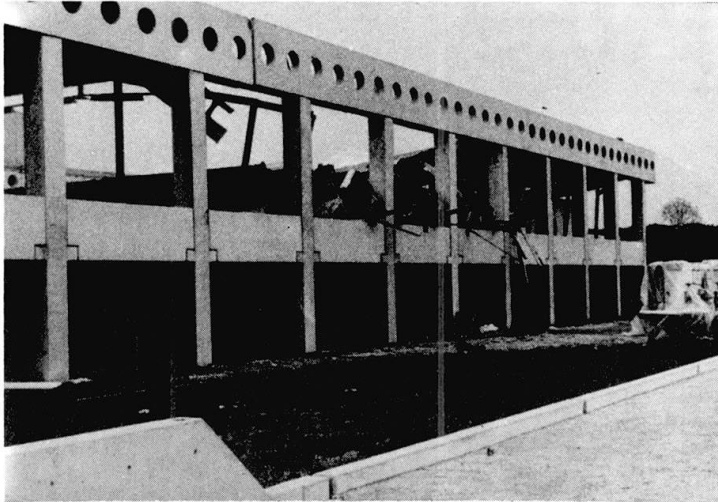
Figure 19: Heavily damaged prefabricated factory shed near Osoppo with roof girders fallen down. Friction joints insufficient to provide structural stability.
