STRUCTURAL BEHAVIOUR OF THE DAMAGED BUILDING DURING THE
FRIULI EARTHQUAKES BETWEEN MAY 6 AND SEPTEMBER 15, 1976

by Ewald Heimgartner, Structural Engineer ETHZ/SIA

BASLER & HOFMANN
Consulting Engineers and Planners
CH - 8029 Zurich, Switzerland

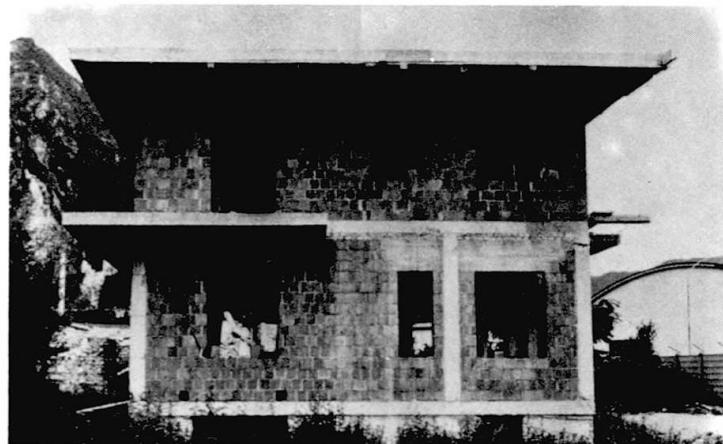
Figure 1: (after May 6th): Uncompleted building in Gemona with groundfloor open on three sides and living floor above. The supporting framework of the groundfloor consists of reinforced concrete columns, partitioned on one of the narrow sides by brick walls. The upper floor is exclusively brick. Due to the earthquake load, the building rotated around the partitioned transverse wall in the groundfloor. The fixing points of the columns were badly damaged in the cellar and groundfloor ceilings. The brick walls on the transverse side on the groundfloor were slightly cracked: the upper floor remained undamaged.

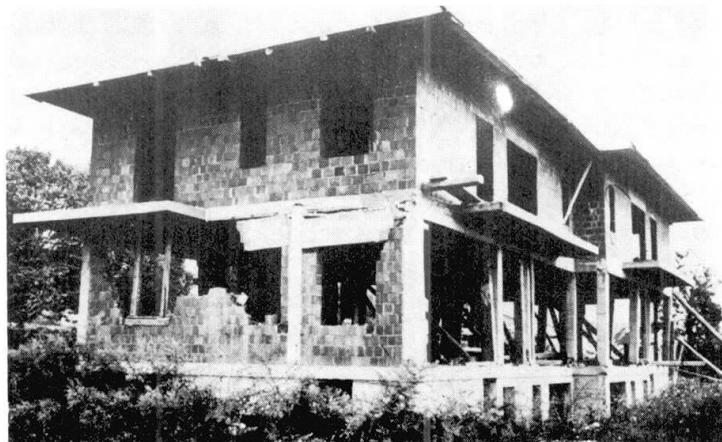
Figure 2: (after September 15th): Uncompleted building in Gemona after renewed earthquake stress. The reinforced concrete columns in the groundfloor were completely destroyed at their fixing points, connection being maintained by the reinforcement only. The massive wooden struts in the groundfloor saved the building from collapse during the second strong earthquake. The already damaged brick wall in the groundfloor was additionally strained due to the strengthening effect of the wooden struts in the open groundfloor area. The wide brick window jamb was broken out and the reinforced concrete window supports shaken from their rests.

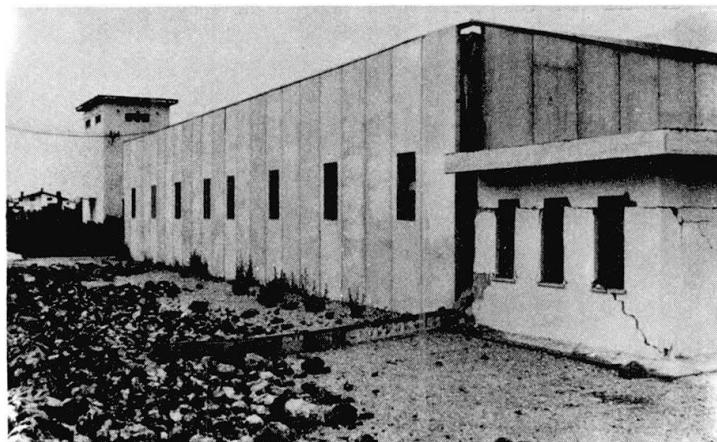
Figure 3: (after May 6th): Prefabricated shed with brick annex in Gemona. The supporting framework of the shed is undamaged. The concrete elements of the side wall, on the other hand, were slightly caved in by the impact of the rigid annex. The plastic material of the wall joints was torn by the large deformation. The roof of the annex was shorn off and pushed over at window level by the impulse load of the impact due to insufficiently wide joints.

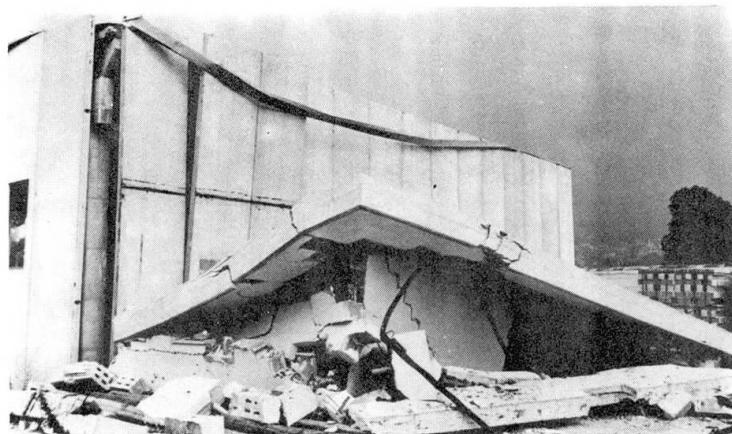
Figure 4: (after September 15th): Prefabricated shed with collapsed annex. The renewed earthquake load caused damage of the supporting framework of the shed at the fixing points of the columns and rests of the bars. The façade slabs of the side wall were severely caved in by the renewed impact: the annex itself collapsed. The increased displacement, as compared with the first earthquake, can be traced back to the reduced structural rigidity due to the destruction of one of the concrete block walls.

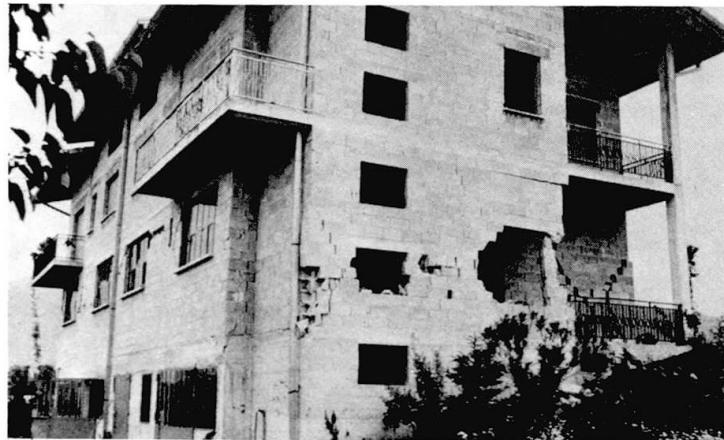
Figure 5: (after May 6th): Residential building with workshop near Artegna with a reinforced concrete cellar and two floors in concrete blocks. The side walls by the entrance incurred gaping X-shaped diagonal cracks due to the high shear stress. These cracks led to partial collapse of the masonry. The highly strained window jambs on the longitudinal façade were badly cracked.

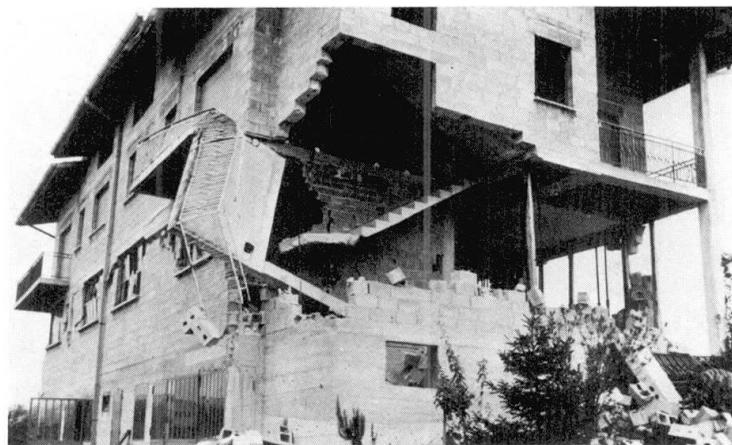
Figure 6: (after September 15th): Residential building with workshop near Artegna after renewed earthquake stress. The side wall in the middle floor collapsed under further earthquake load. The door and window jambs on the longitudinal walls shattered and partially collapsed. The shear resistance of these concrete block walls was minimal due to failure of the mortar joints to prevent the layers from shifting.

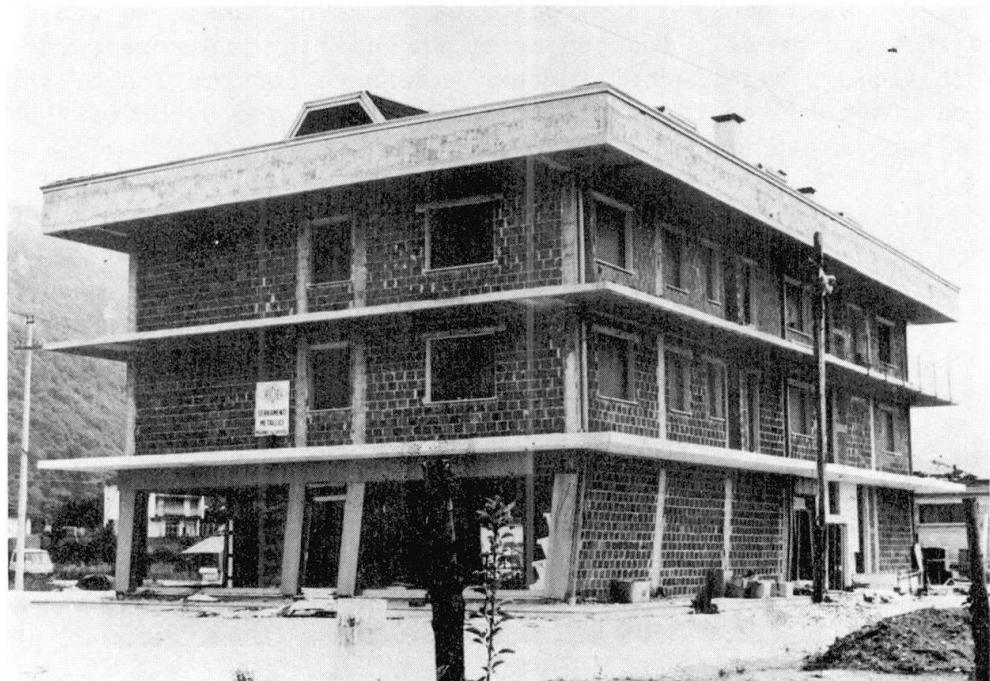
Figure 7: (after May 6th): Residential building with shop near Artegna. Reinforced concrete frame building with brick partitioning in the two upper storeys. In the groundfloor, open on three sides, only the rear longitudinal wall and the staircase are braced. The destruction was concentrated on the groundfloor where a rotating motion of approximately 40 cm maximum displacement occurred around the staircase core. The brick walls of the staircase were badly destroyed, while those of the upper floors remained undamaged.

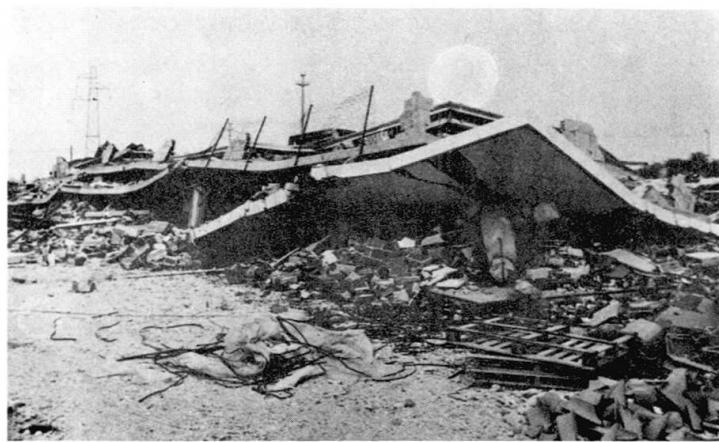
Figure 8: (after September 15th): Wreckage of the residential and business house near Artegna. The groundfloor of the building collapsed during the earthquake of September 11th. Through the impact, the undamaged living storeys also collapsed. The destroyed fixing points of the reinforced concrete columns in the groundfloor as well as the cracked brick walls of the staircase were not enough to carry the renewed strong earthquake stress. The experts had hoped, despite the doubts of the owner, to be able to repair the building.

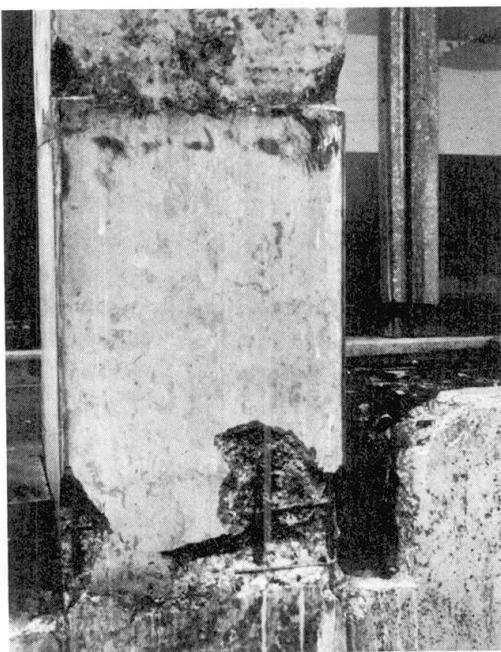
Figure 9: (after September 15th): Foot of a column in the Fantoni furniture factory in Rivoli di Osoppo. By repairing the cracked column foot it was hoped to restore the original carrying capacity. The renewed earthquake load caused the same damage as the first shock, the repaired fixing points of the columns were again cracked and the concrete crumbled in the most highly stressed areas.

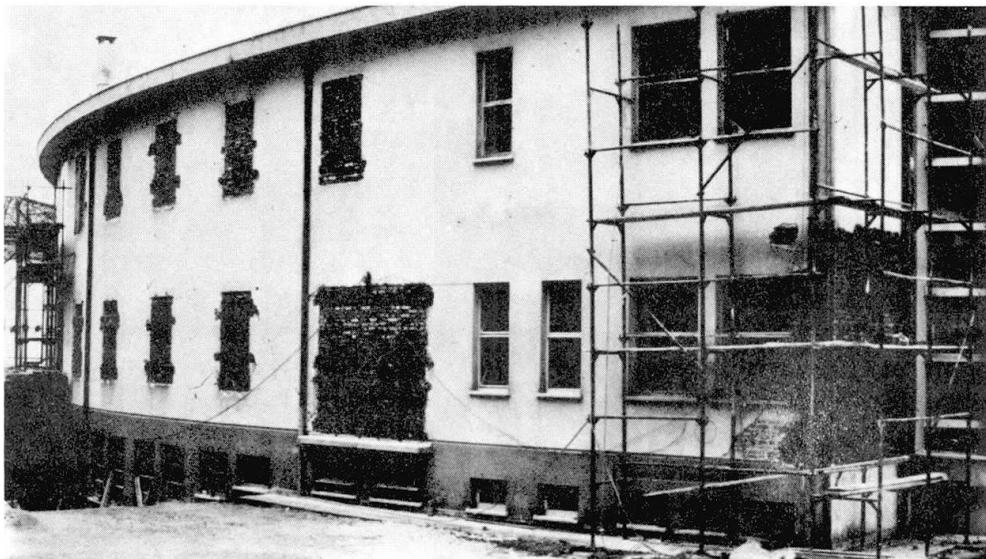
Figure 10: (after September 15th): Business building SBUELZ in Tricesimo. To strengthen the carrying capacity, the door and window openings were walled in. The vibration behaviour of the building was so improved that, during renewed earthquake stress hardly any further damage occurred as opposed to the destruction which occurred during the earthquake of May 6th.

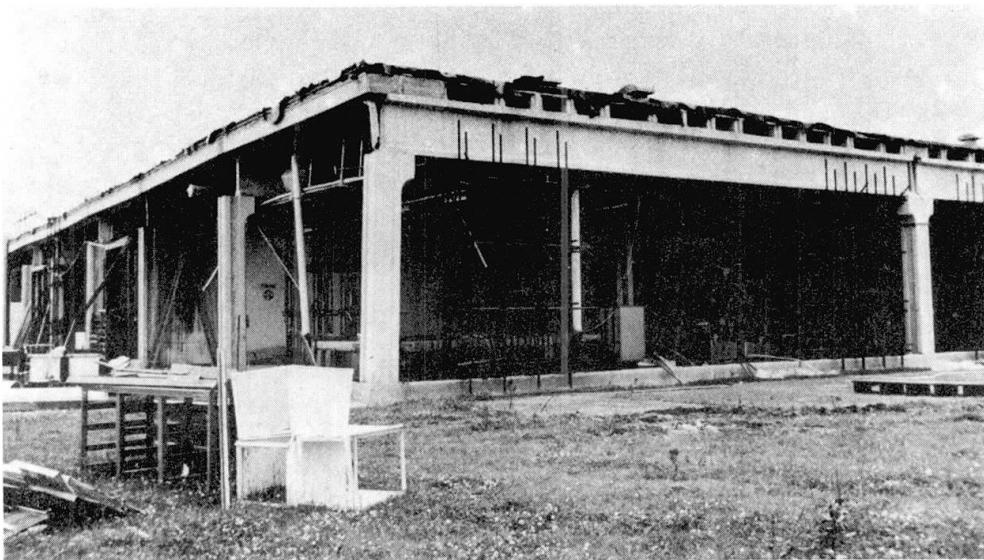
Figure 11: (after May 6th): Factory building near Artegna. Severe displacement of the prefabricated reinforced concrete framework together with distortion of the foundation and tilting of a corner column. A large number of the only lightly secured reinforced concrete façade elements were thrown off.

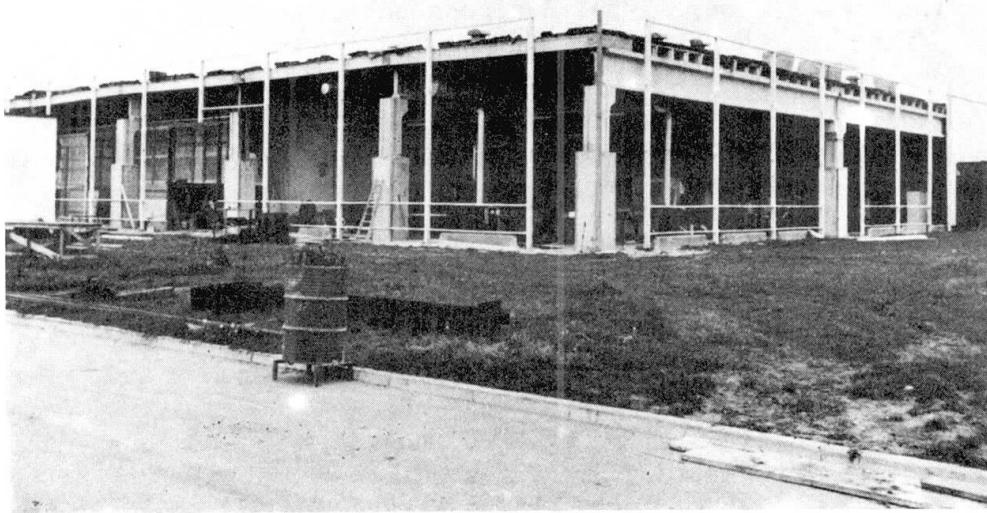
Figure 12: (after September 15th): Factory building near Artegna, after repair, without further earthquake damage. In order to increase the carrying capacity, the concrete columns were surrounded with a 15 cm strong concrete sheath. The earthquake load was reduced by replacing the heavy concrete façade elements by a light metal façade.

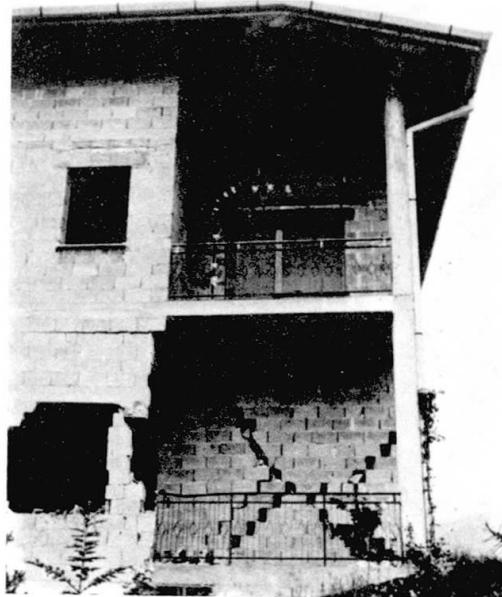
Walls and partitions consisting of brick and masonry are both rigid and brittle. Where the walls are insufficiently strong or where many openings exist, the masonry walls are no longer able to absorb horizontal forces. When overstrained, these walls crack mostly crosswise under 45° (Figure 13), the crack spreading, either along the mortar joints or in the bricks. Because of the brittle nature of masonry constructions, the cracks widen, joints gape open or the walls concerned even collapse. In a skeleton construction, the reinforced concrete framework can in certain cases continue to uphold the weight of the buildings. For purely masonry construction, on the other hand, at least a partial collapse of the building is unavoidable.

Figure 13: Dwelling house with workshop near Artegna. Basement in reinforced concrete and the upper stories in masonry without framing. Typical diagonal cross cracks in a wall of the ground floor.

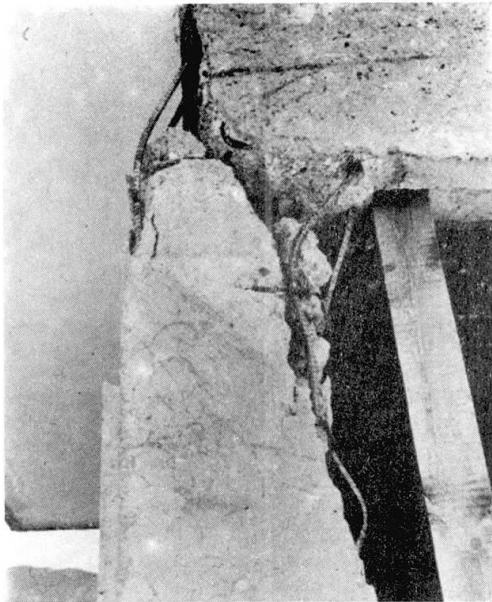
Figure 14: Shearing-off of a column at its connection with the crossbeam due to insufficient stirrups.

The ability of the resulting plastic joint to rotate is, however, increased and a sheer failure prevented.

In the event that it is impossible to design the columns, taking actual earthquake forces into consideration, then at least the plastic deformation of the columns in all directions must be guaranteed. The movements should not be hindered by any secondary elements. An improved building method for the prevention of collapse could, therefore, be to shape the columns in a manner that the plastic hinges, necessary to absorb energy, are formed in the crossbeams.

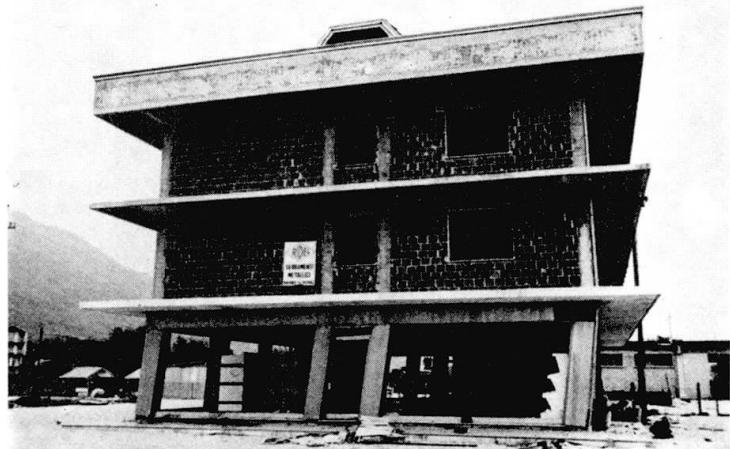
Figure 15:

Open or only slightly stiffened ground floors, mostly for commercial use, are particularly vulnerable. The locally severe destruction in the area of such weak spots caused the collapse of entire buildings or made their demolition necessary, even with otherwise only minor damage, because restoration would have been too difficult (Figure 15).

Three-storey dwelling house with shop in the ground floor near Artegna. Reinforced concrete frame with brick partitioning walls in the upper floors and mostly open ground floor. Plastic hinges at bottom and top of the ground floor reinforced concrete columns caused large deformations. No damage in the upper floors.

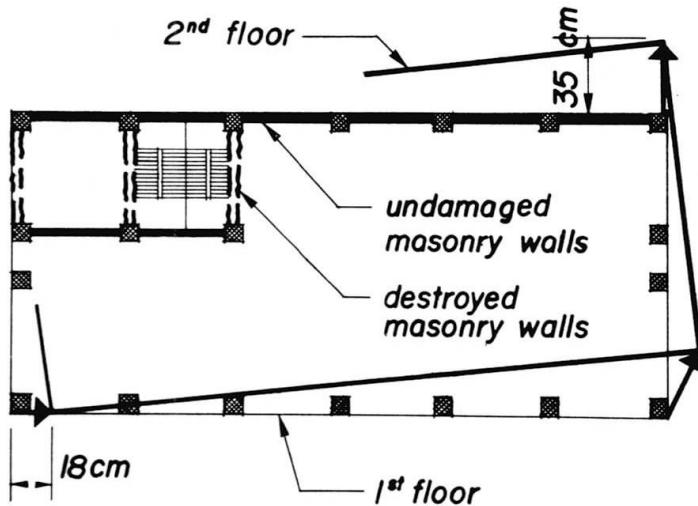
The ground plan of the dwelling house with the open ground floor shown before. Twisting of the building around the staircase stiffened with masonry walls.

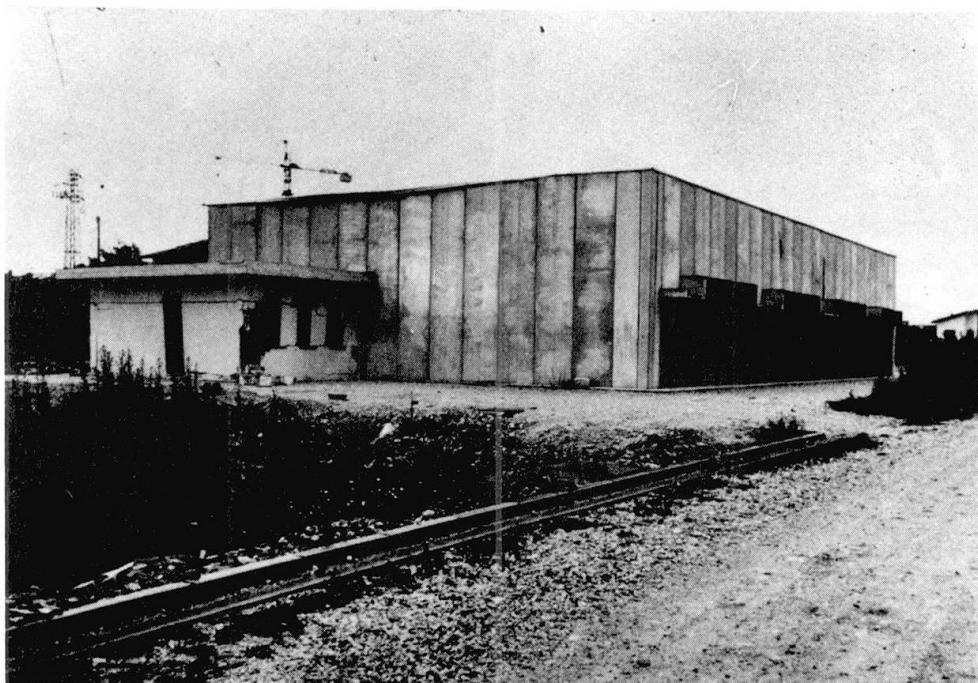
Severe damage could be located in structures composed of building sections with greatly differing rigidity due to diverse types of construction (for instance, reinforced concrete frame and pure brick) or which varied considerably in their design (Figure 16). This damage occurred because the individual deformation of each component was obstructed.

Figure 16: Prefabricated storage shed with brick annex in Gemona. Side wall panels slightly caved in by impact with rigid annex. Upper part of the annex shorn off and pushed over by the impact force due to insufficiently wide joints.

This problem can be overcome by arranging the joints as to divide the structure into sections, each with its own clearly distinct vibration behaviour. The joints should be made adequately wide since numerous uncertainties make an exact calculation impossible. It must be taken into consideration that, for example, the deformation usually provided for in a homogenous supporting structure can turn out to be considerably larger due to the formation of cracks or plastification. An adequate freedom of movement, therefore, allows for greater plastification and a larger capacity to carry earthquake stress.

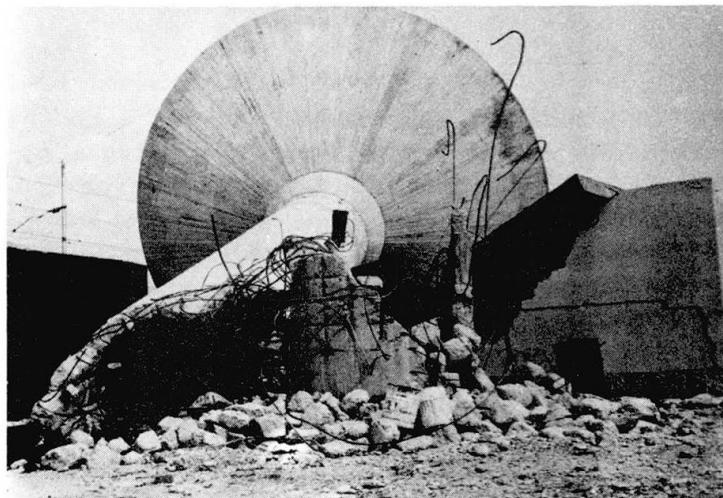
Figure 17: Overturned water tower belonging to the Italian State Railways in Gemona station. Foot of the shaft completely destroyed and concrete shattered.

Special structures (e.g., bridges and water-towers) (Figure 17), because of their unusual form and distribution of mass, necessitate a dynamic analysis which takes the vibration behaviour of the structure and the real properties of an anticipated earthquake into consideration.

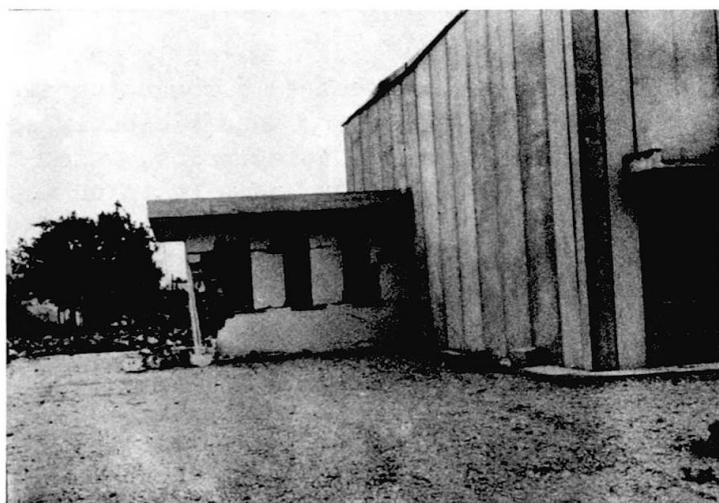
Figure 18: Prefabricated storage shed in Gemona as shown before. The supporting frames and the wall panels generally not damaged because of energy absorption in the material of the joints between the single panels.

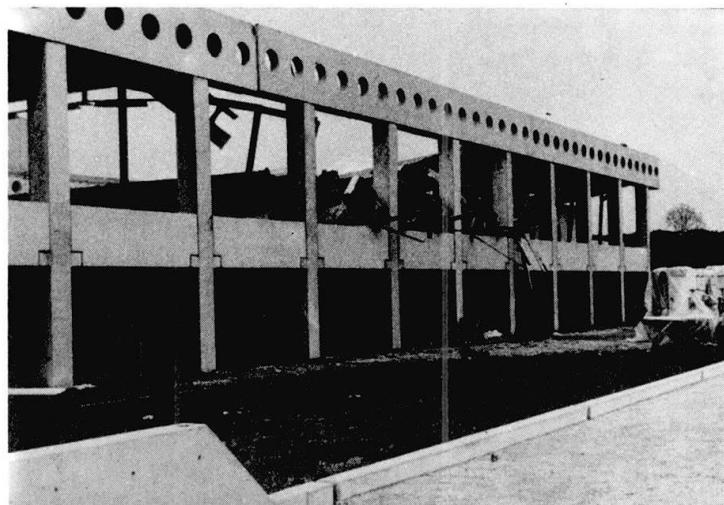
If prefabricated structures are designed only in accordance with the Standards laid down for earthquake forces or these forces are overlooked altogether, then the result is greatly underdimensioned connections of the structure elements. Load bearing connexions should be properly designed against the expected dynamic forces. Purely friction-type joints are no longer sufficient to transfer the forces that arise, even from only weak earthquake loads (Figure 19).

Figure 19: Heavily damaged prefabricated factory shed near Osoppo with roof girders fallen down. Friction joints insufficient to provide structural stability.

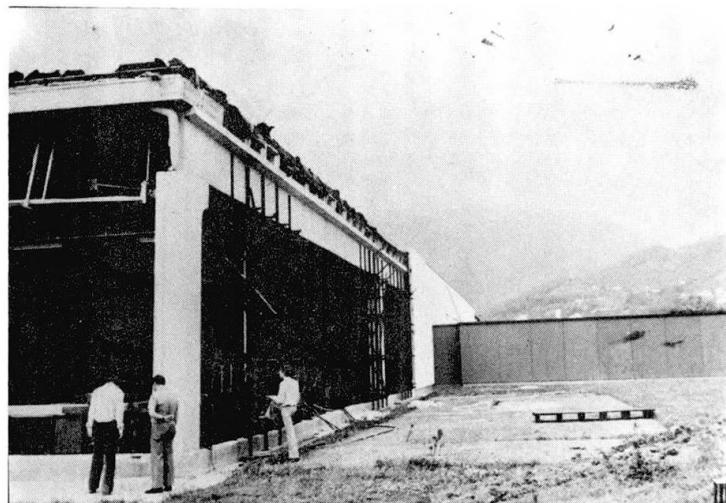
Figure 20: Prefabricated factory shed near Artegna. Wall panels fallen out during the earthquake because of insufficient fixation.
