Artikel: Behaviour of large panel building during the Romania earthquake of March 4, 1977

BEHAVIOUR OF LARGE PANEL BUILDING DURING
THE ROMANIA EARTHQUAKE OF MARCH 4,1977

Miodrag Velkov *

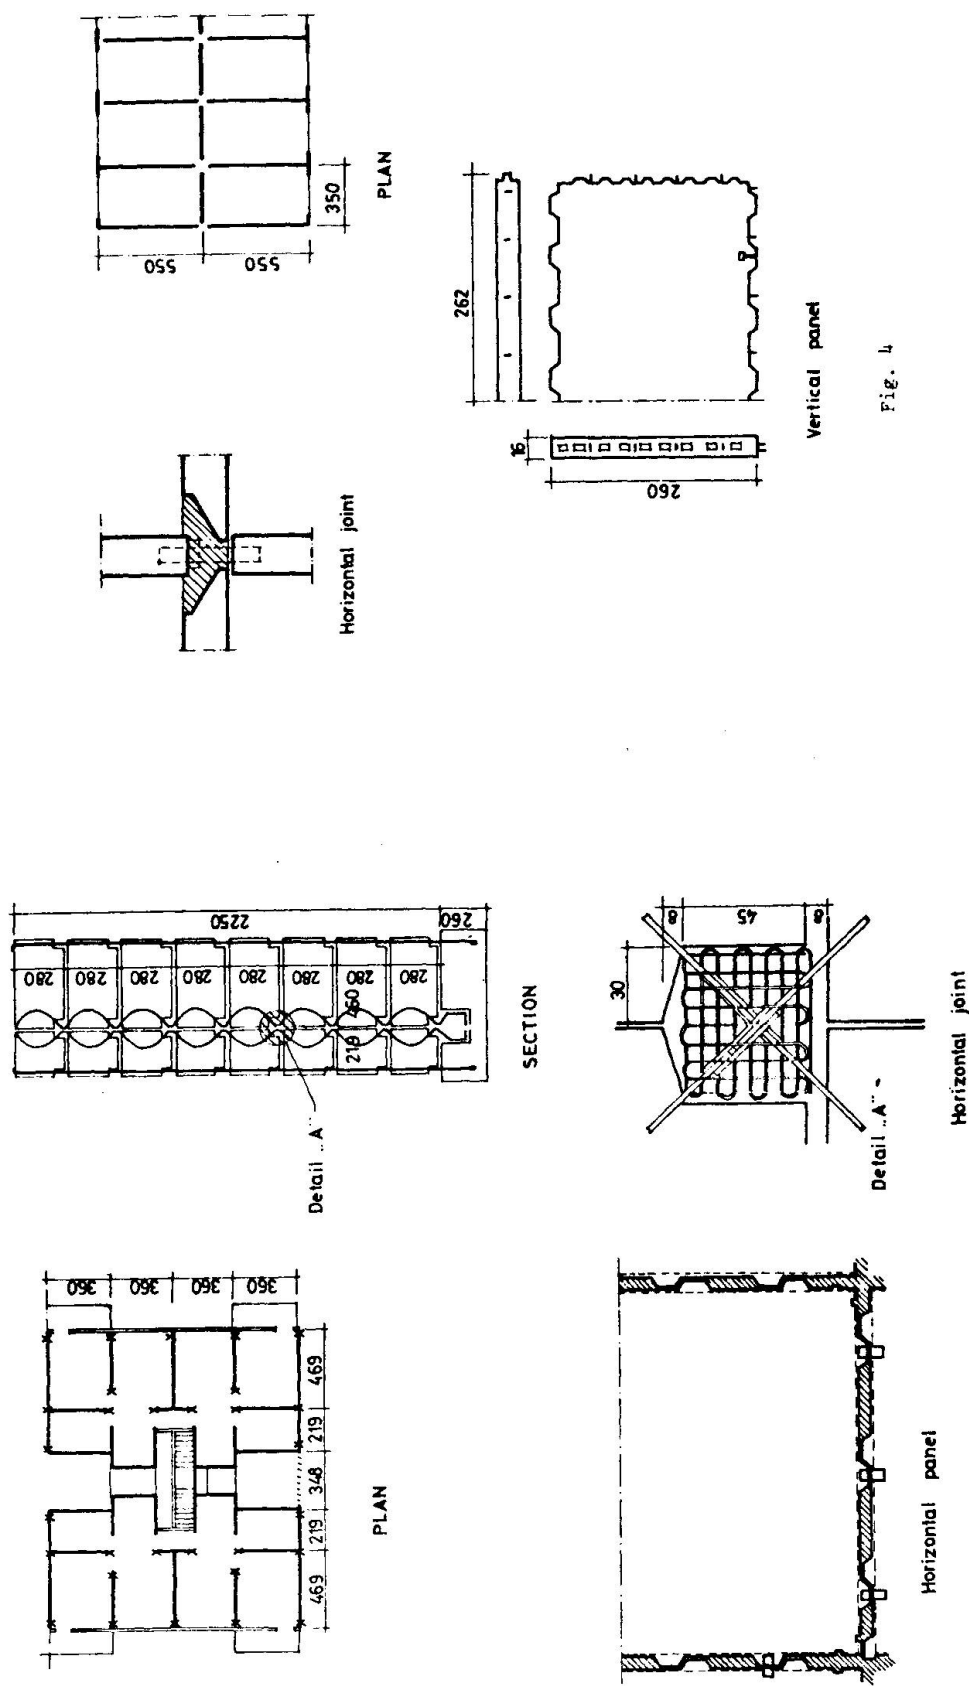
1. Two way system of eight storeys and nonbearing facade panels. These structures have no basement and the prefabricated system is placed on monolith foundations. It was constructed in series some 15 years ago in Bucharest. It is solved with monolythic horizontal and vertical joints, welded reinforcement of vertical panels and monolith slabs above the last precast structure. Fig. 3

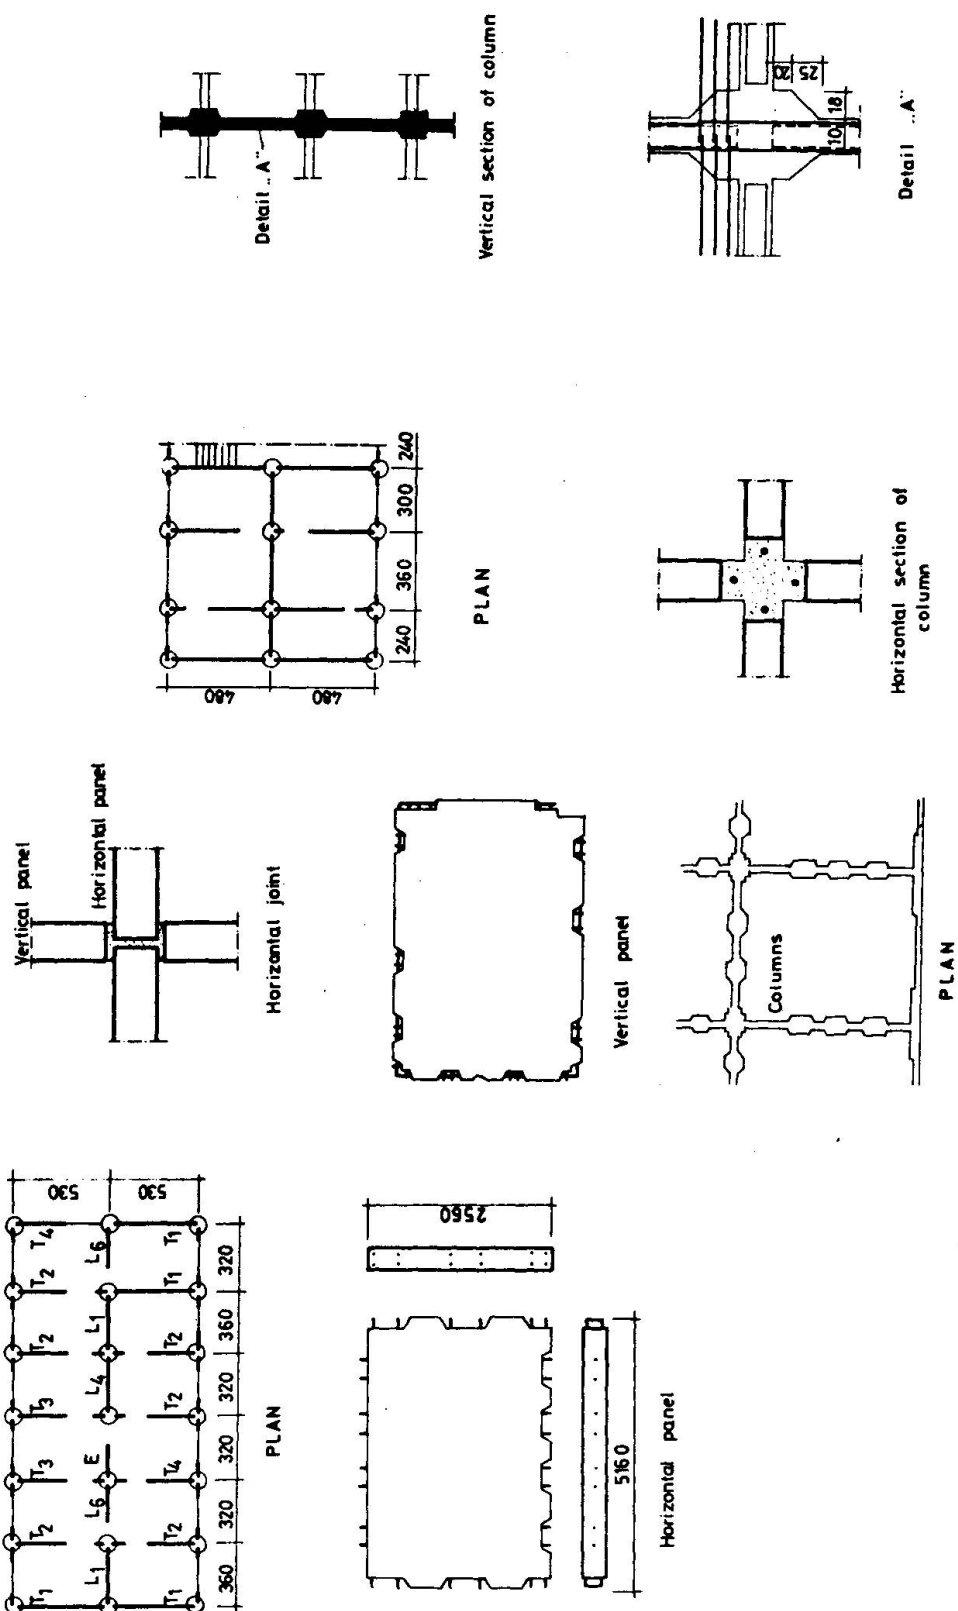
Fig. 6

4. In Ploesti which is closer to the epicentral region, construction of large panel structures is limited to 5 storeys. They always have monolith basement with monolith floor slab above it. The walls are in two-way system. Fig. 6. gives details of the most frequent type of system used. It should be noticed here the enlarged section of the monolythic column in order to increase its shear strength. This system was previously constructed without this enlargement for shears. The base shear coefficient is 15%.

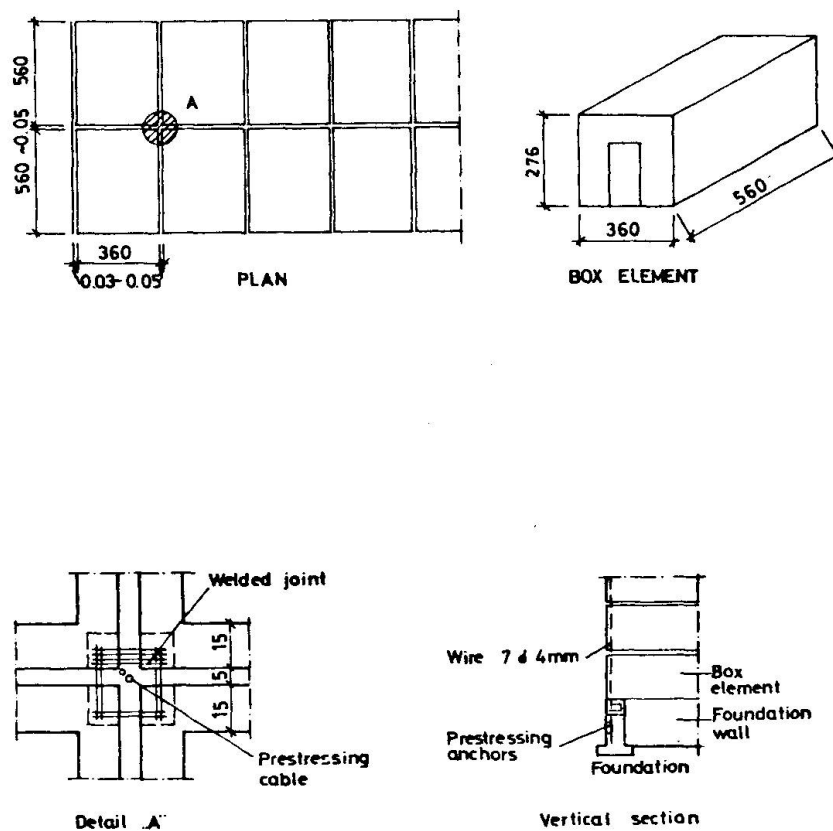
5. In Kraiova a large panel system is both prefabricated and constructed. It is a 5 storey system of box type, i.e. complete room. Each apartment consists of 3,5 boxes monolithically connected in situ along the edges by welding and placed concrete. Each corner is then prestressed by vertical cables of 12 t (wire of $7\phi 4$ mm.) along the height of the building. The prestressed cables are then anchored to the monolithic basement walls which were constructed in situ together with the foundation. Fig. 8
