Artikel: Behaviour of large panel building during the Romania earthquake of March 4, 1977

BEHAVIOUR OF LARGE PANEL BUILDING DURING
THE ROMANIA EARTHQUAKE OF MARCH 4, 1977

Miodrag Velkov *

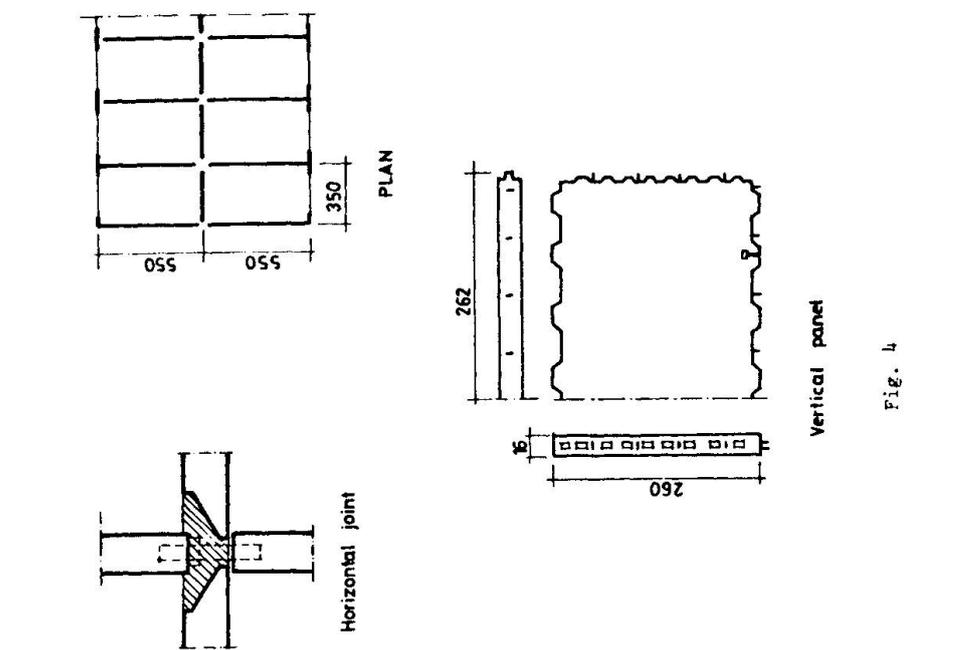
2. Two way system of ten storeys with basement. It is a precast basement structure on monolythic foundations. The system is constructed in series in Bucharest and its use will continue in future, no matter of the recent earthquake event. Fig. 4

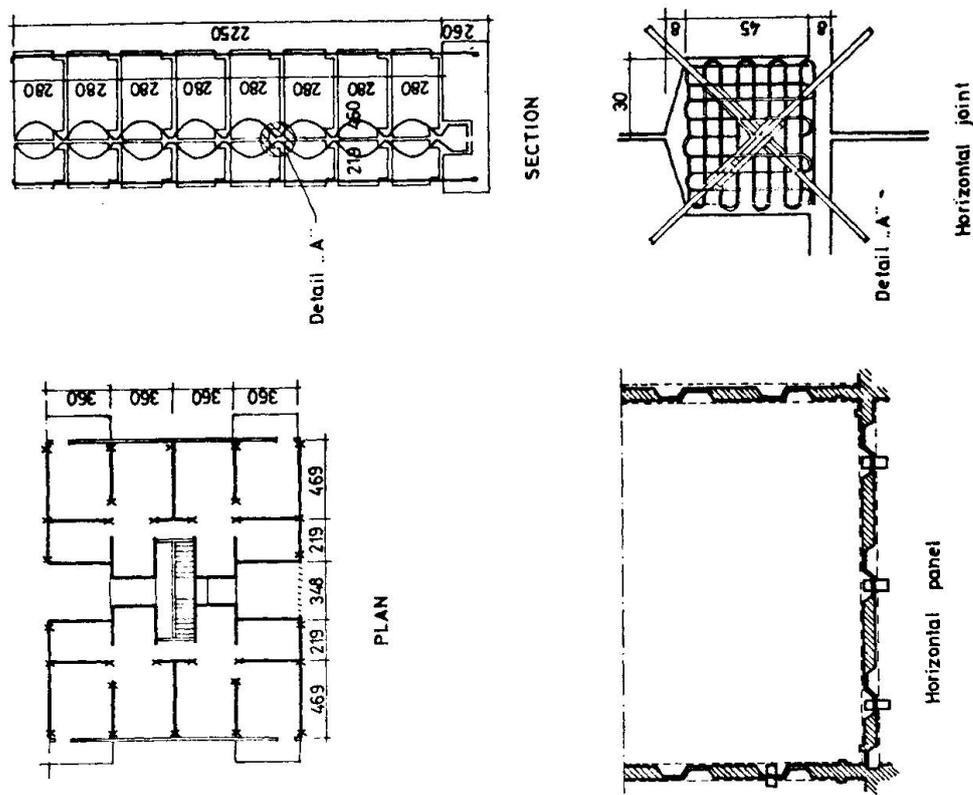
1. Two way system of eight storeys and nonbearing facade panels. These structures have no basement and the prefabricated system is placed on monolyth foundations. It was constructed in series some 15 years ago in Bucharest. It is solved with monolythic horizontal and vertical joints, welded reinforcement of vertical panels and monolyth slabs above the last precast structure. Fig. 3

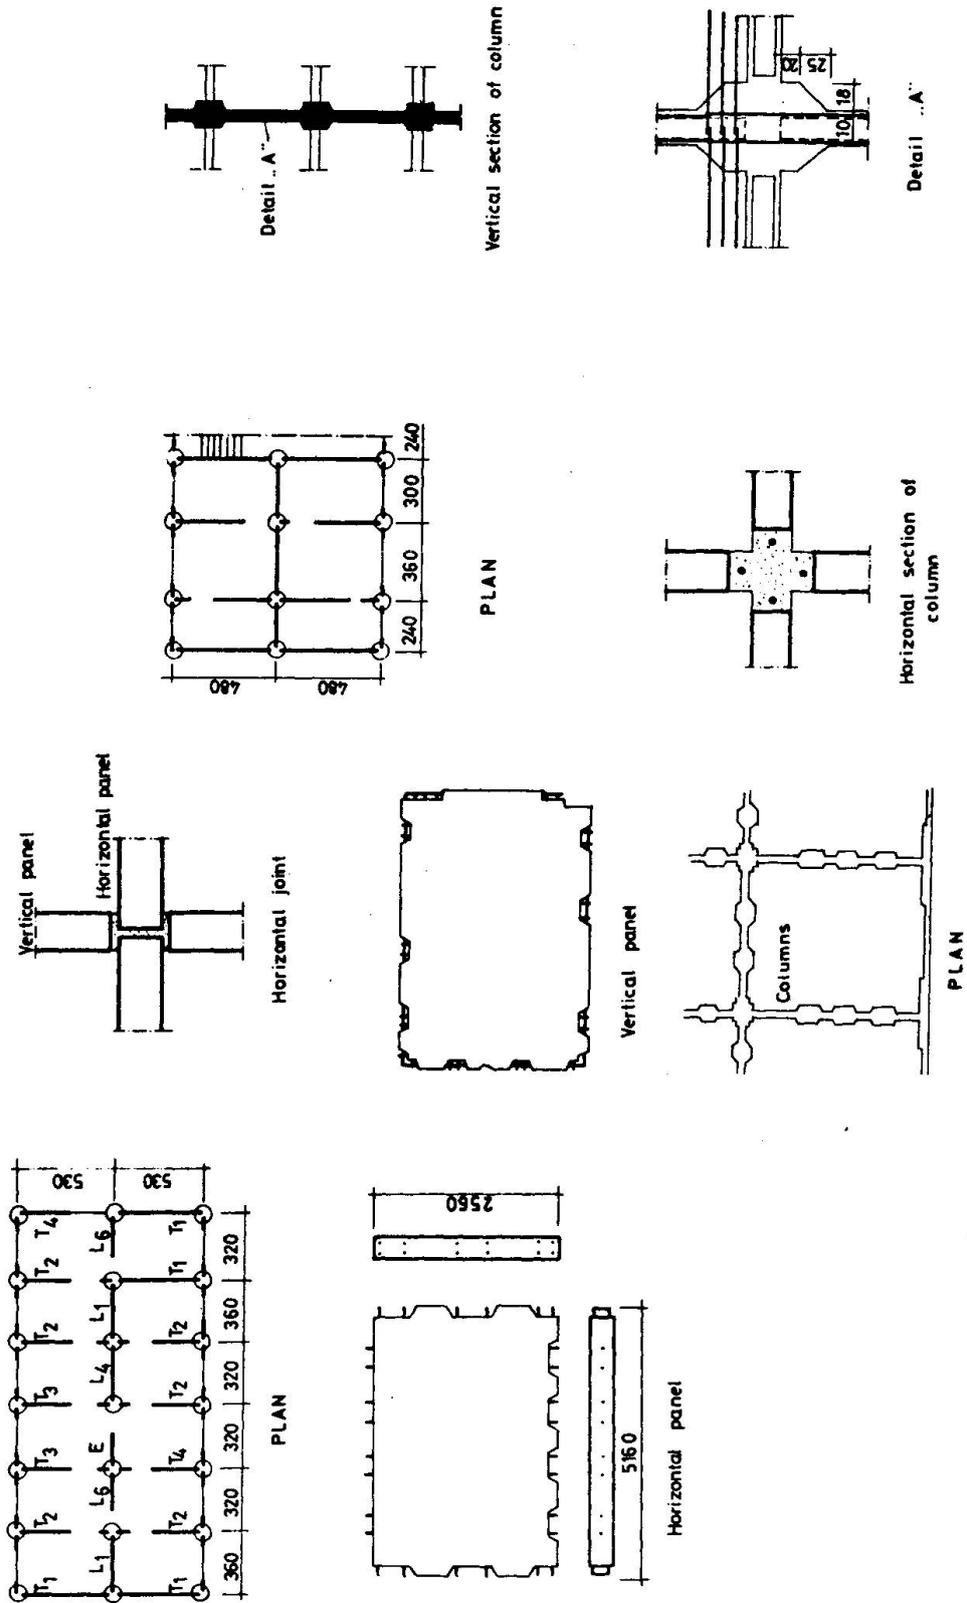
Fig. 6

4. In Ploesti which is closer to the epicentral region, construction of large panel structures is limited to 5 storeys. They always have monolyth basement with monolyth floor slab above it. The walls are in two-way system. Fig. 6. gives details of the most frequent type of system used. It should be noticed here the enlarged section of the monolythic column in order to increase its shear strength. This system was previously constructed without this enlargement for shears. The base shear coefficient is 15%.

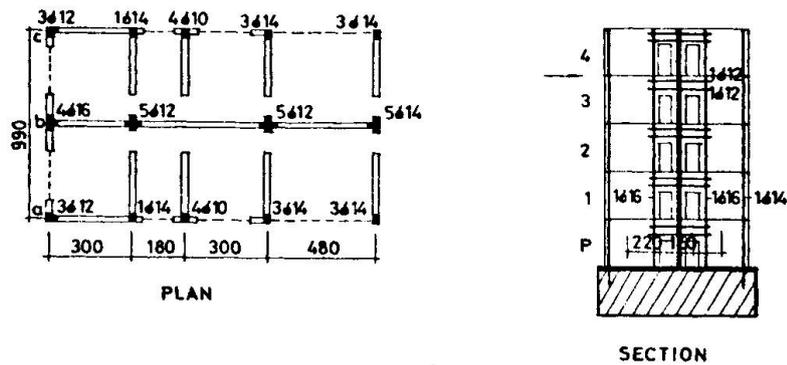
Fig. 7

In Kraiova, buildings with same design, same number of storeys and similar solutions are constructed. The plan of reinforcement distribution is given in Fig. 7. These structures have a shear base coefficient of 10-12% up to the yield point in bending of the reinforcement.

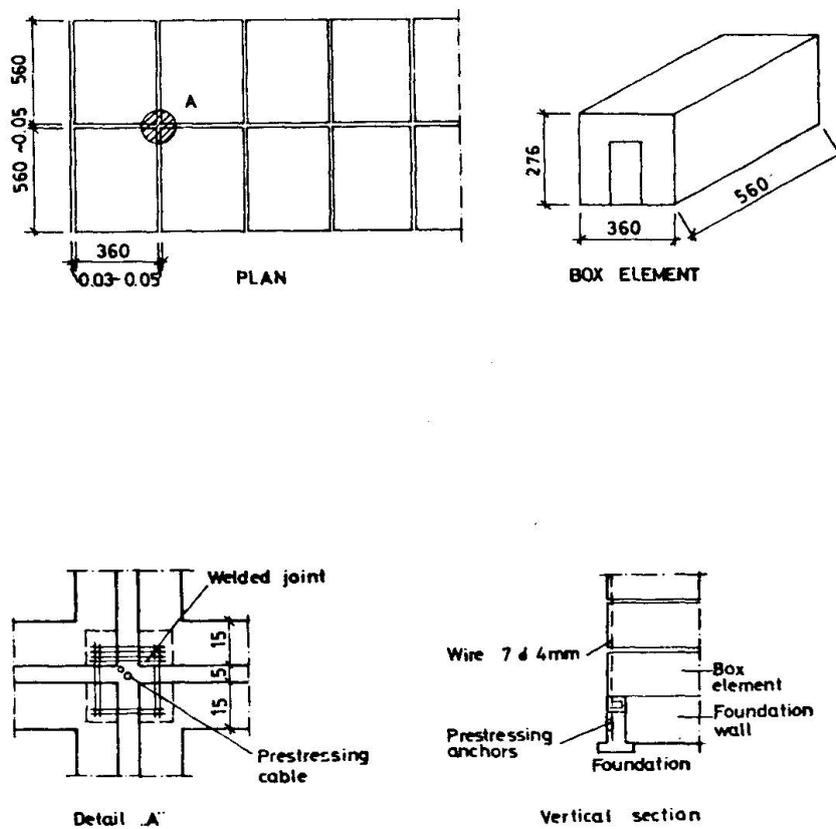
5. In Kraiova a large panel system is both prefabricated and constructed. It is a 5 storey system of box type, i.e. complete room. Each apartment consists of 3,5 boxes monolithically connected in situ along the edges by welding and placed concrete. Each corner is then prestressed by vertical cables of 12 t (wire of $7\phi 4$ mm.) along the height of the building. The prestressed cables are then anchored to the monolithic basement walls which were constructed in situ together with the foundation. Fig. 8
