QUANTITATIVE APPRAISAL OF DESTRUCTIVE EARTHQUAKES

by Dimitri Papastamatiou - Senior Engineer

This presentation is concerned with direct correlations of the field measurements with damage on engineering structures. The first part is a discussion of the set of simple structures that have the characteristics of field indicators. In the second part correlations are indicated between the field measurements and the inflicted damage. All the illustrations were obtained in the epicentral region of the May 6, 1976 Friuli earthquake.

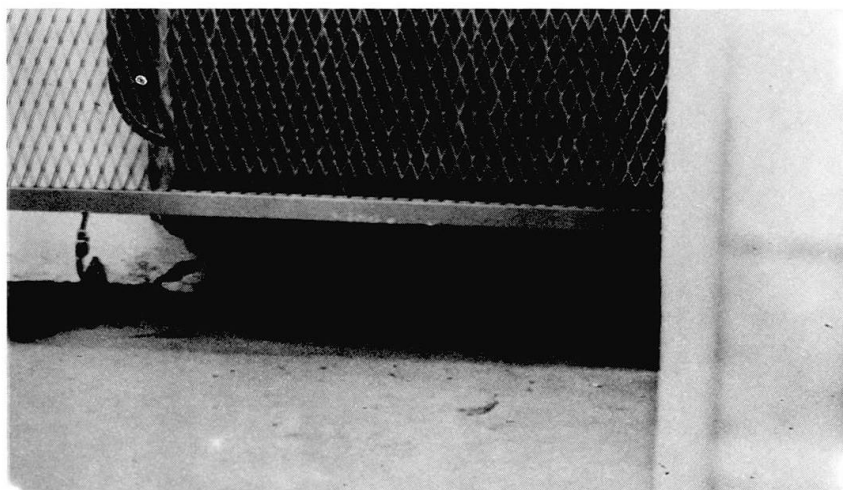
Fig 3. The transformer inside the cabin has moved during the earthquake; one of the back wheels fell into the oil drainage well.

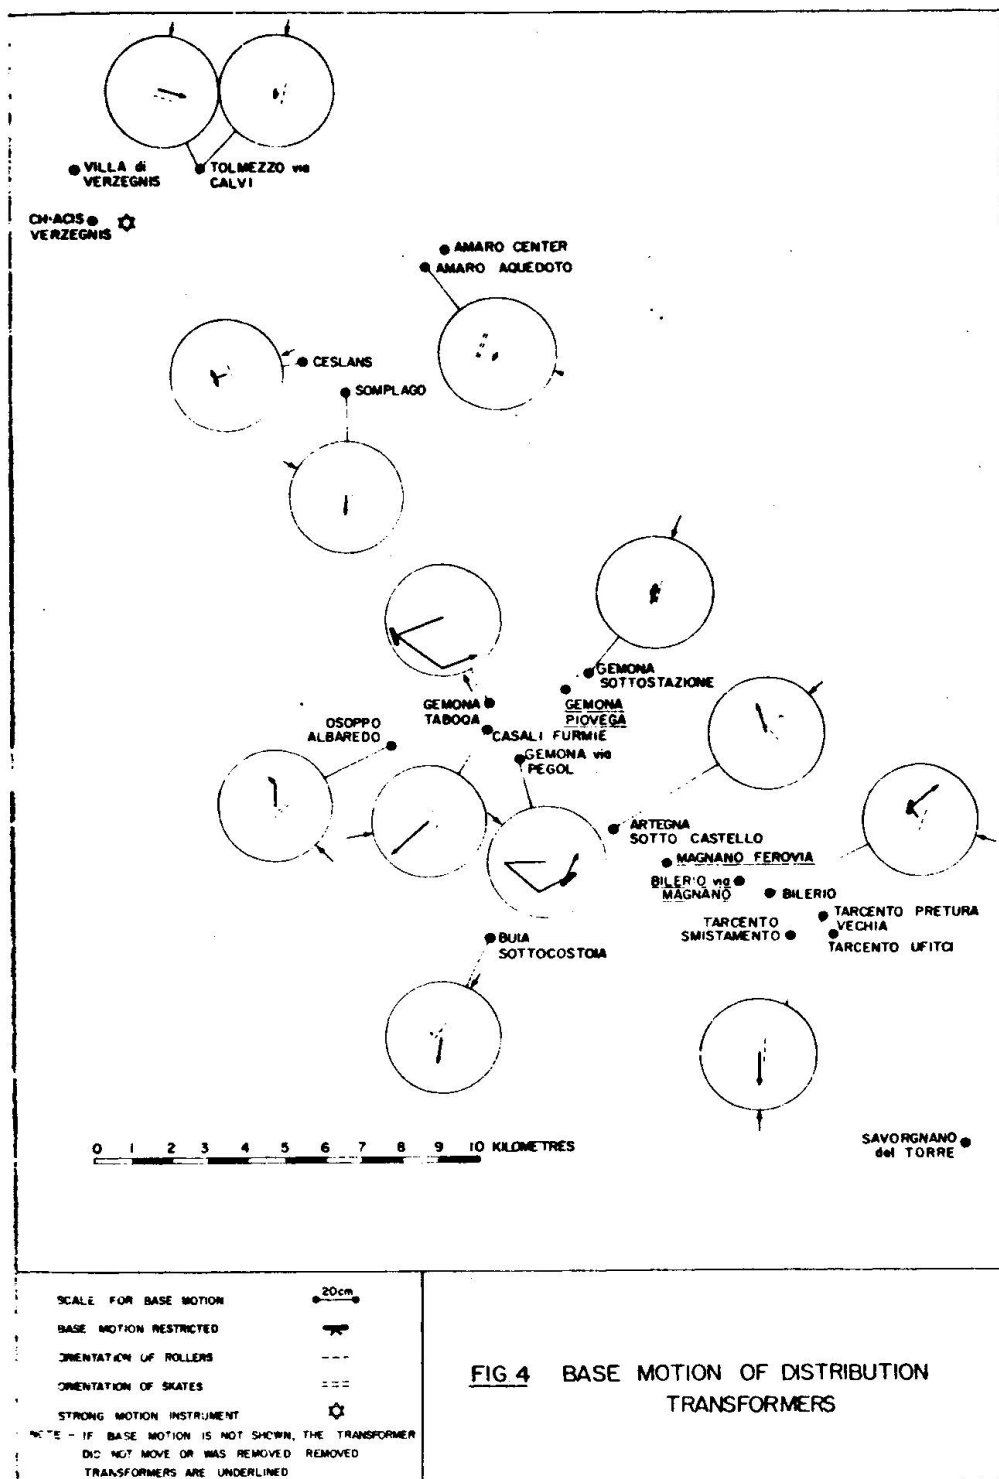
Field measurements in the epicentral area of the May 6, 1976 earthquake were restricted in a zone running NW-SE. The slip vectors of the transformers that were studied in this zone are shown on Fig. 4. The transformers at the NW end of the zone surround the nearest strong motion instrument that recorded the main shock at Diga de l' Ambiesta. The measurements have been described elsewhere (1,2). The transformers, in general, moved in a N-S direction. Exceptions were found on recent alluvium where motion was in both directions. Displacements were also larger on recent alluvium.
