Rubrik: Short communications

BEHAVIOUR OF AN ASEISMIC STRUCTURE DURING CAUCETE EARTHQUAKE OF NOVEMBER 23, 1977

DAMAGE TO BRIDGES DURING THE NORTH CAUCASUS EARTHQUAKES

A FIRST GEOTECHNICAL ASSESSMENT OF THE RECENT PATTI EARTHQUAKE (SICILY)

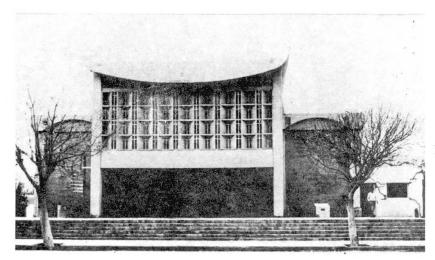
Fig. 1 - Front of the Church

Building examination after the earthquake reveals no damage in the reinforced concrete elements. The front brick walls show limited cracks, while there are no apparent cracks in lateral walls, but inner plaster spalled in wide areas. Some glass breakage in windows occurred (approx. 10 %), and light damages in masonry can be seen at both sides of apse, where roof shell touches the wall.

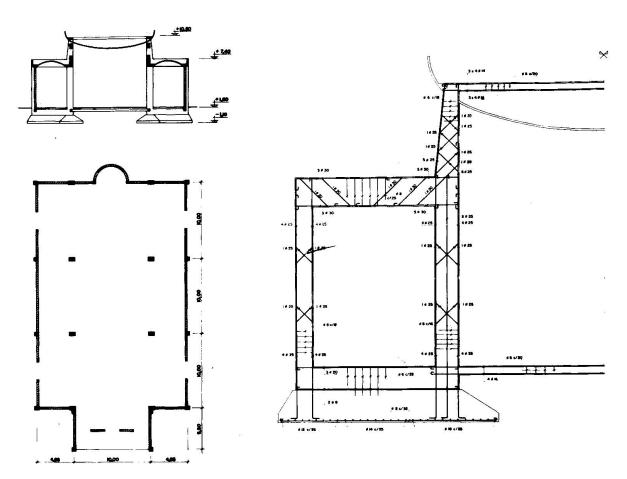
Fig. 5 - Reinforcing of transverse frame

In the original conception of the structure, earthquake-resistant elements in the transverse direction were formed by two simple frames in each line, joined together only by the roof whose stiffness in the plane of frames was negligible. These frames were designed in accordance with the Seismic Regulations in force as of 1958, using a seismic coefficient of 0.15; and an increase of 33 % for allowable stresses. Main columns, 50 cm by 80 cm in cross section, were reinforced with a total area of steel of 1.2 % of concrete area; shear reinforcing in provided by stirrups and bent bars in both directions.

The two columns of each frame have a common footing, designed for a maximum pressure on soil of 1.1 kg/cm2. The large stiffness of this foundation ensures a practically perfect fixed end for both columns. Due to the change of roof design these frames were joined by an element of certain stiffness, formed by the shell plus the top compression beams.

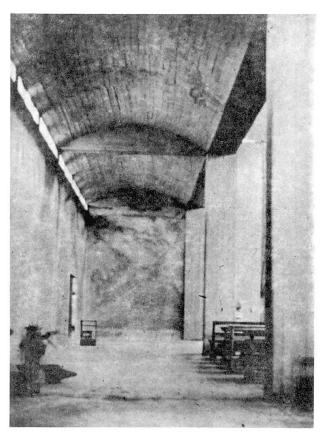
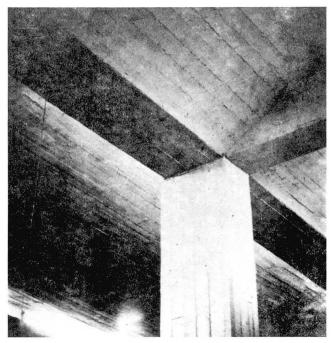
Fig. 7 - Detail of main frame joint

- a. Under horizontal static loads the complete frame behaviour, due to slenderness of top beams, is almost the same as originally foreseen. Highest stresses appear at the foot of the inner columns. In this section reinforcing yield would be reached under horizontal loads which corresponds to a seismic coefficient of 0.33. The structure horizontal displacement, under these horizontal loads, would be 1.5 cm.
 - b. Natural period of structure first mode is 0.43 sec.
- c. Dynamic analysis of the structure, assumed fully elastic and subject to spectrum of pseudoaccelerations of fig. 4, gives the following results:
 - Maximum displacement of highest points is 3.9 cm.
 - Maximum horizontal acceleration of the same point is 0.89 g.
 - Bending moments at joints, of columns and beams, are much larger than ultimate moments of that sections.

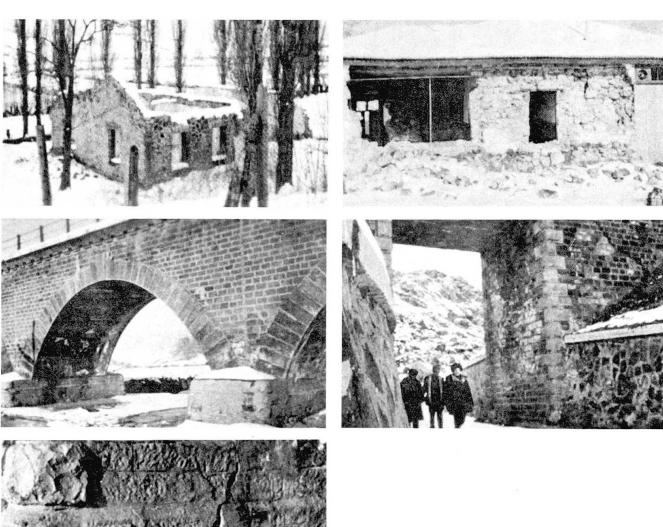
Fig. 1	Fig. 2
Fig. 3	Fig. 4
Fig. 5

The earthquake of 1970 with magnitudo M = 6.6 and focal depth H = 13 Km spreaded over an area of about 600 Km² with intensity 8 (MSK scale). It was accompanied by rockfalls and landslides along river banks and steep mountain slopes. The volume of landslides in some places exceeded 1 million m³, the extent of the breaches reached several hundred meters [1, 2]. Some of the stone buildings in the settlements, located on the epicentral area, were collapsed (fig. 1). The quake of 1975 had intensity 7. It caused heavy damages to rubble buildings (fig. 2).

In 1970 most of girder and arch railway bridges, constructed in 1914 (fig. 3), suffered moderate damages such as deep cracks in wing walls of abutments (fig. 4), ice-breakers (fig. 5), bridge seats and concrete arches. Among massive structures the least damages were received by simple-span bridges with reinforced concrete slab superstructures, anchored in the abutment masonry.

As a rule the damages of stone and concrete bridges in 1970 didn't create dangerous conditions for service of the structures. The quake of 1975 caused the development of the initial cracks and considerable decrease of the bearing capacity of these structures. In some cases stone and concrete bridges needed reinforcing.
