Zeitschrift: IABSE reports of the working commissions = Rapports des commissions de travail AIPC = IVBH Berichte der Arbeitskommissionen

BEHAVIOUR OF AN ASEISMIC STRUCTURE
DURING CAUCETE EARTHQUAKE
OF NOVEMBER 23, 1977

DAMAGE TO BRIDGES DURING THE NORTH CAUCASUS EARTHQUAKES

A FIRST GEOTECHNICAL ASSESSMENT OF THE RECENT PATTI EARTHQUAKE
(SICILY)

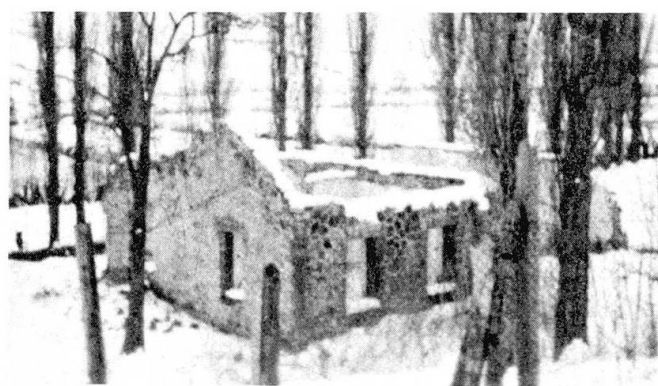
| Fig. 1 | Fig. 2 |

The earthquake of 1970 with magnitude $M = 6.6$ and focal depth $H = 13$ Km spreaded over an area of about 600 Km^2 with intensity 8 (MSK scale). It was accompanied by rockfalls and landslides along river banks and steep mountain slopes. The volume of landslides in some places exceeded 1 million m^3 , the extent of the breaches reached several hundred meters [1, 2]. Some of the stone buildings in the settlements, located on the epicentral area, were collapsed (fig. 1). The quake of 1975 had intensity 7. It caused heavy damages to rubble buildings (fig. 2).

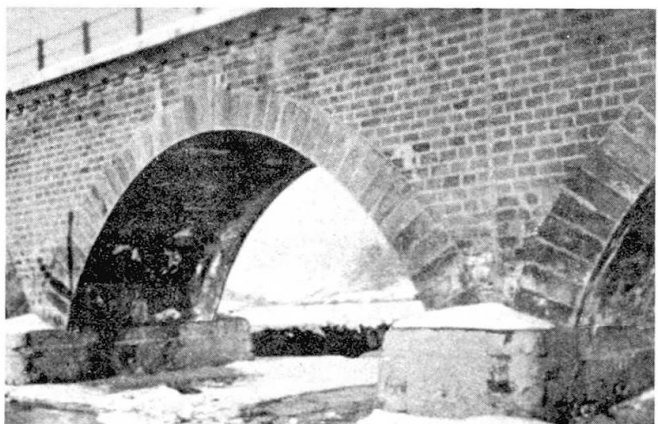
| Fig. 3 | Fig. 4 |

In 1970 most of girder and arch railway bridges, constructed in 1914 (fig. 3), suffered moderate damages such as deep cracks in wing walls of abutments (fig. 4), ice-breakers (fig. 5), bridge seats and concrete arches. Among massive structures the least damages were received by simple-span bridges with reinforced concrete slab superstructures, anchored in the abutment masonry.

As a rule the damages of stone and concrete bridges in 1970 didn't create dangerous conditions for service of the structures. The quake of 1975 caused the development of the initial cracks and considerable decrease of the bearing capacity of these structures. In some cases stone and concrete bridges needed reinforcing.

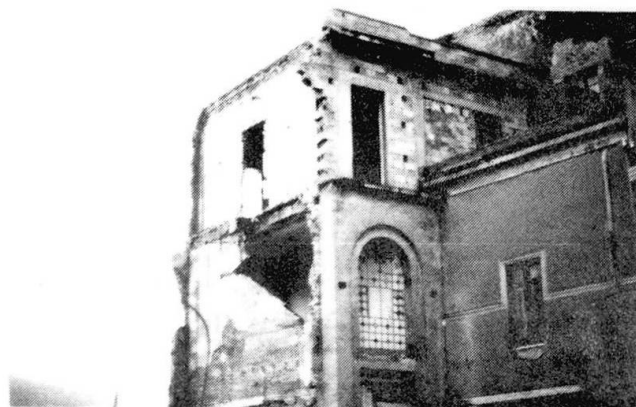
The worst damaged houses in Patti were those founded on sandstone, built of masonry and rarely cemented, in the old centre of the town.

On that site the sandstone formation assumes a hill configuration, which could produce an amplification on maximum ground acceleration (Maugeri, 1976), which can explain, together with the poor construction quality, the severe destruction of some houses.

In fig. 6 the damage suffered by one wing of Patti Cathedral is visible and in fig. 7, the damage at the corner of the main nave is evident.

Fig. 6: Patti Cathedral: the left wing.

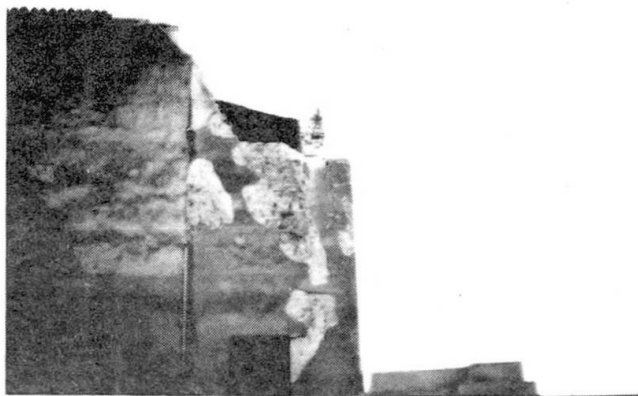
Fig. 7: Patti Cathedral: the corner of the main nave.

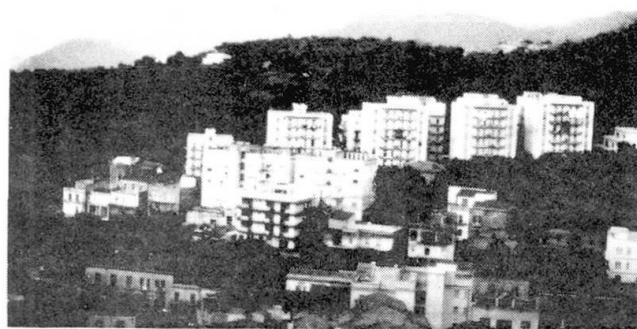
The new concrete buildings in Patti, shown in fig. 8, are built on fissured clay and were apparently damaged on the buffer walls only, mainly at the lower levels.

Fig. 8: Concrete buildings at Patti virtually undamaged.

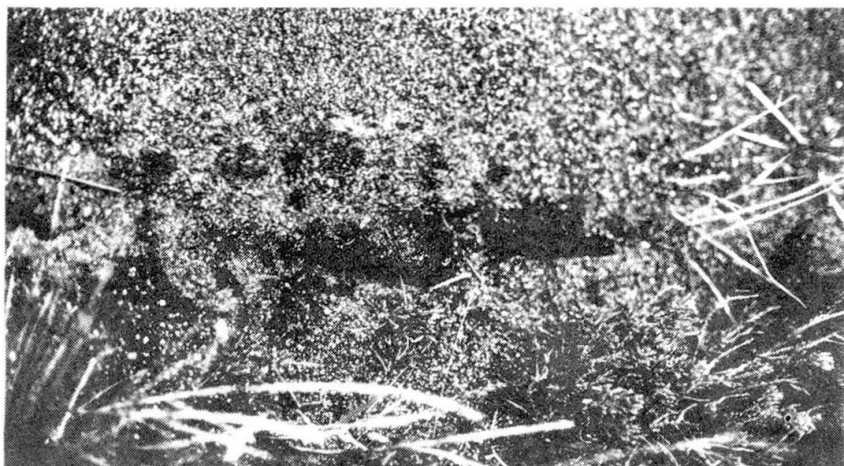
Liquefaction phenomena noted in the marshy area to the left of the town in the gulf of Olivieri could not be confirmed because their traces were quickly cancelled by human activity (fig.9). In any case limited liquefaction would be favoured by a water level near to the surface and by the regular and constant grain size of the sand of the site, and this phenomena cannot be generalised to the alluvium site.

Fig. 9: Dubious traces of liquefaction.

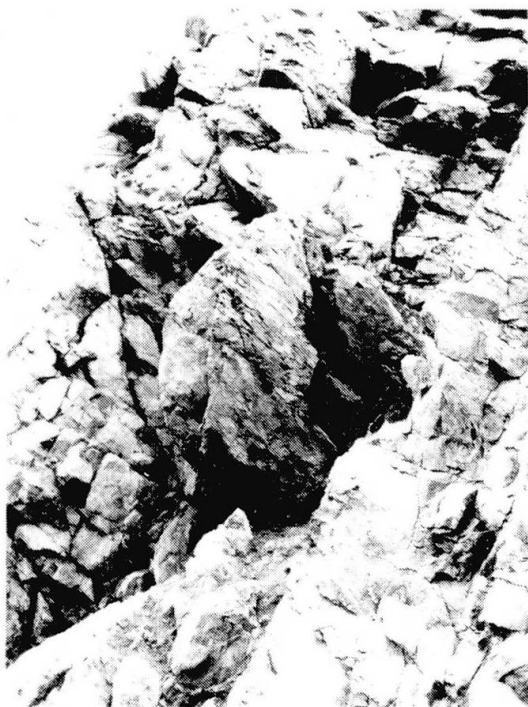
A landslide, consisting in a rock mass failure, was observed at Capo Calavà, whose location is on the left of the Patti gulf. The slope was high and formed of very jointed and altered rock, which has been consolidated in the past by spritz beton and anchorages.

Because of the earthquakes the rock failure was accelerated and a series of blocks, from 10 to 60 cm in diameter fell down into the road. As is clear from fig. 10 the entire cliff is at present in a dangerous limit equilibrium.

Fig. 10: Rock fall at Capo Calavà.
