Zeitschrift:	IABSE reports of the working commissions = Rapports des commissions de travail AIPC = IVBH Berichte der Arbeitskommissionen
Band:	30 (1978)
Rubrik:	Short communications

B E H A V I O U R O F A N A S E I S M I C S T R U C T U R E
D U R I N G C A U C E T E E A R T H Q U A K E
O F N O V E M B E R 2 3, 1 9 7 7

DAMAGE TO BRIDGES DURING THE NORTH CAUCASUS EARTHQUAKES

A FIRST GEOTECHNICAL ASSESSMENT OF THE RECENT PATTI EARTHQUAKE
(SICILY)

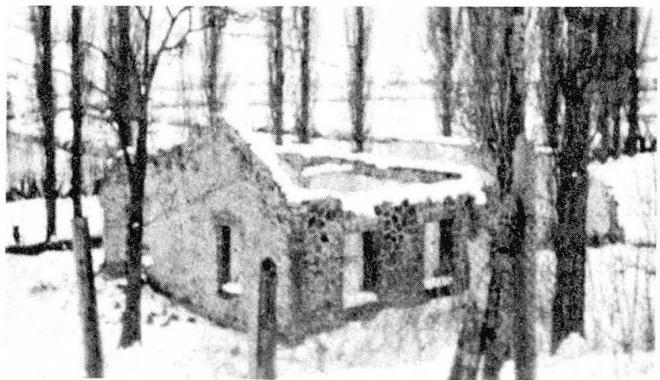
The earthquake of 1970 with magnitudo $M = 6.6$ and focal depth $H = 13$ Km spreaded over an area of about 600 Km 2 with intensity 8 (MSK scale). It was accompanied by rockfalls and landslides along river banks and steep mountain slopes. The volume of landslides in some places exceeded 1 million m 3 , the extent of the breaches reached several hundred meters [1, 2]. Some of the stone buildings in the settlements, located on the epicentral area, were collapsed (fig. 1). The quake of 1975 had intensity 7. It caused heavy damages to rubble buildings (fig. 2).

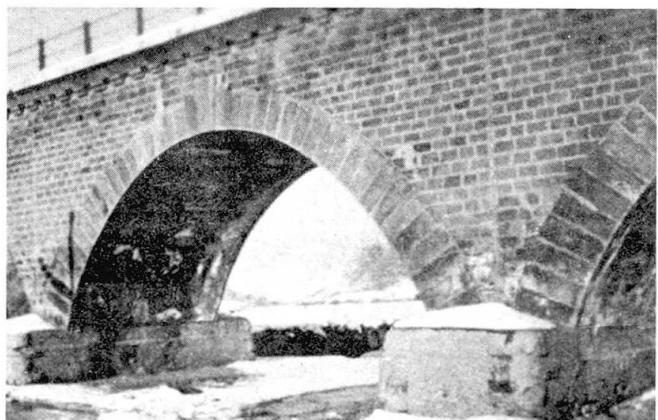
In 1970 most of girder and arch railway bridges, constructed in 1914 (fig. 3), suffered moderate damages such as deep cracks in wing walls of abutments (fig. 4), ice-breakers (fig. 5), bridge seats and concrete arches. Among massive structures the least damages were received by simple-span bridges with reinforced concrete slab superstructures, anchored in the abutment masonry.

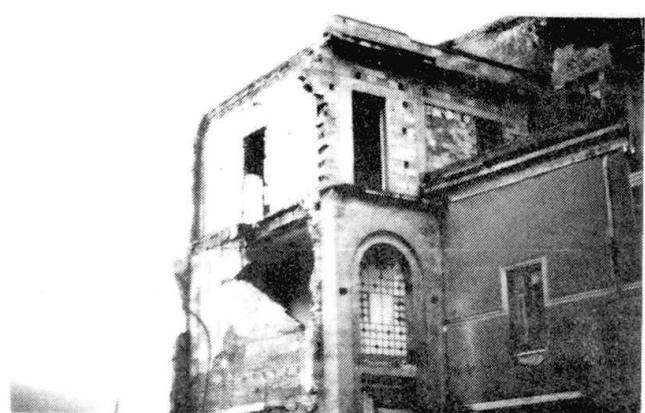
Fig. 6: Patti Cathedral: the left wing.

The worst damaged houses in Patti were those founded on sandstone, built of masonry and rarely cemented, in the old centre of the town.

On that site the sandstone formation assumes a hill configuration, which could produce an amplification on maximum ground acceleration (Maugeri, 1976), which can explain, together with the poor construction quality, the severe destruction of some houses.

In fig. 6 the damage suffered by one wing of Patti Cathedral is visible and in fig. 7, the damage at the corner of the main nave is evident.

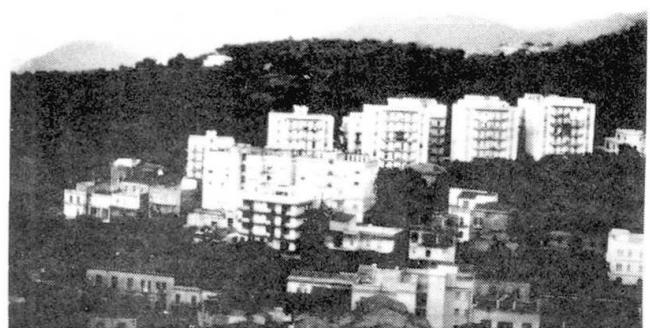
The new concrete buildings in Patti, shown in fig. 8, are built on fissured clay and were apparently damaged on the buffer walls only, mainly at the lower levels.

Fig. 8: Concrete buildings at Patti virtually undamaged.

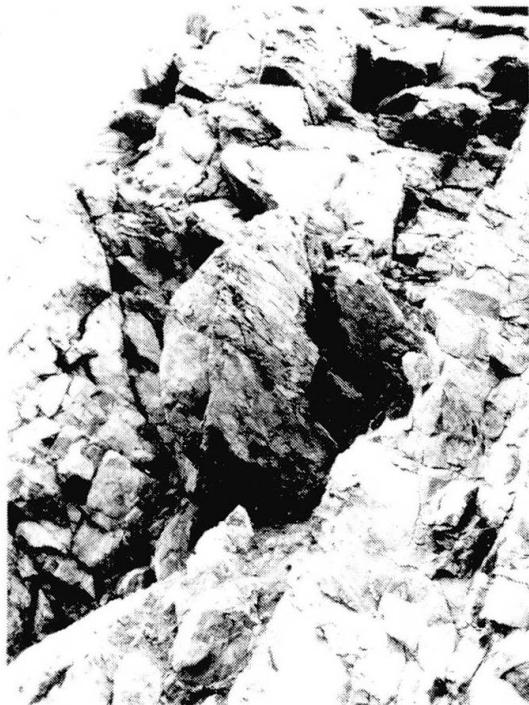
A landslide, consisting in a rock mass failure, was observed at Capo Calavà, whose location is on the left of the Patti gulf. The slope was high and formed of very jointed and altered rock, which has been consolidated in the past by spritz beton and anchorages.

Because of the earthquakes the rock failure was accelerated and a series of blocks, from 10 to 60 cm in diameter fell down into the road. As is clear from fig. 10 the entire cliff is at present in a dangerous limit equilibrium.

Fig. 10: Rock fall at Capo Calavà.
