B E H A V I O U R O F A N A S E I S M I C S T R U C T U R E
D U R I N G C A U C E T E E A R T H Q U A K E
O F N O V E M B E R 2 3, 1 9 7 7

SILVESTRO BRUSCHI

TECHINT Engineering Company

S U M M A R Y

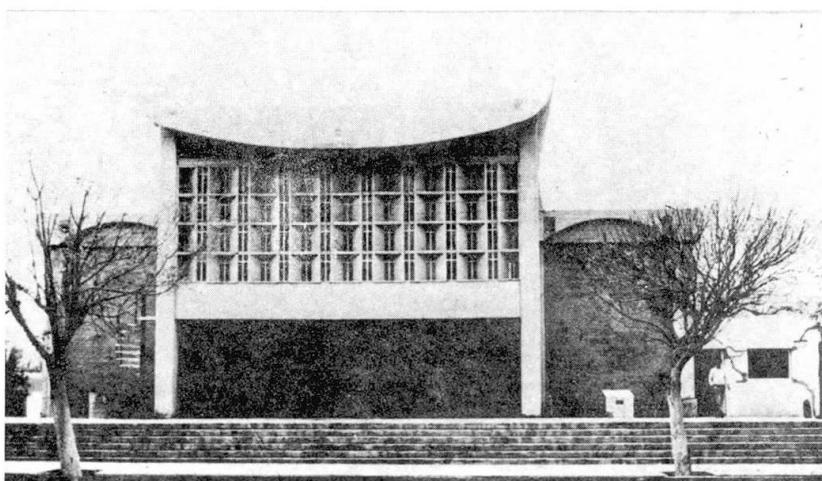
Fig. 1 - Front of the Church

Building examination after the earthquake reveals no damage in the reinforced concrete elements. The front brick walls show limited cracks, while there are no apparent cracks in lateral walls, but inner plaster spalled in wide areas. Some glass breakage in windows occurred (approx. 10 %), and light damages in masonry can be seen at both sides of apse, where roof shell touches the wall.

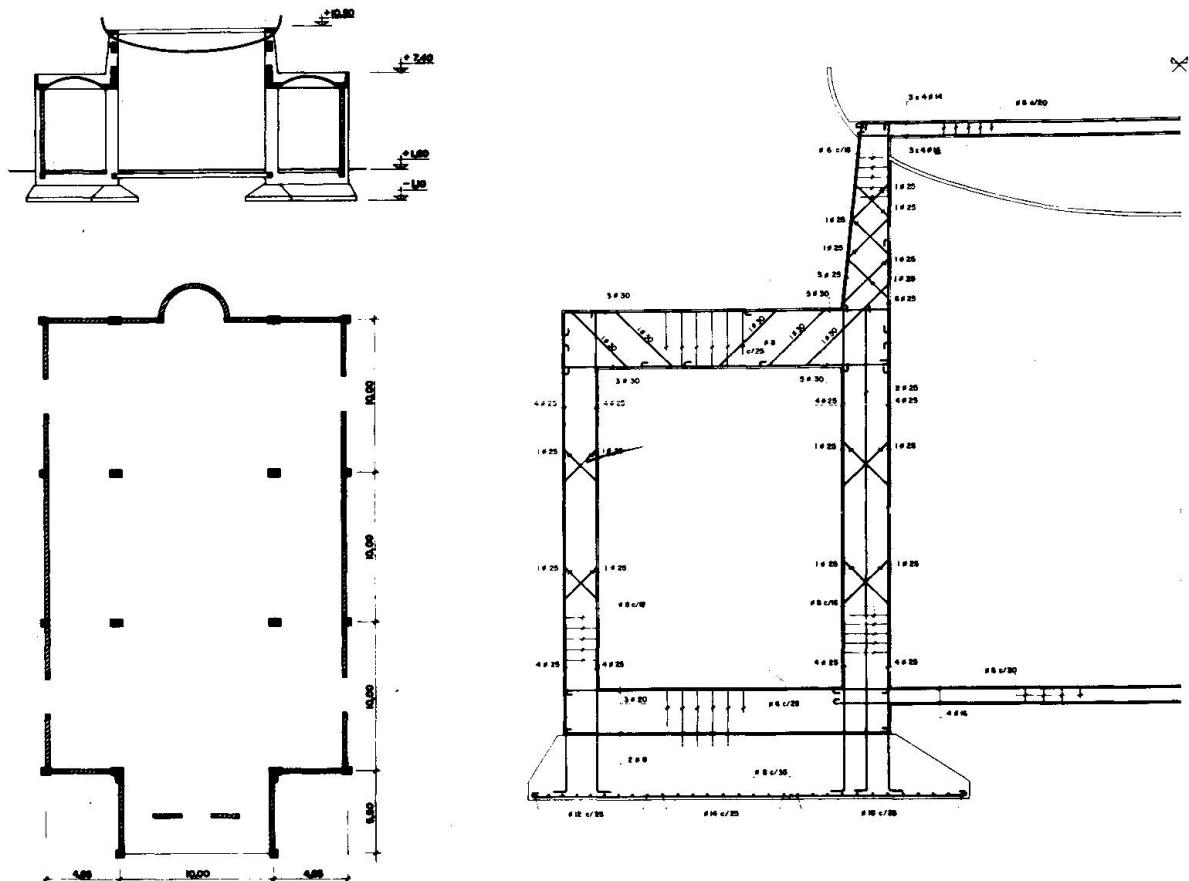
Fig. 5 - Reinforcing of transverse frame

In the original conception of the structure, earthquake-resistant elements in the transverse direction were formed by two simple frames in each line, joined together only by the roof whose stiffness in the plane of frames was negligible. These frames were designed in accordance with the Seismic Regulations in force as of 1958, using a seismic coefficient of 0.15; and an increase of 33 % for allowable stresses. Main columns, 50 cm by 80 cm in cross section, were reinforced with a total area of steel of 1.2 % of concrete area; shear reinforcing is provided by stirrups and bent bars in both directions.

Yield stress of steel is 2200 kg/cm²; concrete has a characteristic ultimate stress of 222 kg/cm², deduced from sclerometer measurements after the earthquake.

The two columns of each frame have a common footing, designed for a maximum pressure on soil of 1.1 kg/cm². The large stiffness of this foundation ensures a practically perfect fixed end for both columns. Due to the change of roof design these frames were joined by an element of certain stiffness, formed by the shell plus the top compression beams.
