BEHAVIOUR OF AN ASEISMIC STRUCTURE
DURING CAUCETE EARTHQUAKE
OF NOVEMBER 23, 1977

SILVESTRO BRUSCHI

TECHINT Engineering Company

S U M M A R Y

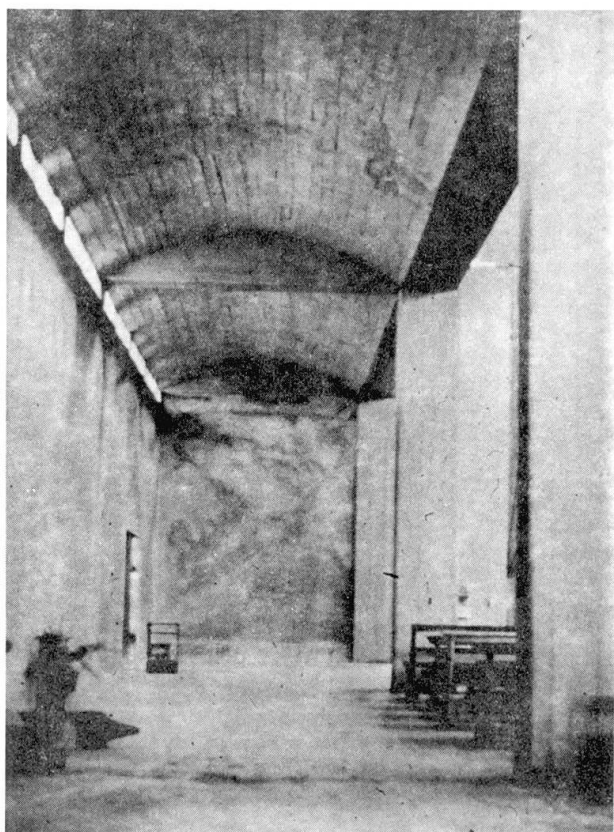
Fig. 5 - Reinforcing of transverse frame

a. Under horizontal static loads the complete frame behaviour, due to slenderness of top beams, is almost the same as originally foreseen. Highest stresses appear at the foot of the inner columns. In this section reinforcing yield would be reached under horizontal loads which corresponds to a seismic coefficient of 0.33. The structure horizontal displacement, under these horizontal loads, would be 1.5 cm.
