**Artikel:** Behaviour of an aseismic structure during Caucete earthquake of

November 23, 1977

Autor: Bruschi, Silvestro

# BEHAVIOUR OF AN ASEISMIC STRUCTURE DURING CAUCETE EARTHQUAKE OF NOVEMBER 23, 1977

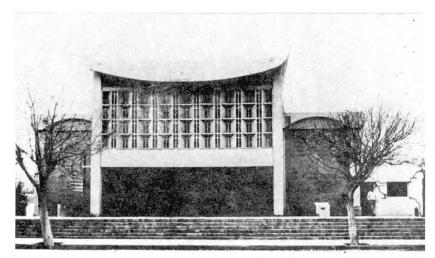
Fig. 1 - Front of the Church

Building examination after the earthquake reveals no damage in the reinforced concrete elements. The front brick walls show limited cracks, while there are no apparent cracks in lateral walls, but inner plaster spalled in wide areas. Some glass breakage in windows occurred (approx. 10 %), and light damages in masonry can be seen at both sides of apse, where roof shell touches the wall.

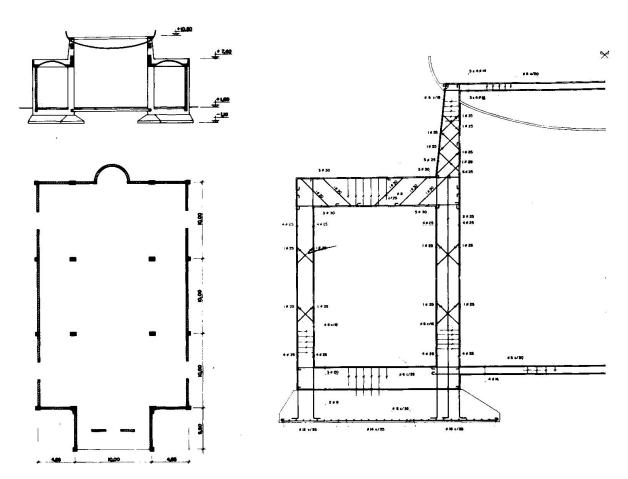
Fig. 5 - Reinforcing of transverse frame

- a. Under horizontal static loads the complete frame behaviour, due to slenderness of top beams, is almost the same as originally foreseen. Highest stresses appear at the foot of the inner columns. In this section reinforcing yield would be reached under horizontal loads which corresponds to a seismic coefficient of 0.33. The structure horizontal displacement, under these horizontal loads, would be 1.5 cm.
  - b. Natural period of structure first mode is 0.43 sec.
- c. Dynamic analysis of the structure, assumed fully elastic and subject to spectrum of pseudoaccelerations of fig. 4, gives the following results:
  - Maximum displacement of highest points is 3.9 cm.
  - Maximum horizontal acceleration of the same point is 0.89 g.
  - Bending moments at joints, of columns and beams, are much larger than ultimate moments of that sections.
