Rubrik: Session III: Construction, performance, renewal

SESSION III

Construction, Performance, Renewal

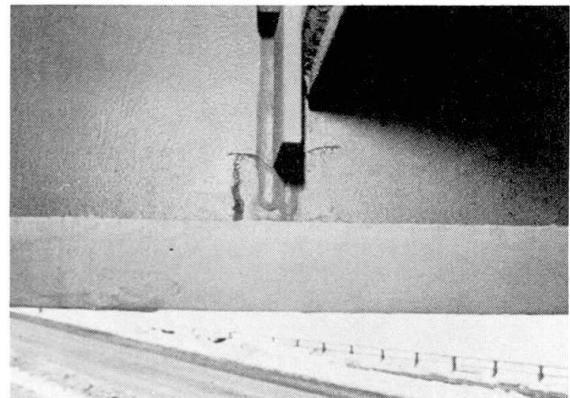
The first group of problems to turn up on our railway on welded structures were cracks at the bottom of stiffeners on skewed structures. Figure 4 is typical of this detail with a diaphragm or brace frame attached to the stiffener. Note that the stiffeners are not extended to the bottom flange. This was in blind obedience to the dictum of an early researcher in welded construction that one should not weld to the tension flange. Because of the stresses introduced by the differential deflections of the connected girders, and to small out-of-plane movements, the first cracks appeared in less than 5 years on heavily travelled lines.

Fig. 4 "U" shape crack

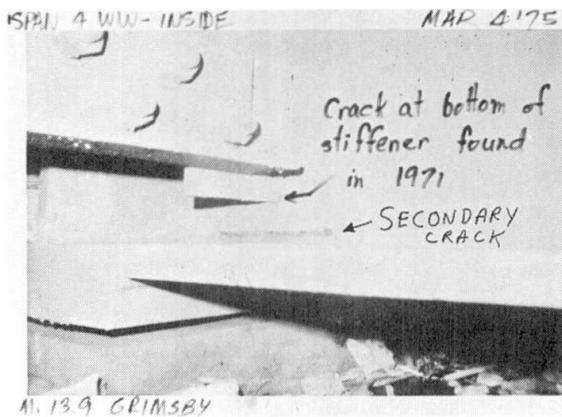
After cracks have occurred as described above, the next point of rigidity is between the web and flange. If there is any out-of-the plane of the girder motion, it is only a matter of time before cracks will occur in the web to flange weld below the stiffener (Figure 5). Stopping these cracks is very important.

Fig. 5 Secondary Cracking

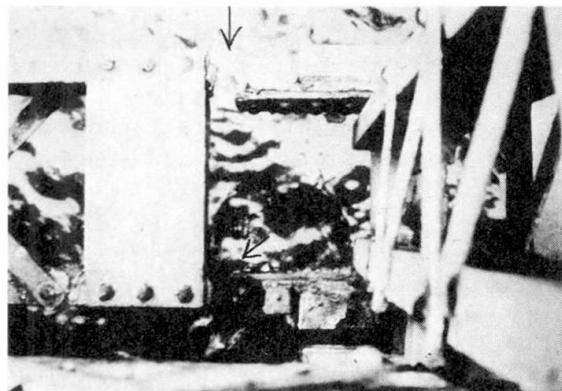
Fig. 14 Chord Severed

Most trusses are multi-load path structures. The truss in Figure 14 had its bottom chord completely severed and yet remained standing because of the alternate load paths provided by the bracing, floor system, etc. The truss shown in Figure 15, which did not have adequate bracing, did not remain standing when one of its diagonals was severed by a shifting load. It is unfortunate that it didn't have sufficient redundancy.

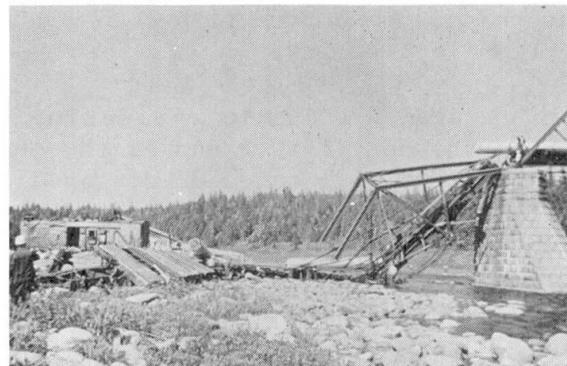
Fig. 15 Insufficient Redundancy

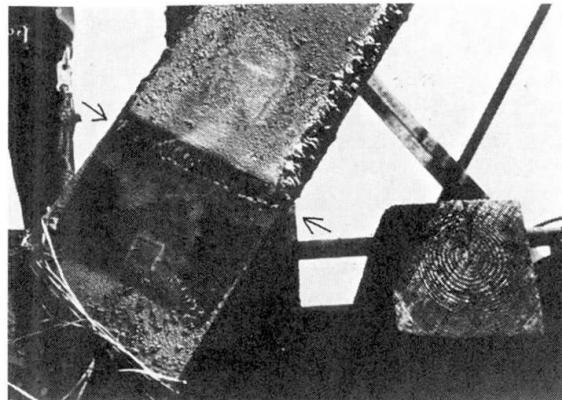
The type of repair shown in Figure 18, the addition of welded plates to an eye bar member could be a disaster in a non-redundant load path structure. The crack is illustrated by the light line of magnaflux at the toe of the weld. In this bridge, because of its multiple load paths, collapse will not occur if one of these members cracks through.

Fig. 18 Eye Bar Weld

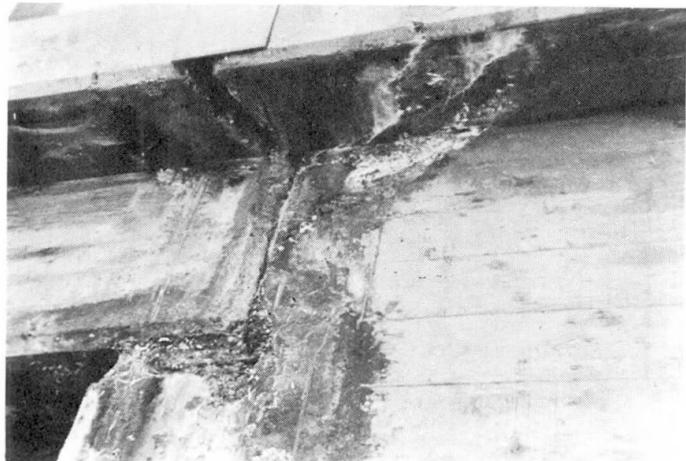
Fig. 2 Exemple de dégât de gel

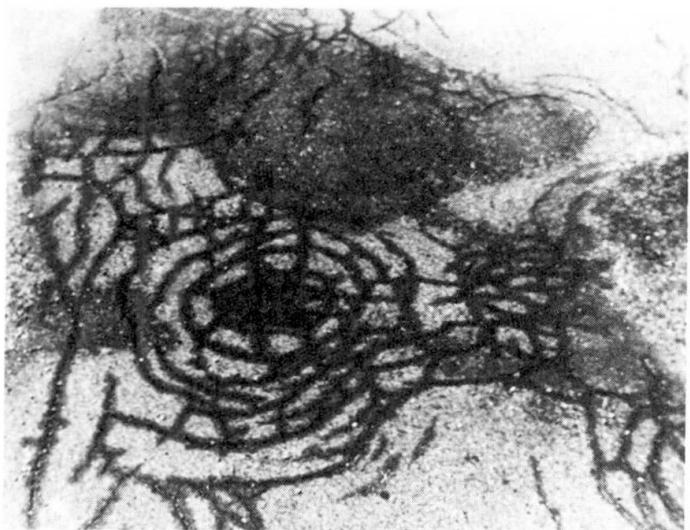
Fig. 3 Destruction du revêtement

La remise en état a entraîné la démolition du revêtement en mortier bitumineux, le piquage du béton sur 10 cm d'épaisseur et son remplacement, le renforcement de l'armature de la dalle, de roulement et la pose d'une couche d'étanchéité en lèves de nylon enrobés d'une masse bitumineuse, adhérente sur le béton de la superstructure. Les dégâts ont été réparés en 1974.

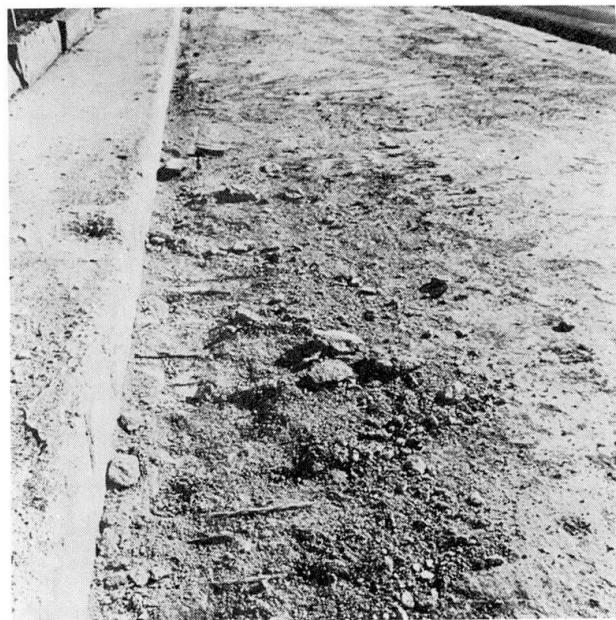
Fig. 4 Dégât de gel sous le revêtement

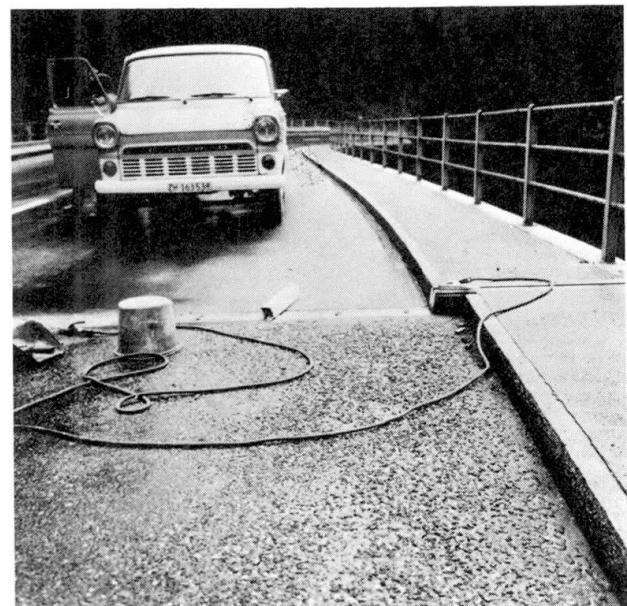
Fig. 5 Déplacement de culée

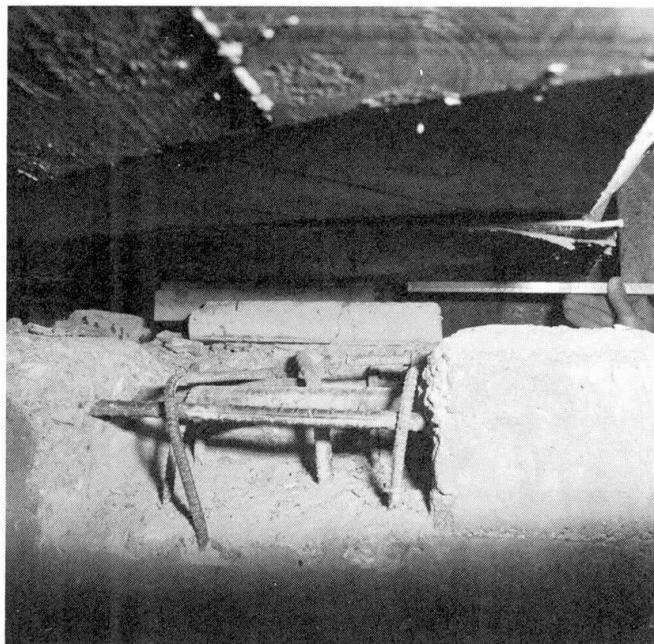
Fig. 6 Appuis déplacés

La remise en état a nécessité le remplacement des appuis glissants linéaires décalés (fig. 6) par des appuis-pots mobiles en tous sens, les gros efforts dus aux effets d'ordre secondaire ne pouvant pas être repris. Les opérations de remplacement ont été difficiles en raison des mauvaises conditions d'accès aux appareils d'appuis. Les désordres ont été réparés en 1973.

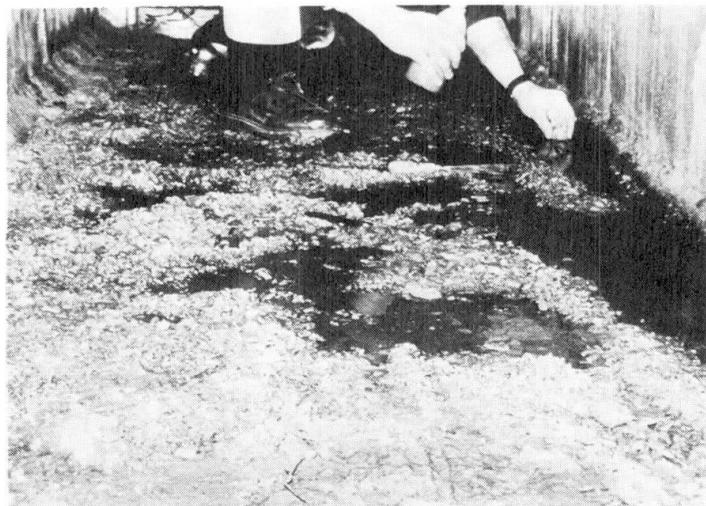
Dégâts de gel au plancher de caissons inaccessibles (fig. 8). Les désordres sont causés par l'action corrosive des sels de dégel. Par suite d'un déboitements de canalisation, l'eau s'est accumulée dans les caissons. La corrosion du béton a atteint 7 cm de profondeur.

Fig. 8 Dégât de gel au plancher de caissons inaccessibles

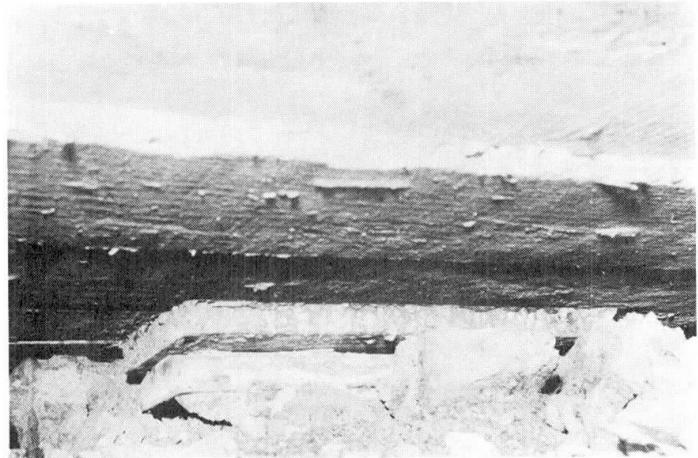
Fig. 9 Désordres aux assises d'appuis

Pont du Steilerbach, Sufers, N 13c, altitude 1420 m, section Andeer - Hinterrhein, année de construction 1959. La remise en état, exécutée en 1972/73, a nécessité le renouvellement de l'étanchéité, le drainage des caissons et le remplacement des appuis et des joints de dilatation.

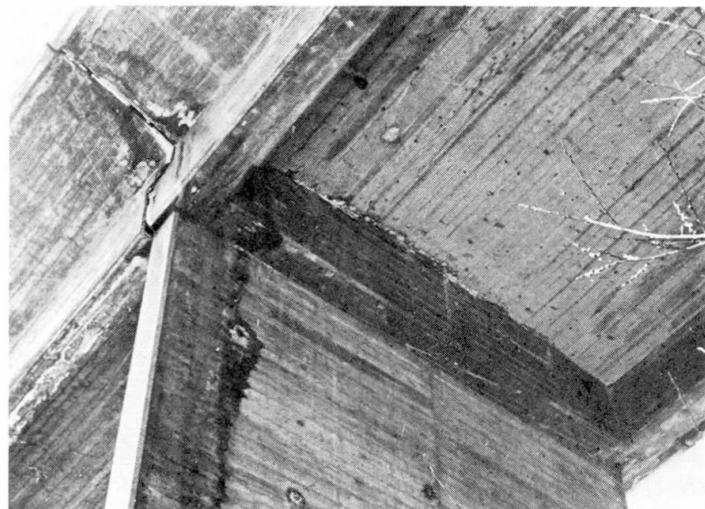
En outre, les articulations Gerber du même ouvrage ont été gravement endommagées par suite des infiltrations d'eau de ruissellement pénétrant dans la structure par les ouvertures des joints de dilatation s'ajoutant aux fuites des canalisations (fig. 11 et 12).

Fig. 12 Vue de l'articulation depuis dessous avant sa remise en état

La remise en état de l'ouvrage a nécessité le remplacement des appuis endommagés, la pose de nouveaux joints de dilatation étanches ainsi que le renouvellement de l'étanchéité et du revêtement du tablier. Les désordres ont été réparés en 1972/73.

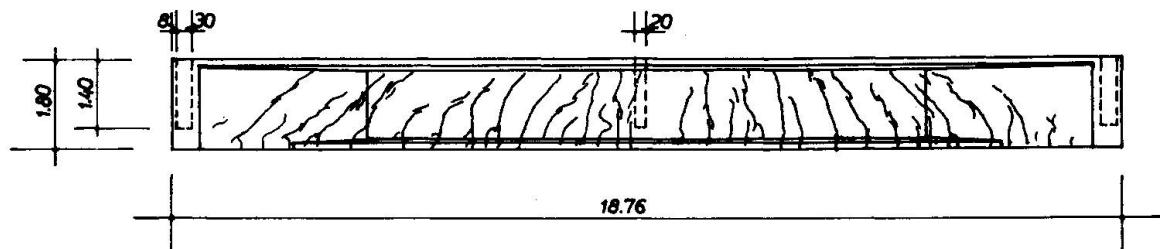
As an example, figure 2 shows the cracks of the external rib of bay No. 21.

Fig. 2 - Crack pattern on the external rib of bay No. 21

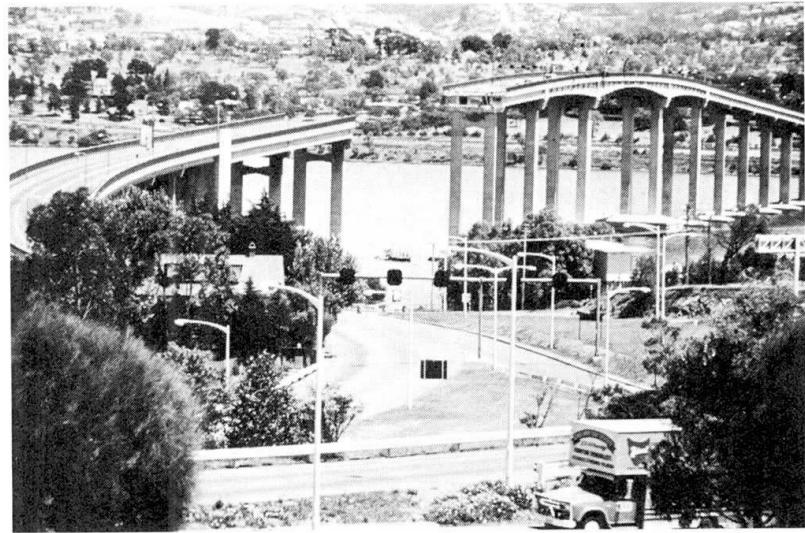
Fig. 1 Tasman Bridge after collapse
although the

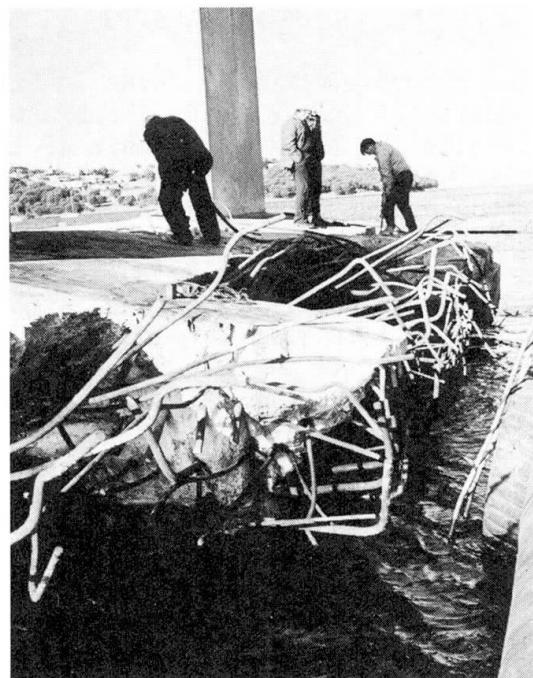
Fig. 5 Damage to Pile Cap 20
