**Zeitschrift:** IABSE reports of the working commissions = Rapports des commissions de travail AIPC = IVBH Berichte der Arbeitskommissionen

**Band:** 032 (1979)

**Rubrik:** Session III: Construction, performance, renewal

**Construction, Performance, Renewal**

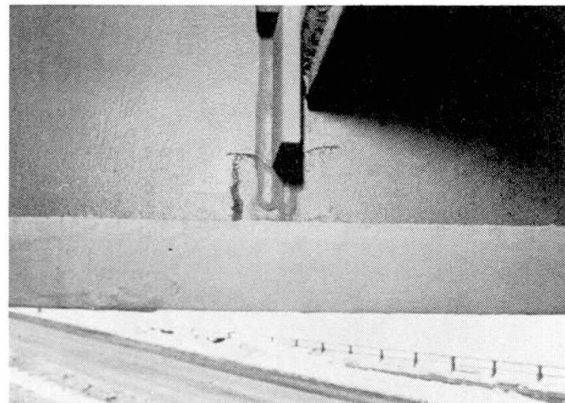
The first group of problems to turn up on our railway on welded structures were cracks at the bottom of stiffeners on skewed structures. Figure 4 is typical of this detail with a diaphragm or brace frame attached to the stiffener. Note that the stiffeners are not extended to the bottom flange. This was in blind obedience to the dictum of an early researcher in welded construction that one should not weld to the tension flange. Because of the stresses introduced by the differential deflections of the connected girders, and to small out-of-plane movements, the first cracks appeared in less than 5 years on heavily travelled lines.

Fig. 4 "U" shape crack

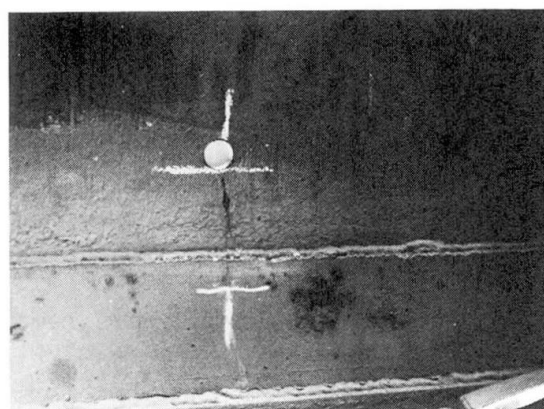
Fig. 10 Cracked Through

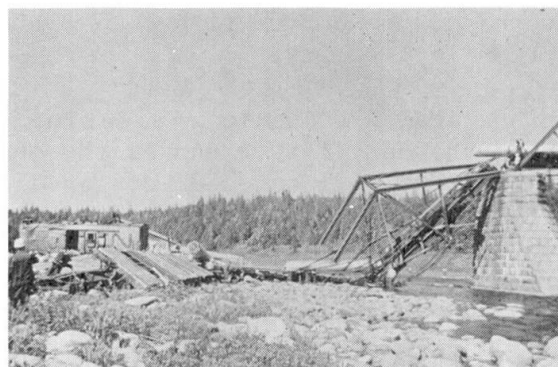
Fig. 15 Insufficient Redundancy

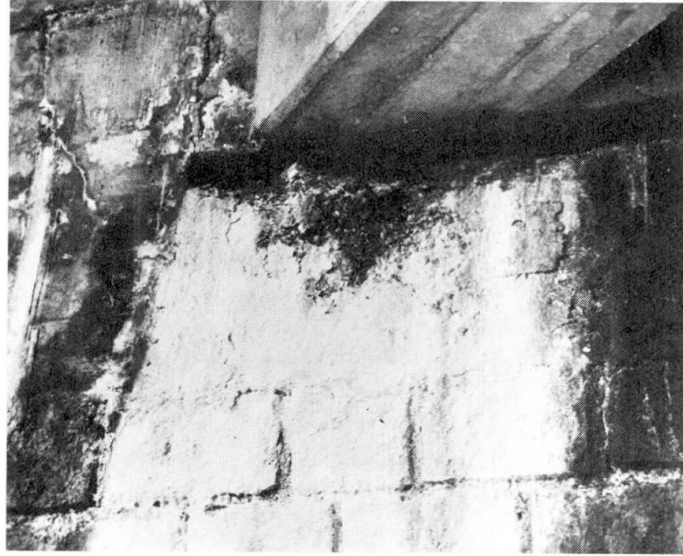
Pont sur le ruisseau de Suretta à Sufers, altitude 1420 m, N 13c, section Andeer - Splügen. Année de construction: 1959. Les désordres ont été réparés en 1972.

Fig. 1 Dégradations à l'infrastructure

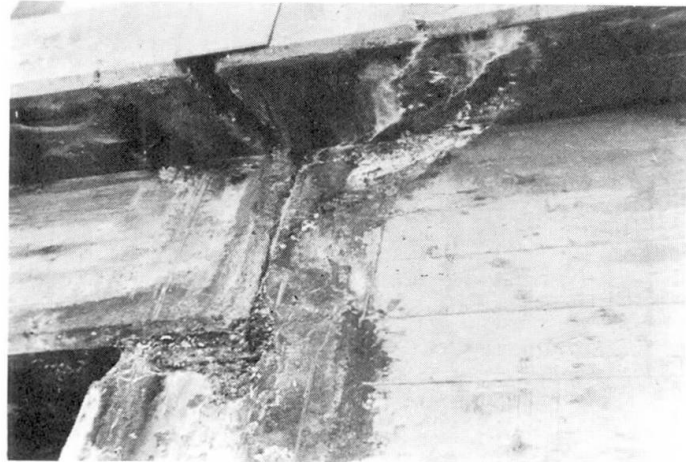
Passage inférieur de la jonction de Splügen, altitude 1450 m, N 13c, section Andeer - Splügen. Année de construction 1965. Les désordres ont été réparés en 1970.

Fig. 2 Exemple de dégât de gel

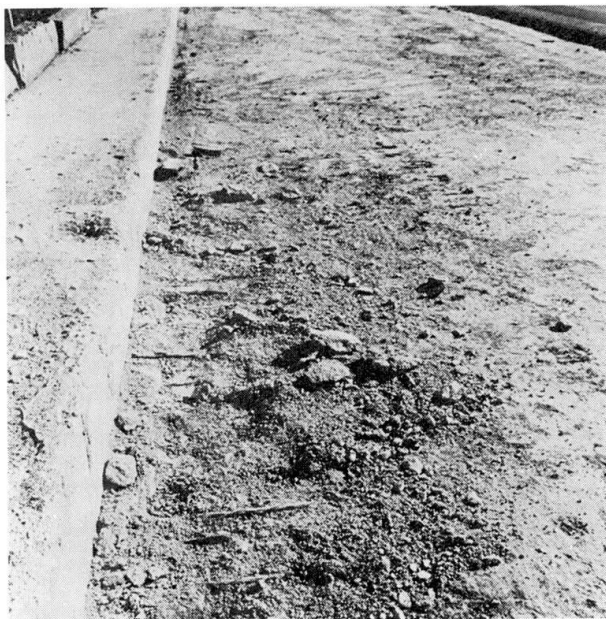
Fig. 4 Dégât de gel sous le revêtement

La remise en état a entraîné la démolition du revêtement en mortier bitumineux, le piquage du béton sur 10 cm d'épaisseur et son remplacement, le renforcement de l'armature de la dalle de roulement et la pose d'une couche d'étanchéité en lès de nylon enrobés d'une masse bitumineuse, adhérente sur le béton de la superstructure. Les désordres ont été réparés en 1974.

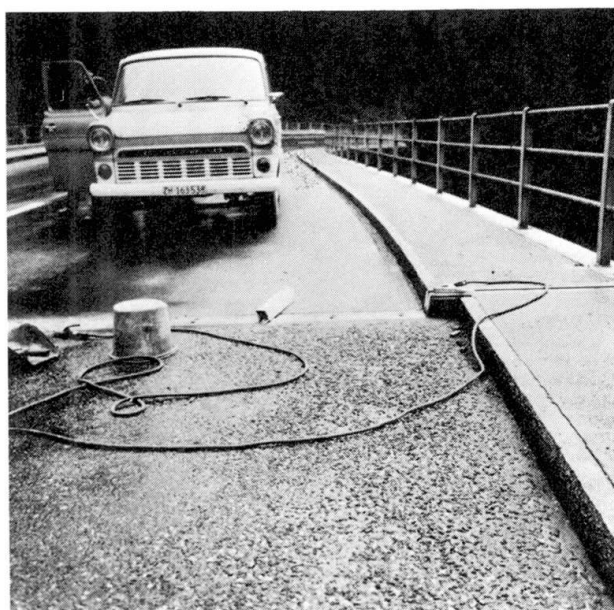
Pont du torrent de Cugnal à Sils im Domleschg, altitude 800 m, section Thusis - Tiefencastel, année de construction: 1952.

Fig. 5 Déplacement de culée

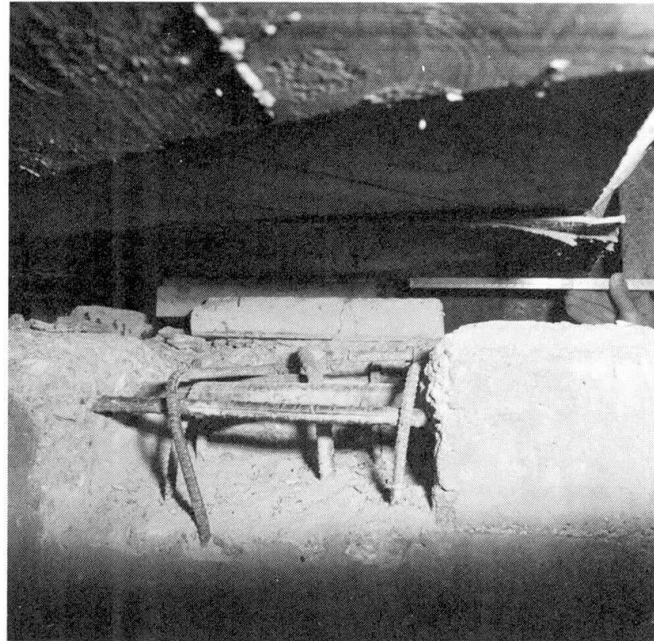
Fig. 6 Appuis déplacés

La remise en état a nécessité le remplacement des appuis glissants linéaires décalés (fig. 6) par des appuis-pots mobiles en tous sens, les gros efforts dus aux effets d'ordre secondaire ne pouvant pas être repris. Les opérations de remplacement ont été difficiles en raison des mauvaises conditions d'accès aux appareils d'appuis. Les désordres ont été réparés en 1973.

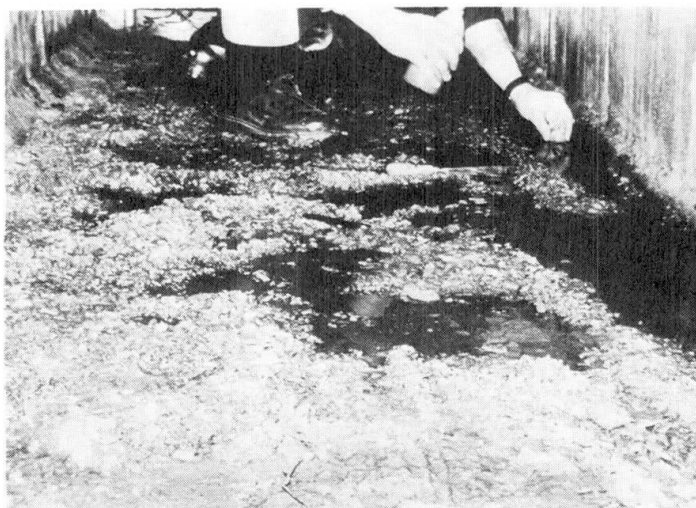
Dégâts de gel au plancher de caissons inaccessibles (fig. 8). Les désordres sont causés par l'action corrosive des sels de dégel. Par suite d'un déboîtement de canalisation, l'eau s'est accumulée dans les caissons. La corrosion du béton a atteint 7 cm de profondeur.

Fig. 8 Dégât de gel au plancher de caissons inaccessibles

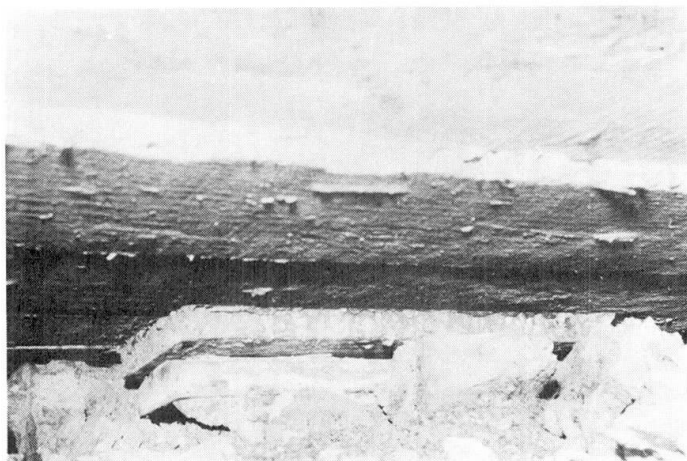
Fig. 9 Désordres aux assises d'appuis

Pont du Steilerbach, Sufers, N 13c, altitude 1420 m, section Andeer - Hinterrhein, année de construction 1959. La remise en état, exécutée en 1972/73, a nécessité le renouvellement de l'étanchéité, le drainage des caissons et le remplacement des appuis et des joints de dilatation.

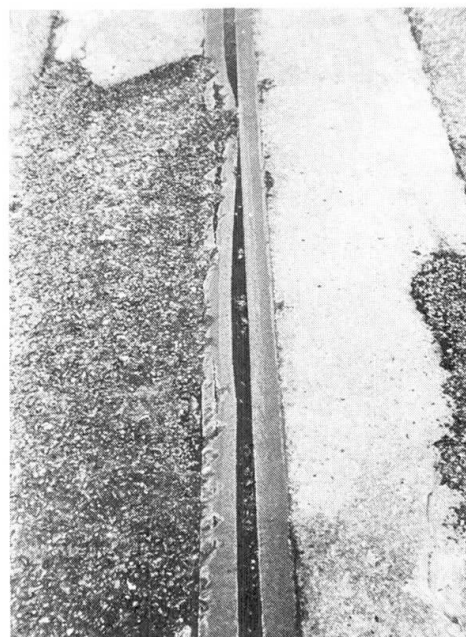
Les joints de dilatation en saillie sur le revêtement sont accrochés au passage par les lames des chasses-neige. Les joints de construction trop légère ne résistent pas aux sollicitations répétées du service hivernal (fig. 10).

Fig. 10 Joint de dilatation endommagé

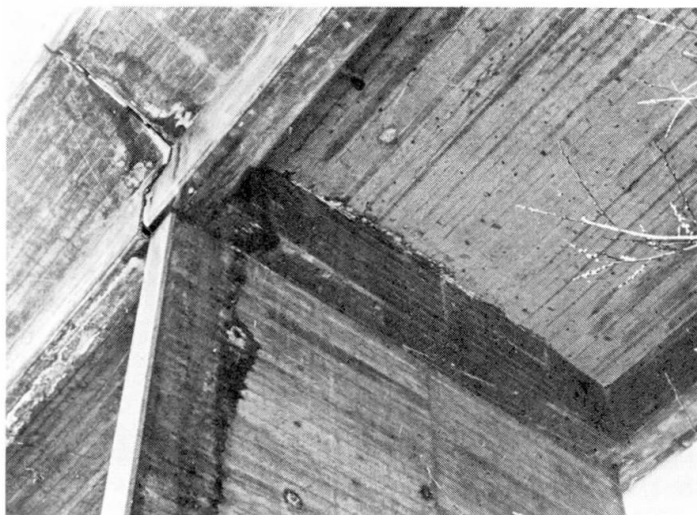
En outre, les articulations Gerber du même ouvrage ont été gravement endommagées par suite des infiltrations d'eau de ruissellement pénétrant dans la structure par les ouvertures des joints de dilatation s'ajoutant aux fuites des canalisations (fig. 11 et 12).

Fig. 12 Vue de l'articulation depuis dessous avant sa remise en état

La remise en état de l'ouvrage a nécessité le remplacement des appuis endommagés, la pose de nouveaux joints de dilatation étanches ainsi que le renouvellement de l'étanchéité et du revêtement du tablier. Les désordres ont été réparés en 1972/73.

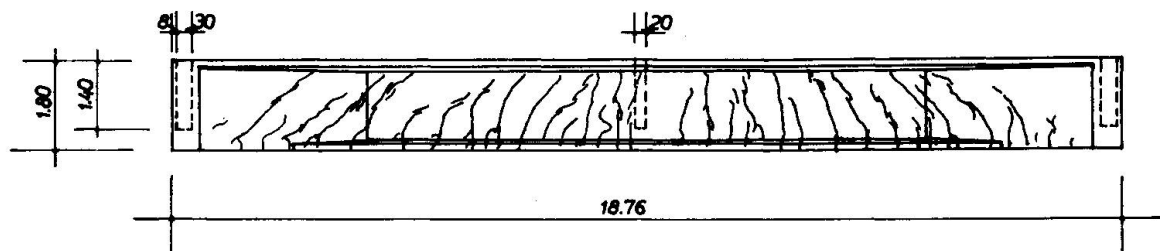
As an example, figure 2 shows the cracks of the external rib of bay No. 21.

Fig. 2 - Crack pattern on the external rib of bay No. 21
