**Zeitschrift:** IABSE reports of the working commissions = Rapports des commissions de travail AIPC = IVBH Berichte der Arbeitskommissionen

**Band:** 032 (1979)

## **SESSION III**

**Construction, Performance, Renewal**

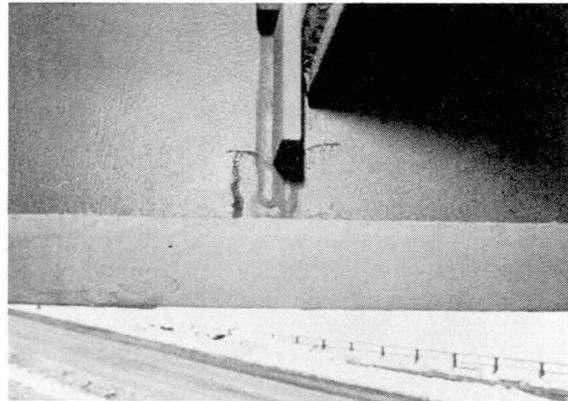
The first group of problems to turn up on our railway on welded structures were cracks at the bottom of stiffeners on skewed structures. Figure 4 is typical of this detail with a diaphragm or brace frame attached to the stiffener. Note that the stiffeners are not extended to the bottom flange. This was in blind obedience to the dictum of an early researcher in welded construction that one should not weld to the tension flange. Because of the stresses introduced by the differential deflections of the connected girders, and to small out-of-plane movements, the first cracks appeared in less than 5 years on heavily travelled lines.

Fig. 4 "U" shape crack

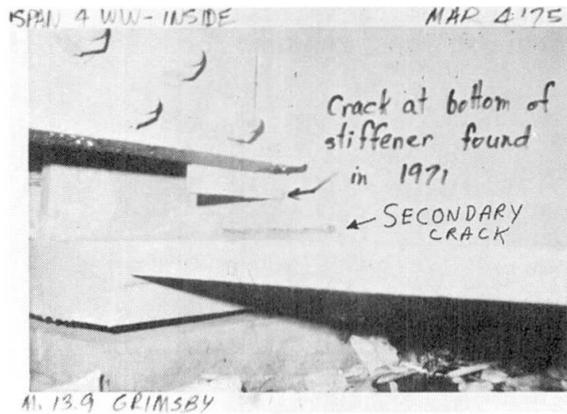
After cracks have occurred as described above, the next point of rigidity is between the web and flange. If there is any out-of-the plane of the girder motion, it is only a matter of time before cracks will occur in the web to flange weld below the stiffener (Figure 5). Stopping these cracks is very important.

Fig. 5 Secondary Cracking

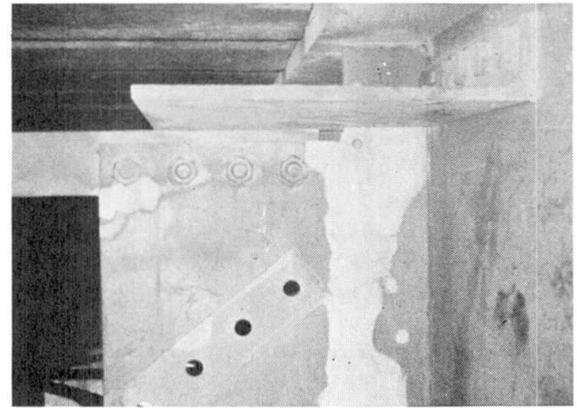
Fig. 6 Gusset to Stiffener

Another detail that has given trouble is the connection of brace frame angles to stiffeners (Figure 6) with the gussets groove welded to the stiffener. Referring to Figure 7, the critical detail has a zero radius. The stress causing crack growth is the lateral force from trains. Since maximum lateral impacts often occur due to hunting (side to side snaking) of empty cars, it took less than five years for these cracks to develop.

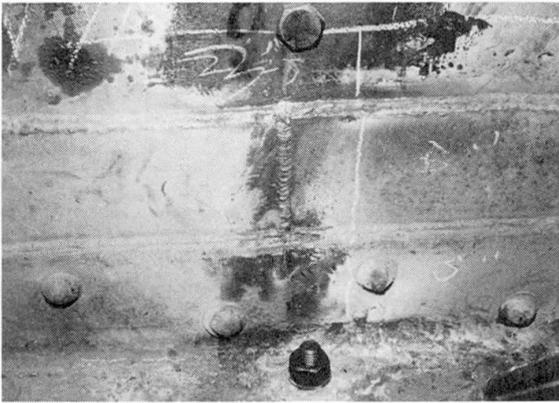
In the late 60's, it was decided to repair the corrosion that occurs in deck plate girders at the web-bottom flange junction on a number of our structures. Because of the production operation, patch plates were of various lengths, and were butt welded as required. After 10 years these welds started to crack under very low stress ranges. The maximum measured stress range was 36.2 MPa (5.25 ksi) with a mean peak per train of 31.92 MPa (4.63 ksi). There was little if any apparent dynamic augment.

Fig. 8 Crack in Patch Plate

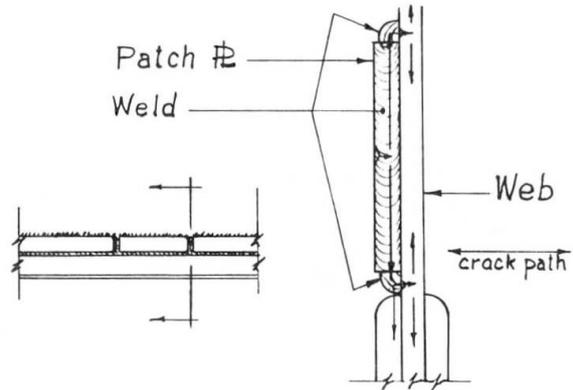
Fig. 9 Crack Growth

1. Crack initiation at a flaw.
2. Crack growth (Figure 9) in the weld upward and downward in those welds that did not have full penetration and horizontally into the web for those that did.
3. Growth from the level of the horizontal fillet welds into the web and bottom flange leaving multiple cracks.

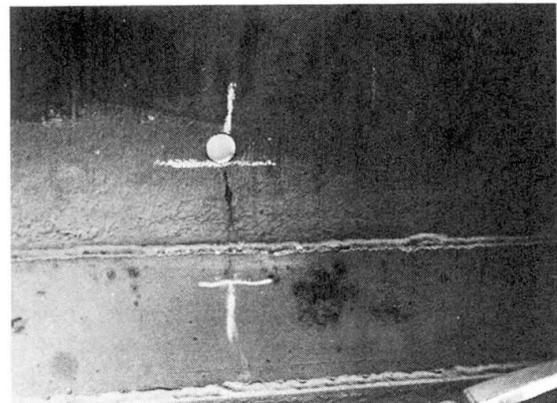
Fig. 10 Cracked Through

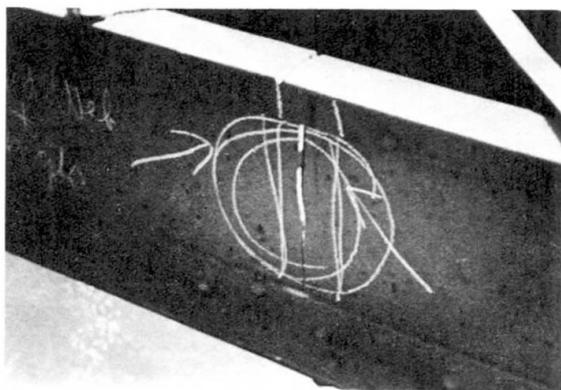
Fig. 13 Crack in chord

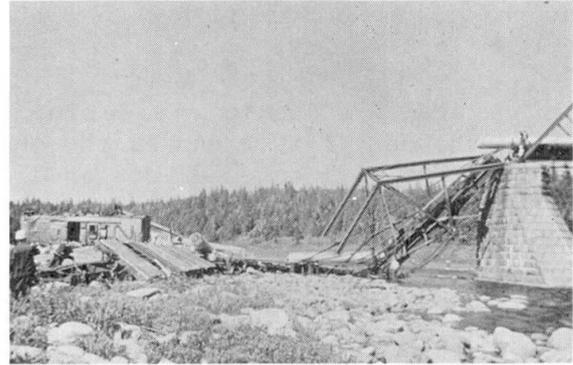
Fig. 15 Insufficient Redundancy

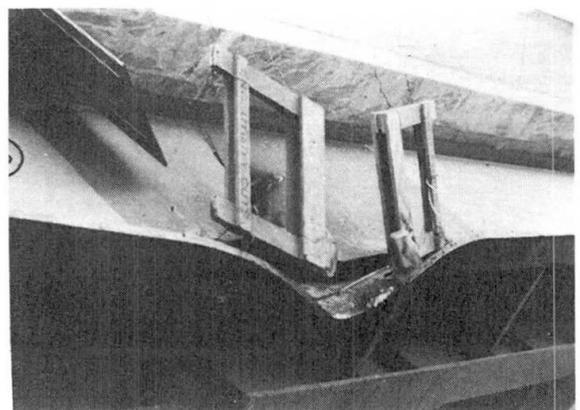
A rather striking example (Figure 16) is this multi-beam welded structure with a composite deck which was hit by the top of a backhoe. Although several girders were badly damaged, the structure did not collapse under train traffic. It is known that several trains crossed on the adjacent track after the accident. Imagine what could have happened if that had been a two girder non-composite welded system.

Fig. 16 Hit by Vehicle

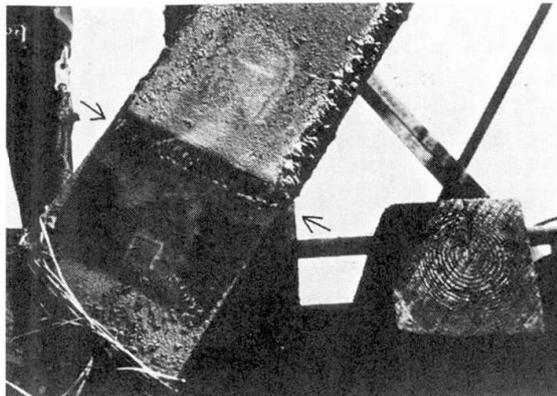
The type of repair shown in Figure 18, the addition of welded plates to an eye bar member could be a disaster in a non-redundant load path structure. The crack is illustrated by the light line of magnaflux at the toe of the weld. In this bridge, because of its multiple load paths, collapse will not occur if one of these members cracks through.

Fig. 18 Eye Bar Weld

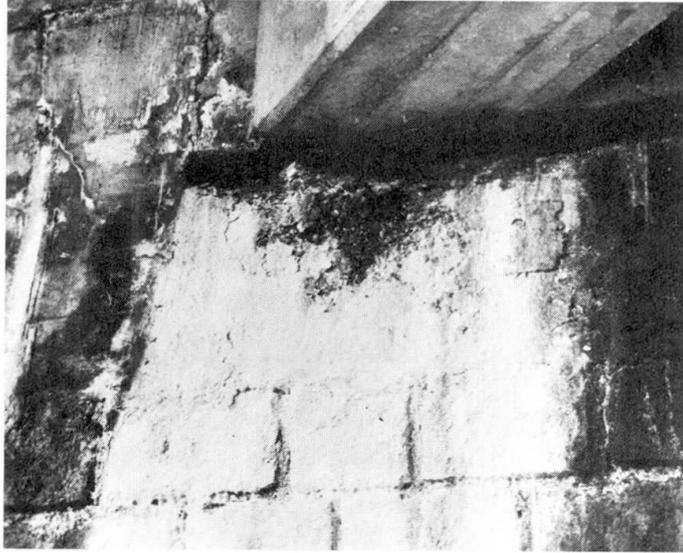
Pont sur le ruisseau de Suretta à Sufers, altitude 1420 m, N 13c, section Andeer - Splügen. Année de construction: 1959. Les désordres ont été réparés en 1972.

Fig. 1 Dégradations à l'infrastructure

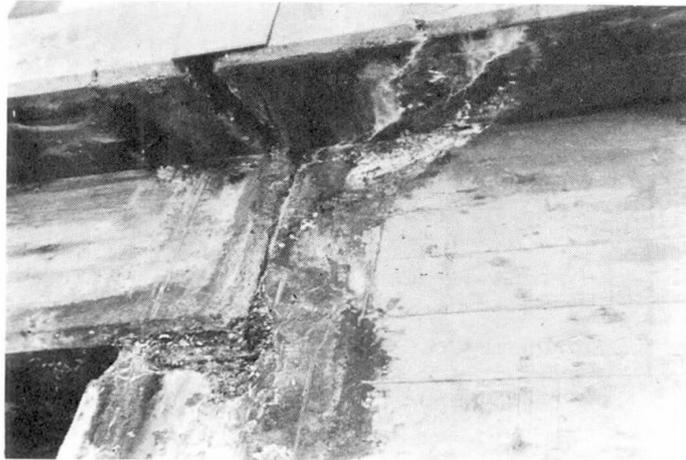
Passage inférieur de la jonction de Splügen, altitude 1450 m, N 13c, section Andeer - Splügen. Année de construction 1965. Les désordres ont été réparés en 1970.

Fig. 2 Exemple de dégât de gel

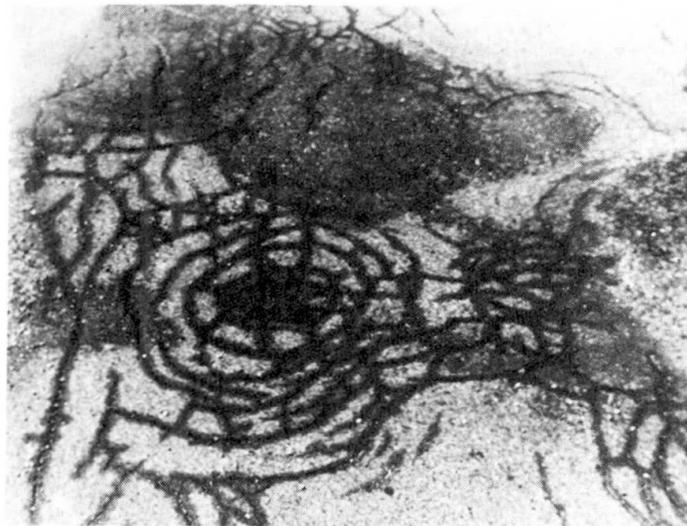
Pont de Giustia à Marmorera, altitude 1684 m, route du Julier, section Bivio - Marmorera. Année de construction: 1958

Fig. 3 Destruction du revêtement

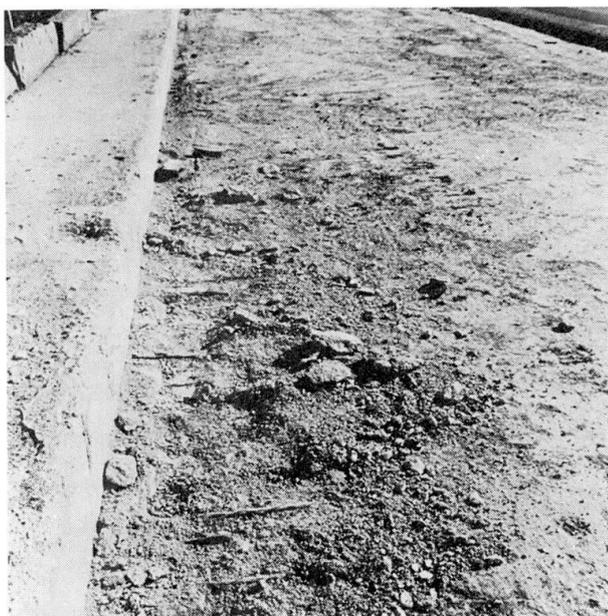
Fig. 4 Dégât de gel sous le revêtement

La remise en état a entraîné la démolition du revêtement en mortier bitumineux, le piquage du béton sur 10 cm d'épaisseur et son remplacement, le renforcement de l'armature de la dalle de roulement et la pose d'une couche d'étanchéité en lès de nylon enrobés d'une masse bitumineuse, adhérente sur le béton de la superstructure. Les désordres ont été réparés en 1974.

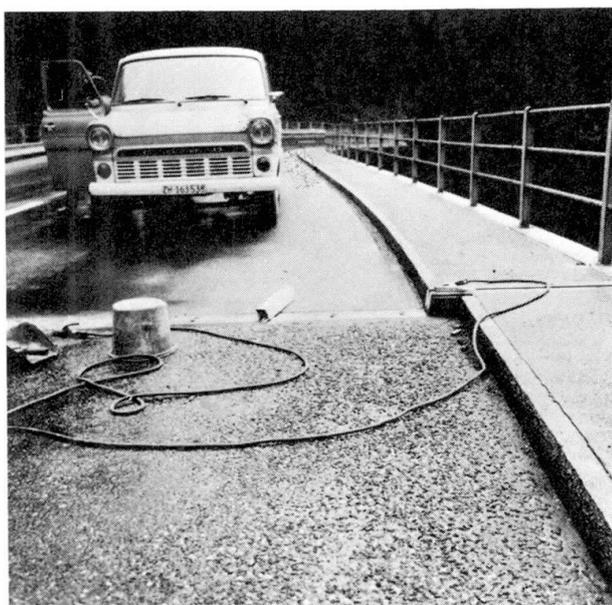
Pont du torrent de Cugnal à Sils im Domleschg, altitude 800 m, section Thusis - Tiefencastel, année de construction: 1952.

Fig. 5 Déplacement de culée

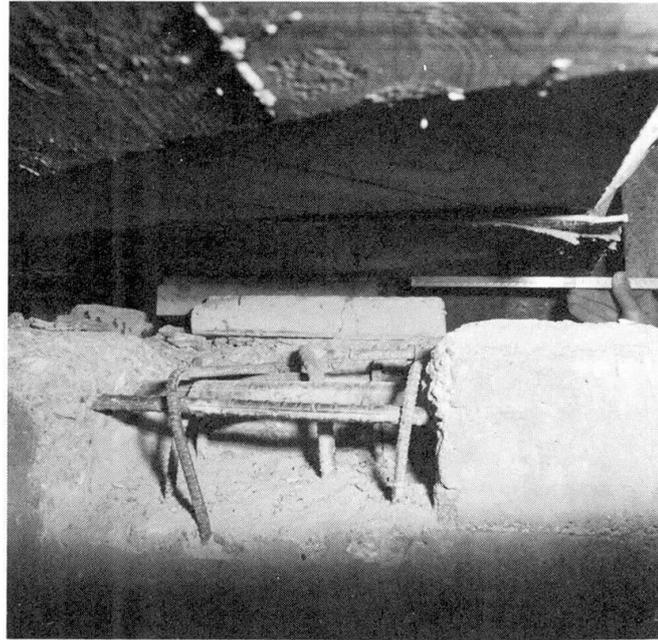
Fig. 6 Appuis déplacés

La remise en état a nécessité le remplacement des appuis glissants linéaires décalés (fig. 6) par des appuis-pots mobiles en tous sens, les gros efforts dus aux effets d'ordre secondaire ne pouvant pas être repris. Les opérations de remplacement ont été difficiles en raison des mauvaises conditions d'accès aux appareils d'appuis. Les désordres ont été réparés en 1973.

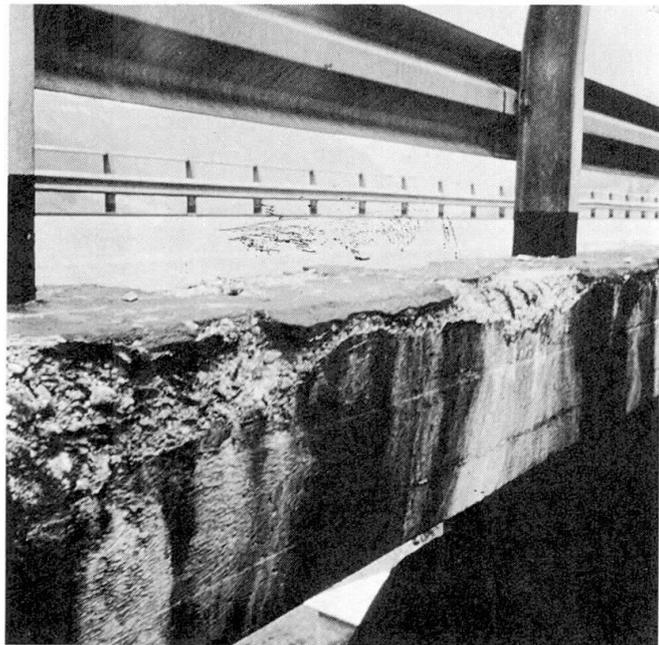
Fig. 7 Destruction de bordure de pont

Pont sur le Rhin postérieur à Splügen, altitude 1450 m, N 13c, section Andeer - Hinterrhein. Année de construction: 1962. La remise en état a nécessité le remplacement du cordon et l'application d'une étanchéité de protection. Les désordres ont été réparés en 1978.

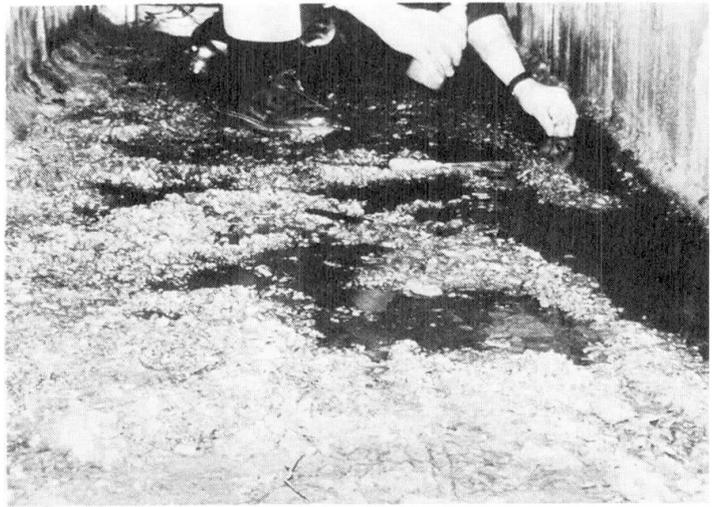
Dégâts de gel au plancher de caissons inaccessibles (fig. 8). Les désordres sont causés par l'action corrosive des sels de dégel. Par suite d'un déboitement de canalisation, l'eau s'est accumulée dans les caissons. La corrosion du béton a atteint 7 cm de profondeur.

Fig. 8 Dégât de gel au plancher de caissons inaccessibles

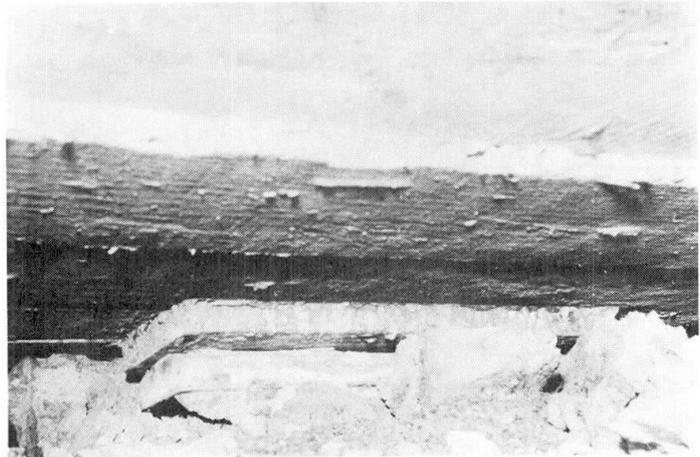
Fig. 9 Désordres aux assises d'appuis

Pont du Steilerbach, Sufers, N 13c, altitude 1420 m, section Andeer - Hinterrhein, année de construction 1959. La remise en état, exécutée en 1972/73, a nécessité le renouvellement de l'étanchéité, le drainage des caissons et le remplacement des appuis et des joints de dilatation.

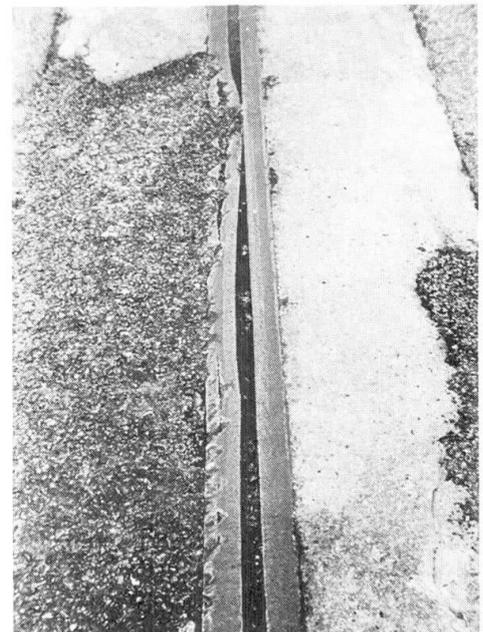
Les joints de dilatation en saillie sur le revêtement sont accrochés au passage par les lames des chasses-neige. Les joints de construction trop légère ne résistent pas aux sollicitations répétées du service hivernal (fig. 10).

Fig. 10 Joint de dilatation endommagé

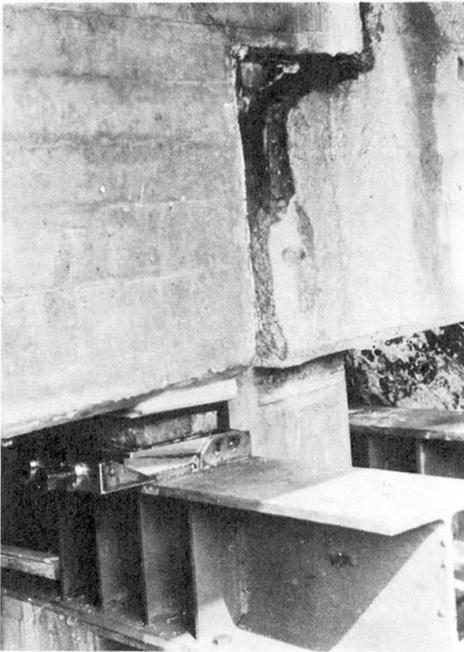
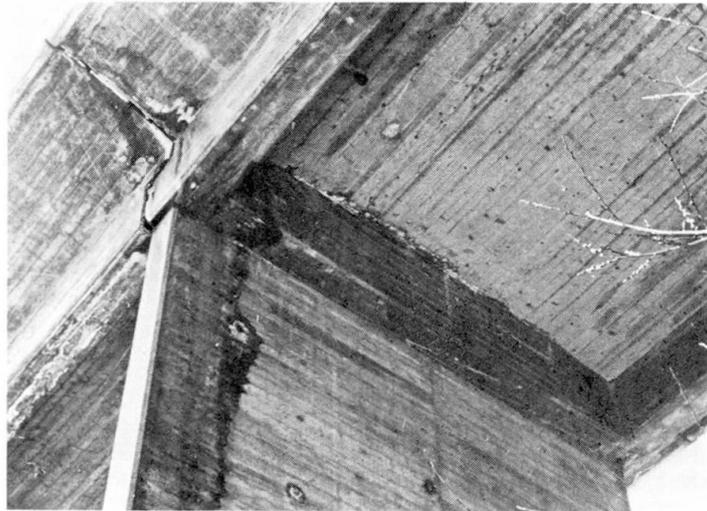
En outre, les articulations Gerber du même ouvrage ont été gravement endommagées par suite des infiltrations d'eau de ruissellement pénétrant dans la structure par les ouvertures des joints de dilatation s'ajoutant aux fuites des canalisations (fig. 11 et 12).

Fig. 12 Vue de l'articulation depuis dessous avant sa remise en état

La remise en état de l'ouvrage a nécessité le remplacement des appuis endommagés, la pose de nouveaux joints de dilatation étanches ainsi que le renouvellement de l'étanchéité et du revêtement du tablier. Les désordres ont été réparés en 1972/73.

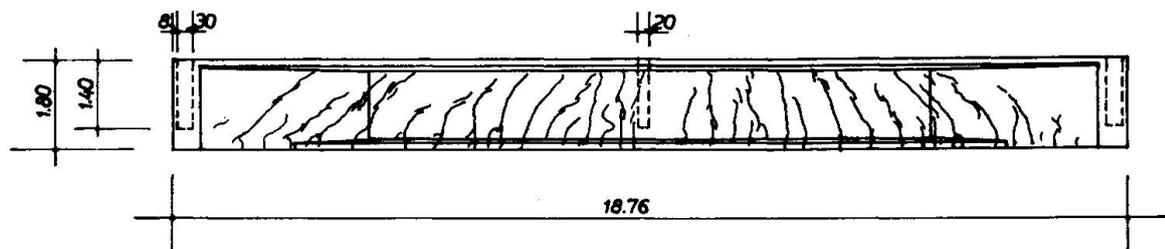
As an example, figure 2 shows the cracks of the external rib of bay No. 21.

Fig. 2 - Crack pattern on the external rib of bay No. 21

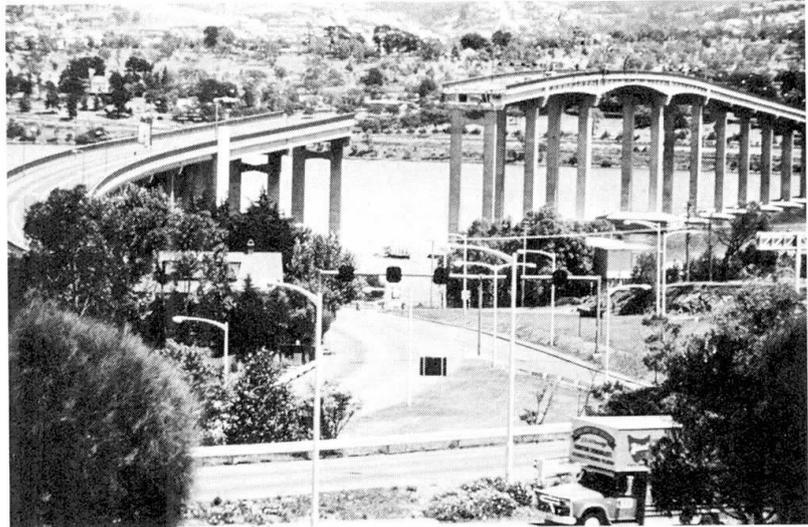
Fig. 1 Tasman Bridge after collapse

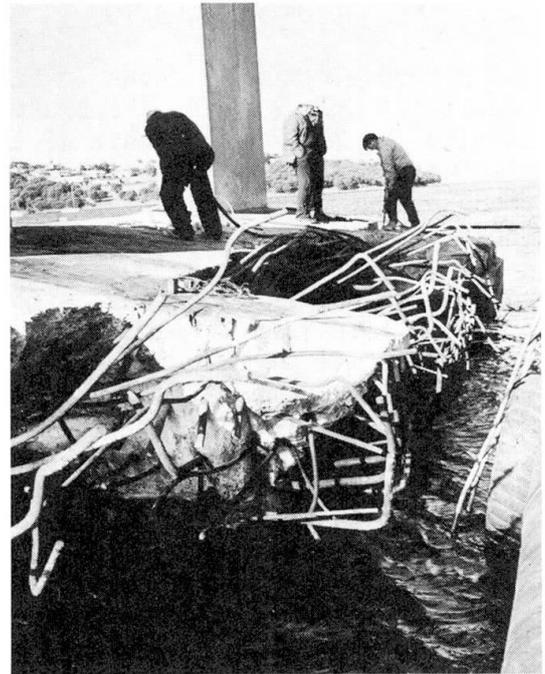
Fig. 5 Damage to Pile Cap 20
