Artikel: Some remarks on the service behaviour of steel railway bridges

Some Remarks on the Service Behaviour of Steel Railway Bridges

R.A.P. SWEENEY

CN Rail

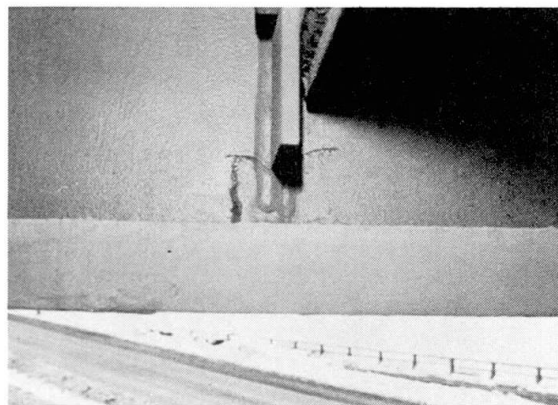
Fig. 4 "U" shape crack

The first group of problems to turn up on our railway on welded structures were cracks at the bottom of stiffeners on skewed structures. Figure 4 is typical of this detail with a diaphragm or brace frame attached to the stiffener. Note that the stiffeners are not extended to the bottom flange. This was in blind obedience to the dictum of an early researcher in welded construction that one should not weld to the tension flange. Because of the stresses introduced by the differential deflections of the connected girders, and to small out-of-plane movements, the first cracks appeared in less than 5 years on heavily travelled lines.

The crack would start at the bottom of the stiffener and form a "U" shape crack around the bottom of the stiffener. If the original stiffener-web weld was of good quality, this crack would turn out into the web and slow down considerably.

Unfortunately in many cases the only adequate cure is not to have the detail in the first place. If the crack isn't going to go anywhere, and if it has not damaged the structure too severely, it is best left alone as the retrofit may make things worse. Cracks at the bottom of stiffeners tend to be in this category.

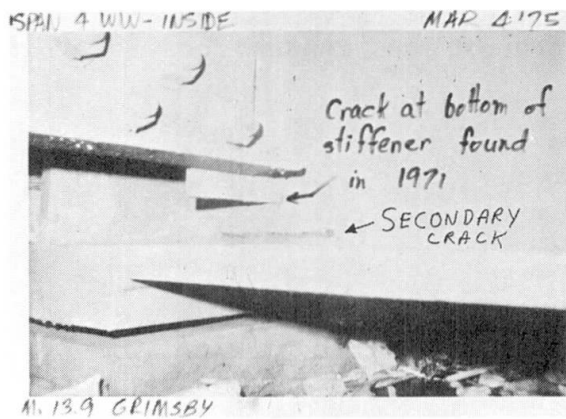
Fig. 5 Secondary Cracking

After cracks have occurred as described above, the next point of rigidity is between the web and flange. If there is any out-of-the plane of the girder motion, it is only a matter of time before cracks will occur in the web to flange weld below the stiffener (Figure 5). Stopping these cracks is very important.

The skewed multi-beam composite structure shown in Figure 5 cracked due to a fatigue related failure. Throughout the repairs, which were delayed for over a year, regular train traffic was permitted. This could

Repairing the cracks that occur between the flange and web is extremely important. The general procedure for any crack is to:

1. Use a chisel to vee out the crack,
2. Fill the resulting groove using a proper electrode, and
3. Grind flush.

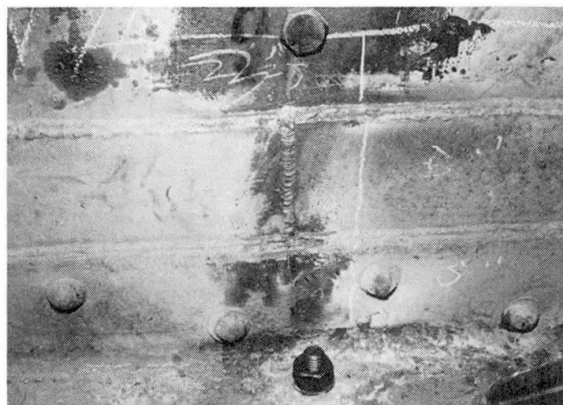
Fig. 8 Crack in Patch Plate

In the late 60's, it was decided to repair the corrosion that occurs in deck plate girders at the web-bottom flange junction on a number of our structures. Because of the production operation, patch plates were of various lengths, and were butt welded as required. After 10 years these welds started to crack under very low stress ranges. The maximum measured stress range was 36.2 MPa (5.25 ksi) with a mean peak per train of 31.92 MPa (4.63 ksi). There was little if any apparent dynamic augment.

The cracks (Figure 8) in these welds were very hard to detect and were not detected until they had propagated from the patch plate welds into the web.

When patching girders, it is a simple matter to run patch plates far enough so that the girder stress will be small enough to permit such a detail.

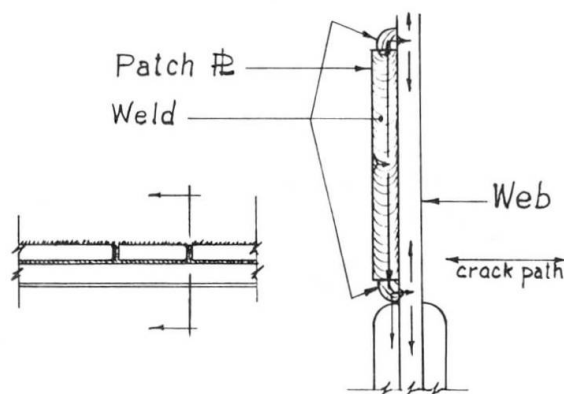
Fig. 9 Crack Growth

The crack path was as follows:

1. Crack initiation at a flaw.
2. Crack growth (Figure 9) in the weld upward and downward in those welds that did not have full penetration and horizontally into the web for those that did.
3. Growth from the level of the horizontal fillet welds into the web and bottom flange leaving multiple cracks.

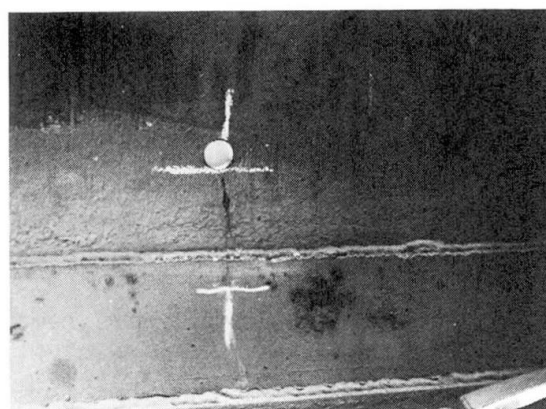
Fig. 10 Cracked Through

Figure 10 shows the same location looking from the inside of the girder. Note that there is no butt weld on the inside at the location of this crack. The crack has propagated from the opposite side.

Four crack fronts have been illustrated from the same initial crack. Depending on the degree of penetration, more crack fronts could theoretically develop. Hence, the repair procedure cannot consist solely in repairing the visible cracks as there may be other hidden cracks.

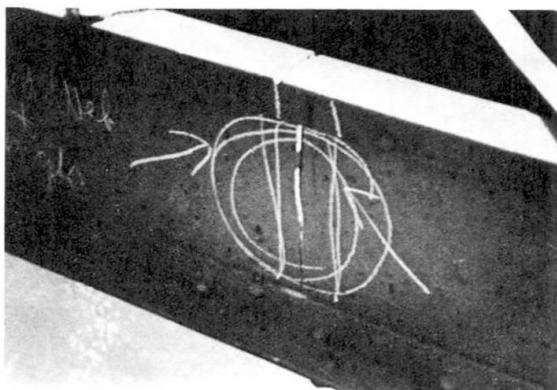
Fig. 13 Crack in chord

Most riveted structures were internally member redundant in that they were fabricated of several components (Figure 3). Their advantage is that cracks do not jump from piece to piece. The chord member of the truss shown in Figure 13 cracked on one side, but not on the other side of the member, and carried rail traffic for some time before detection and repair. In a welded box like member the crack would have propagated all around.

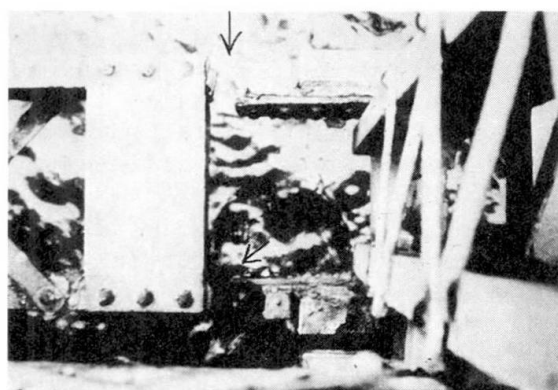
Fig. 14 Chord Severed

Most trusses are multi-load path structures. The truss in Figure 14 had its bottom chord completely severed and yet remained standing because of the alternate load paths provided by the bracing, floor system, etc. The truss shown in Figure 15, which did not have adequate bracing, did not remain standing when one of its diagonals was severed by a shifting load. It is unfortunate that it didn't have sufficient redundancy.

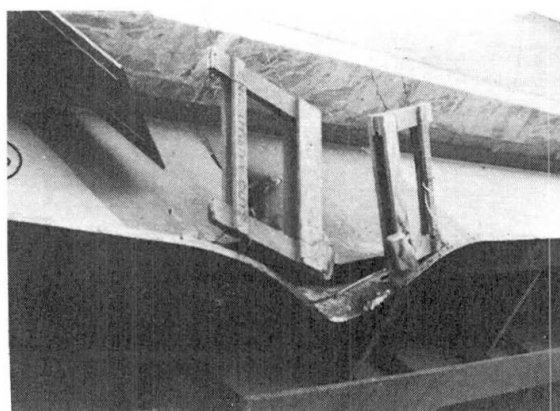
Fig. 16 Hit by Vehicle

A rather striking example (Figure 16) is this multi-beam welded structure with a composite deck which was hit by the top of a backhoe. Although several girders were badly damaged, the structure did not collapse under train traffic. It is known that several trains crossed on the adjacent track after the accident. Imagine what could have happened if that had been a two girder non-composite welded system.

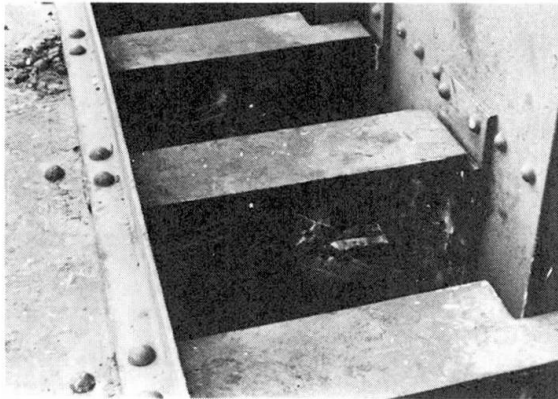
Fig. 17 Torsional loading

This (Figure 17) structure cracked due to torsional loading caused by constant train breaking. Although the floor beams are not welded there is no component redundancy as the beams are rolled. Nevertheless, the redundancy of the deck system has permitted regular train operations for over a year with 4 adjacent floor beams failed.

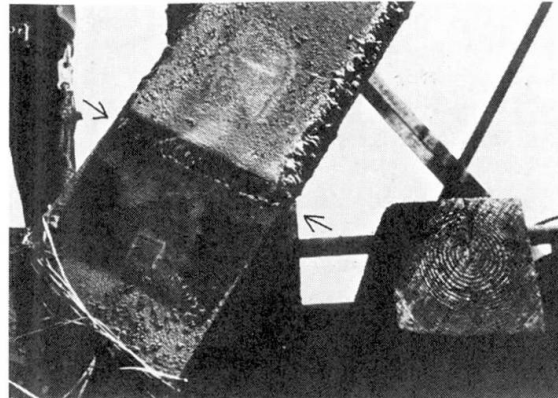
Fig. 18 Eye Bar Weld

The type of repair shown in Figure 18, the addition of welded plates to an eye bar member could be a disaster in a non-redundant load path structure. The crack is illustrated by the light line of magnaflux at the toe of the weld. In this bridge, because of its multiple load paths, collapse will not occur if one of these members cracks through.
