**Artikel:** Some remarks on the service behaviour of steel railway bridges

## **Some Remarks on the Service Behaviour of Steel Railway Bridges**

**R.A.P. SWEENEY**

CN Rail

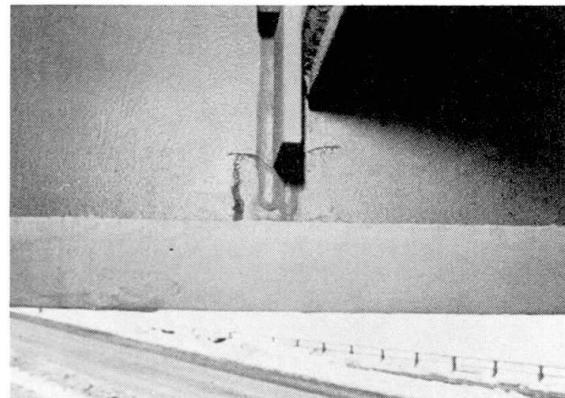
The first group of problems to turn up on our railway on welded structures were cracks at the bottom of stiffeners on skewed structures. Figure 4 is typical of this detail with a diaphragm or brace frame attached to the stiffener. Note that the stiffeners are not extended to the bottom flange. This was in blind obedience to the dictum of an early researcher in welded construction that one should not weld to the tension flange. Because of the stresses introduced by the differential deflections of the connected girders, and to small out-of-plane movements, the first cracks appeared in less than 5 years on heavily travelled lines.

Fig. 4 "U" shape crack

The crack would start at the bottom of the stiffener and form a "U" shape crack around the bottom of the stiffener. If the original stiffener-web weld was of good quality, this crack would turn out into the web and slow down considerably.

Unfortunately in many cases the only adequate cure is not to have the detail in the first place. If the crack isn't going to go anywhere, and if it has not damaged the structure too severly, it is best left alone as the retrofit may make things worse. Cracks at the bottom of stiffeners tend to be in this category.

If the structure cracked because it was restrained from movement and if movement is essential to its function, as in the case of a skew-girder, then a repair of the existing detail will be of no value. In fact it may not crack in the same place next time but at a more serious location. In addition to the obvious differences in vertical deflection of skewed girders, one should consider conceptually that torsion in a girder will occur in the part most capable of rotating. The flange is generally much stiffer than the web, particularly in the space between the stiffener and the bottom flange, and any girder rotation (out-of-plane movement) will be forced to occur in this small

space. Needless to say the stresses will be enormous. To solve the problem, the stiffeners must be run down to the bottom flange, or cut back far enough to relieve the stresses, or the source of rotation removed. If the stiffeners are connected to the bottom flange in a high positive moment area, this may entail a reduction in capacity.

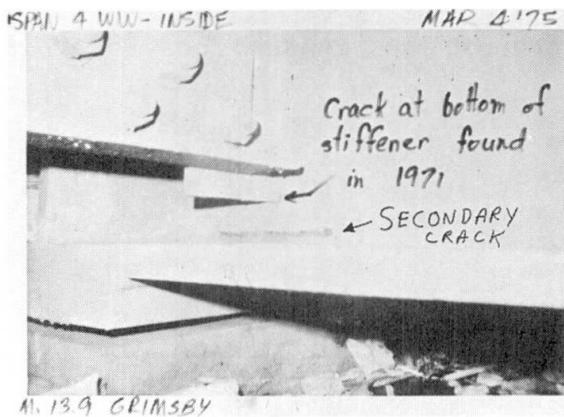
After cracks have occurred as described above, the next point of rigidity is between the web and flange. If there is any out-of-the plane of the girder motion, it is only a matter of time before cracks will occur in the web to flange weld below the stiffener (Figure 5). Stopping these cracks is very important.

Fig. 5 Secondary Cracking

The skewed multi-beam composite structure shown in Figure 5 cracked due to a fatigue related failure. Throughout the repairs, which were delayed for over a year, regular train traffic was permitted. This could

Repairing the cracks that occur between the flange and web is extremely important. The general procedure for any crack is to:

1. Use a chisel to vee out the crack,
2. Fill the resulting groove using a proper electrode, and
3. Grind flush.

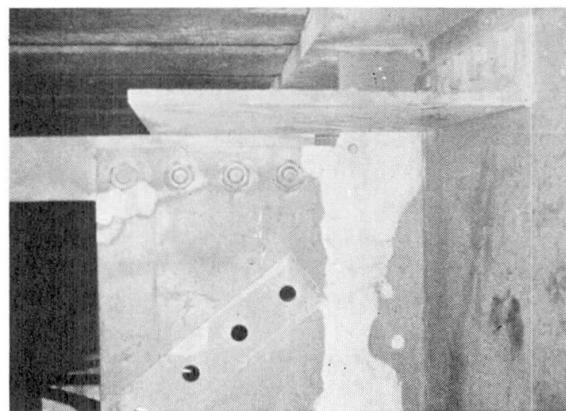
Fig. 6 Gusset to Stiffener

Another detail that has given trouble is the connection of brace frame angles to stiffeners (Figure 6) with the gussets groove welded to the stiffener. Referring to Figure 7, the critical detail has a zero radius. The stress causing crack growth is the lateral force from trains. Since maximum lateral impacts often occur due to hunting (side to side snaking) of empty cars, it took less than five years for these cracks to develop.

In the case of the gussets groove welded to the stiffener, since these developed in less than 5 years, they could be expected to re-occur in the same time frame if repaired. It was decided to replace the butt welded detail with a bolted detail for the brace frames. Prior to doing this, all cracks were repaired by welding and the top and bottom three inches of the stiffener where the gusset place was removed were ground smooth to get rid of any incipient cracks.

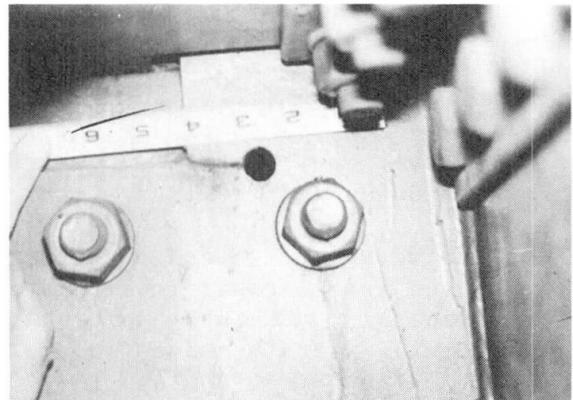
Fig. 7 Zero Radius

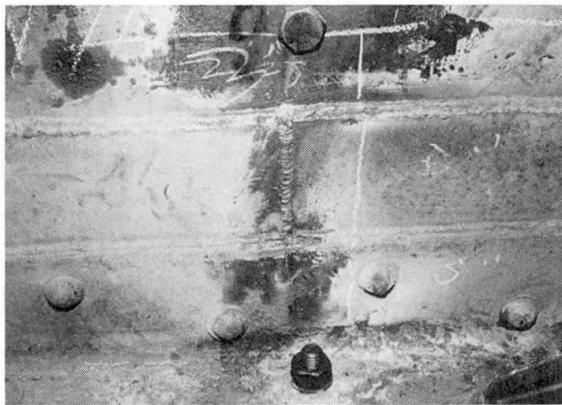
In the late 60's, it was decided to repair the corrosion that occurs in deck plate girders at the web-bottom flange junction on a number of our structures. Because of the production operation, patch plates were of various lengths, and were butt welded as required. After 10 years these welds started to crack under very low stress ranges. The maximum measured stress range was 36.2 MPa (5.25 ksi) with a mean peak per train of 31.92 MPa (4.63 ksi). There was little if any apparent dynamic augment.

Fig. 8 Crack in Patch Plate

The cracks (Figure 8) in these welds were very hard to detect and were not detected until they had propagated from the patch plate welds into the web.

When patching girders, it is a simple matter to run patch plates far enough so that the girder stress will be small enough to permit such a detail.

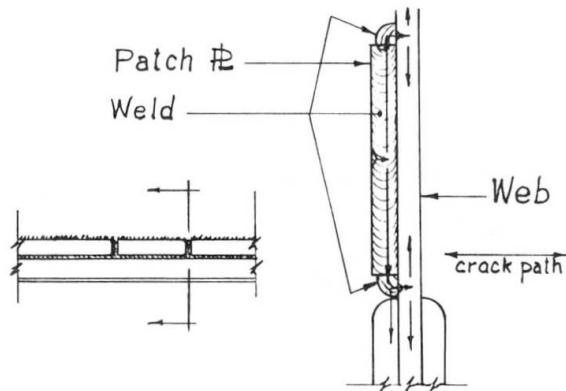
Fig. 9 Crack Growth

1. Crack initiation at a flaw.
2. Crack growth (Figure 9) in the weld upward and downward in those welds that did not have full penetration and horizontally into the web for those that did.
3. Growth from the level of the horizontal fillet welds into the web and bottom flange leaving multiple cracks.

Four crack fronts have been illustrated from the same initial crack. Depending on the degree of penetration, more crack fronts could theoretically develop. Hence, the repair procedure cannot consist solely in repairing the visible cracks as there may be other hidden cracks.

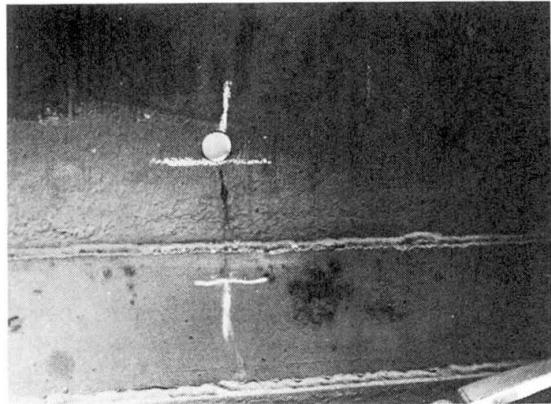
Figure 10 shows the same location looking from the inside of the girder. Note that there is no butt weld on the inside at the location of this crack. The crack has propagated from the opposite side.

Fig. 10 Cracked Through

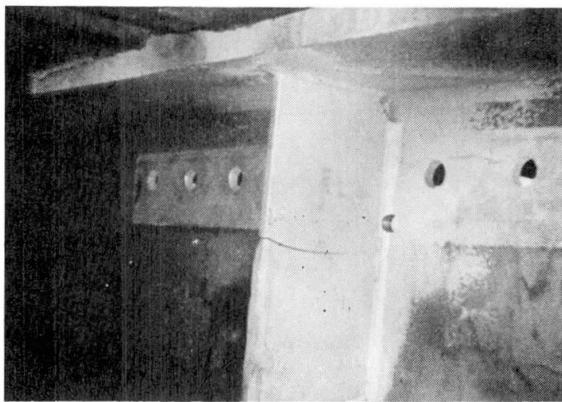
Fig. 11 Hole at Stiffener

1. Drill 7/16 diameter holes on both sides at the stiffener through the web at an approximate angle of 30° away from the stiffener (Figure 11) making sure

to get a truly circular hole with as few rough edges as possible.

2. The resulting hole in the web should be reamed from the outside using a reamer of the same diameter throughout.
3. Attention should be taken so that all rough edges are made smooth even though a truly circular hole is not obtained. Hand filing may be necessary.

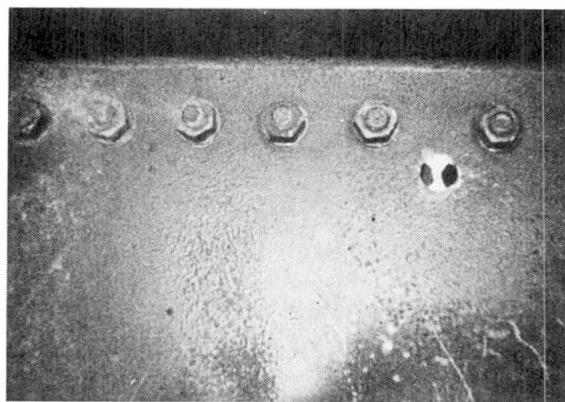
Fig. 12 Other Side

Figure 12 was taken after the two holes drilled from the inside had been reamed to one hole from the outside flush with the stiffener on the inside. The white metal along the vertical centerline of the hole is the stiffener.

In cases where the round hole remains an unacceptable fatigue detail, and where it is physically possible, a high strength bolt can be placed ensuring that the non-burr side of the washer is placed against the steel. The clamping force of the bolt will ensure a better detail and will prevent any further crack propagation should the crack tip have penetrated the far side of the hole. After stopping the crack, attention can then be focused on the repair.

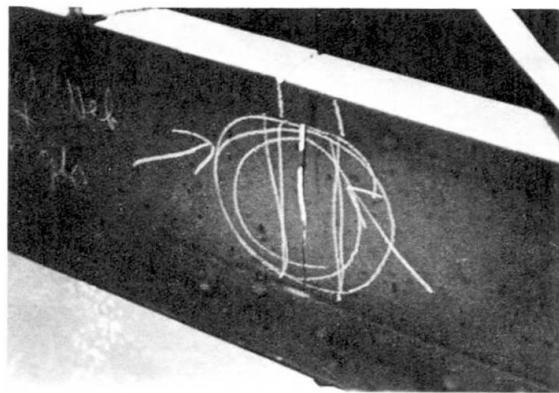
Most riveted structures were internally member redundant in that they were fabricated of several components (Figure 3). Their advantage is that cracks do not jump from piece to piece. The chord member of the truss shown in Figure 13 cracked on one side, but not on the other side of the member, and carried rail traffic for some time before detection and repair. In a welded box like member the crack would have propagated all around.

Fig. 13 Crack in chord

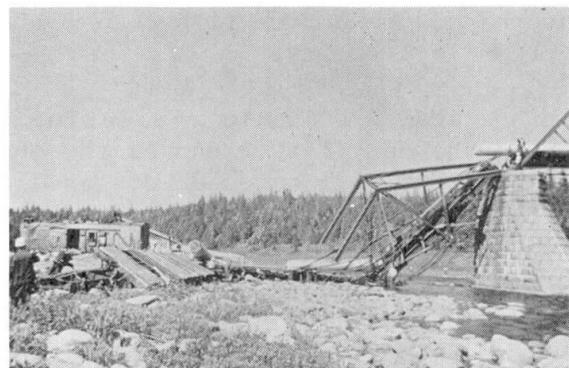
Fig. 15 Insufficient Redundancy

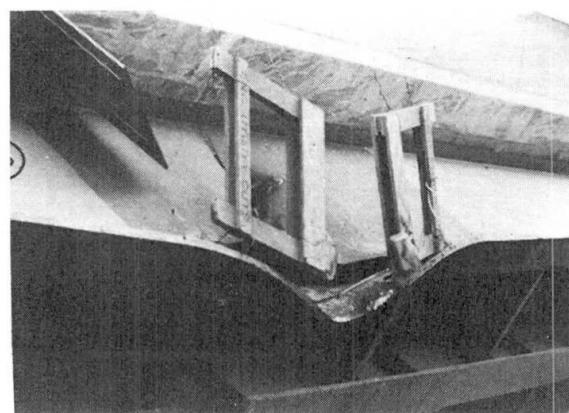
A rather striking example (Figure 16) is this multi-beam welded structure with a composite deck which was hit by the top of a backhoe. Although several girders were badly damaged, the structure did not collapse under train traffic. It is known that several trains crossed on the adjacent track after the accident. Imagine what could have happened if that had been a two girder non-composite welded system.

Fig. 16 Hit by Vehicle

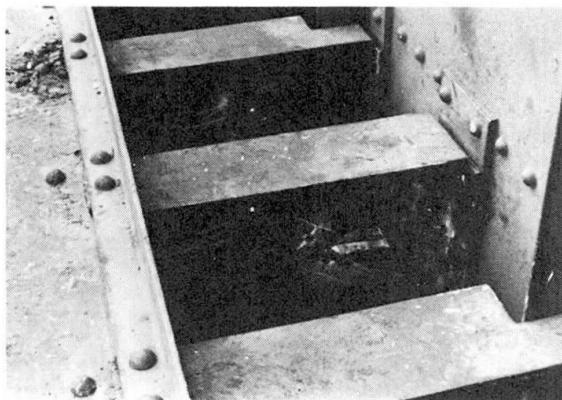
This (Figure 17) structure cracked due to torsional loading caused by constant train breaking. Although the floor beams are not welded there is no component redundancy as the beams are rolled. Nevertheless, the redundancy of the deck system has permitted regular train operations for over a year with 4 adjacent floor beams failed.

Fig. 17 Torsional loading

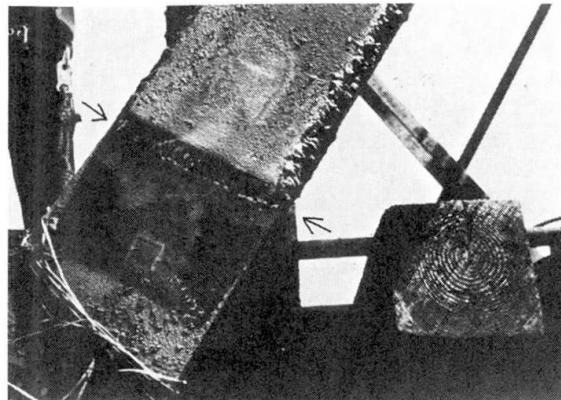
The type of repair shown in Figure 18, the addition of welded plates to an eye bar member could be a disaster in a non-redundant load path structure. The crack is illustrated by the light line of magnaflux at the toe of the weld. In this bridge, because of its multiple load paths, collapse will not occur if one of these members cracks through.

Fig. 18 Eye Bar Weld
